A STUDY ON
RIVER BANK EROSION ALONG
BATANG RAJANG
AND
ITS DISTRIBUTARIES

C. P. LIM, Y. L. TIE

SEPTEMBER, 1977

SOIL SURVEY DIVISION
RESEARCH BRANCH

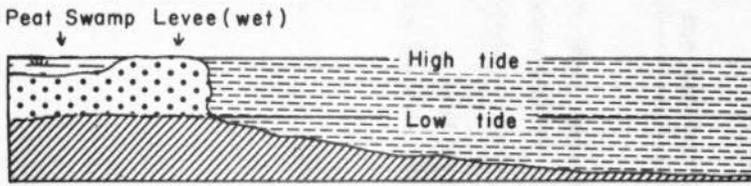
FIG. 2a. Lower river section : flood plain
Narrow levee alluvium, permanently wet;
bank subjected to daily erosion between low and high
tides. (Section corresponds approximately to Binatang
and downriver)

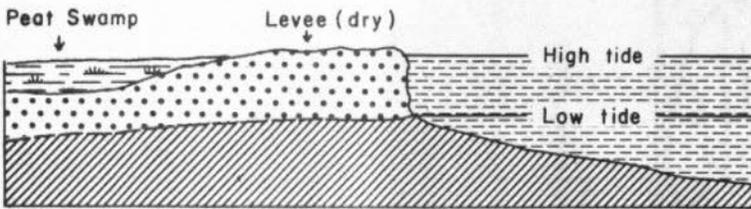
FIG. 2b. Lower - middle river section : flood plain
Extensive levee alluvium, mainly dry and highly erodible;
bank subjected to daily erosion between low and high
tides (Section corresponds approximately to
Durin - Binatang)

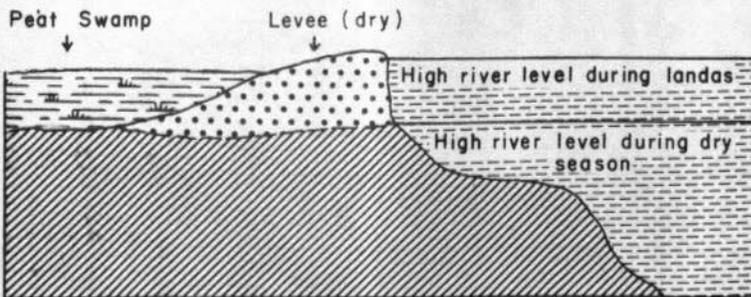
FIG. 2c. Middle river section : flood plain
Deep narrow levee alluvium backed by peat swamp;
river bank erosion is seasonal and occurs mainly
during landas. (Section corresponds approximately
to Durin - Song)

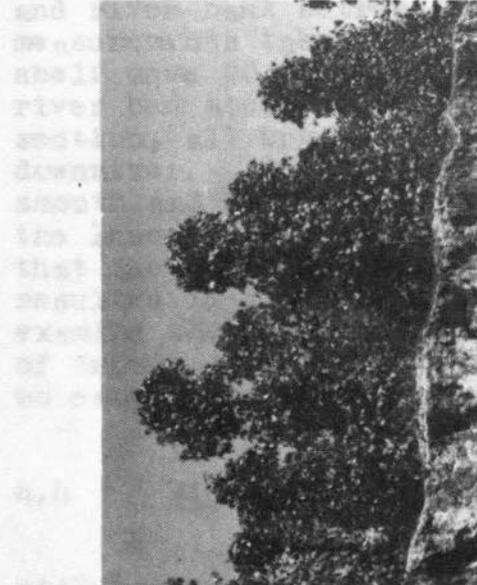
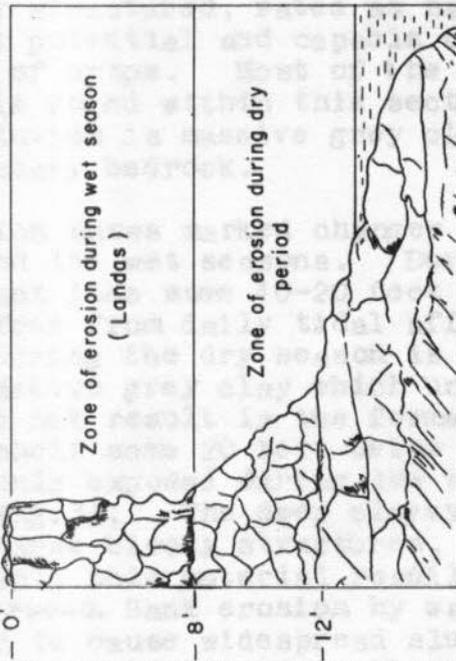
Weakly structured deep clay loam to clay above tidal zone during dry period but severely eroded during landas when river level is high.

Massive clay, permanently wet, erosion occurs mainly during dry period when river level is low.

Eroded shelving bank partly submerged and steepened by river current.

Fig. 3 : Riverbank section near Durin showing the zones of erosion during the dry and wet seasons.

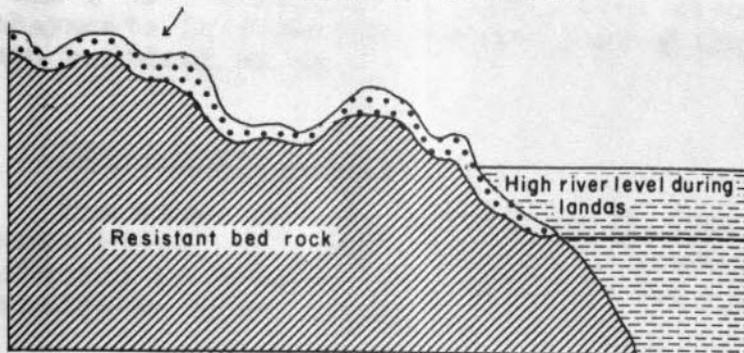
FIG. 2d. Middle-upper river section : low hilly

River bank erosion occurs only during landas and results in slope steepening and slope retreat.

(Section corresponds approximately to Song-Kapit)

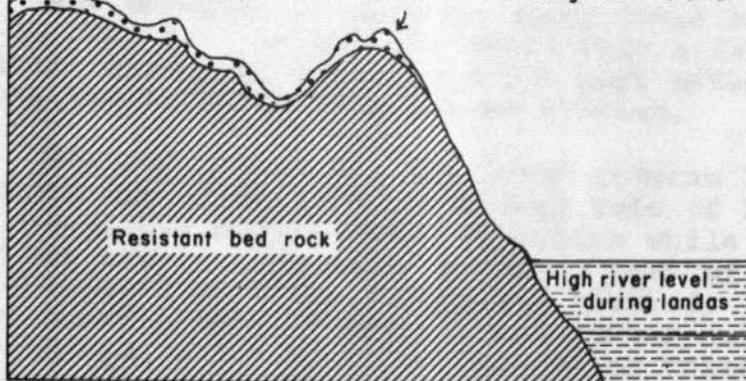
FIG. 2e. Upper river section : steep hilly

Very little erosion as river bank is bedrock controlled and not affected by seasonal river level changes.

(Section corresponds to Kapit - Pelagus and upriver)

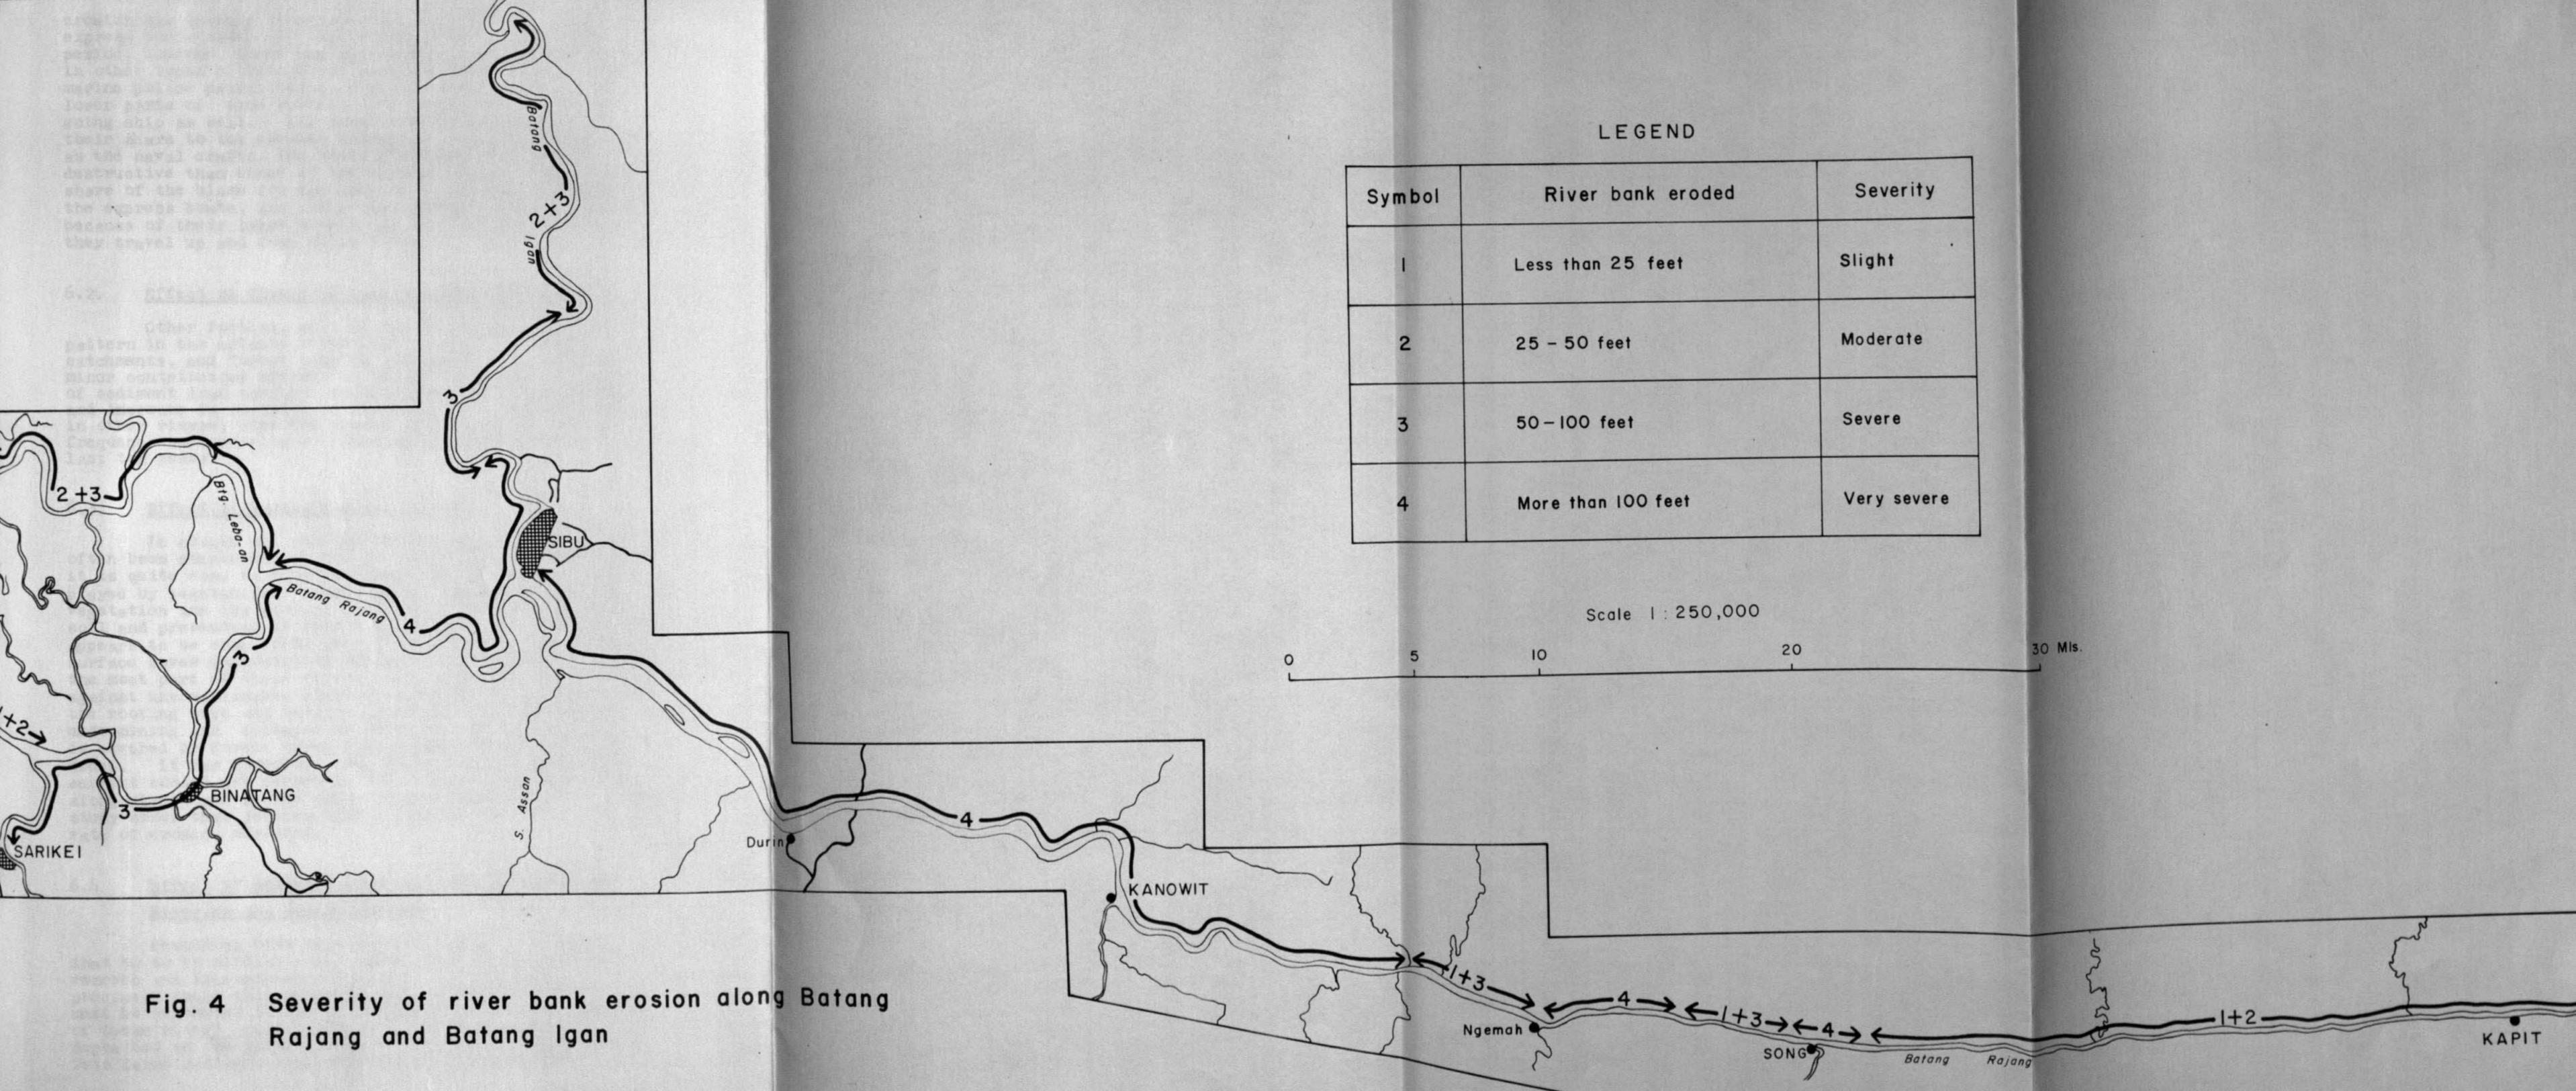
Fig. 4 Severity of river bank erosion along Batang Rajang and Batang Igan

The severity of erosion along these rivers is shown in Fig. 4. It will be noted that a large part of the rivers examined, especially the part between Sarikei and Song has suffered very severe erosion.

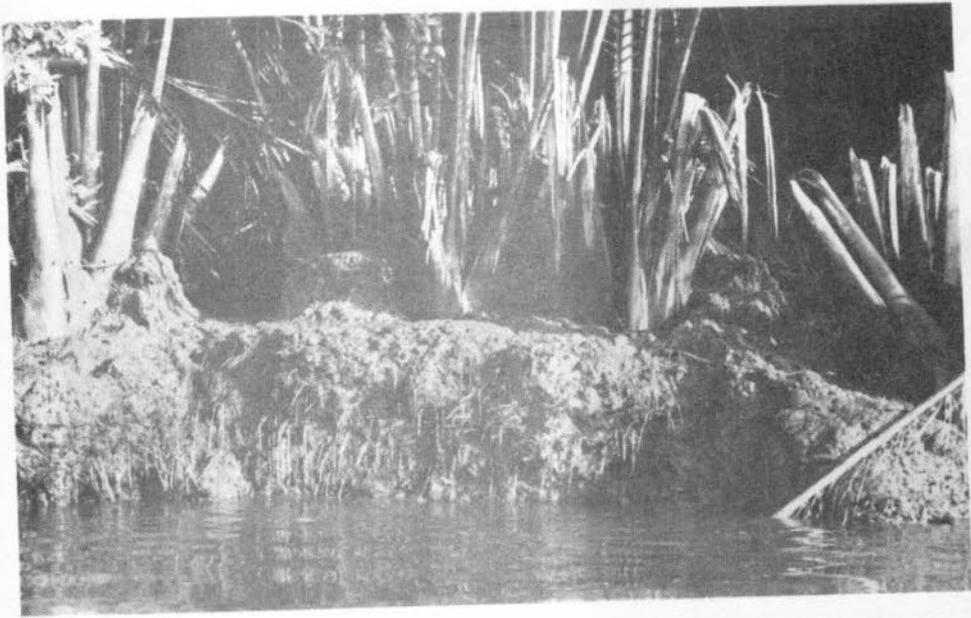
Plate 1. *Fig. 3.* River bank along Sarikei-Binatang with nipah palms (*Nipa fruticans*) being eroded.

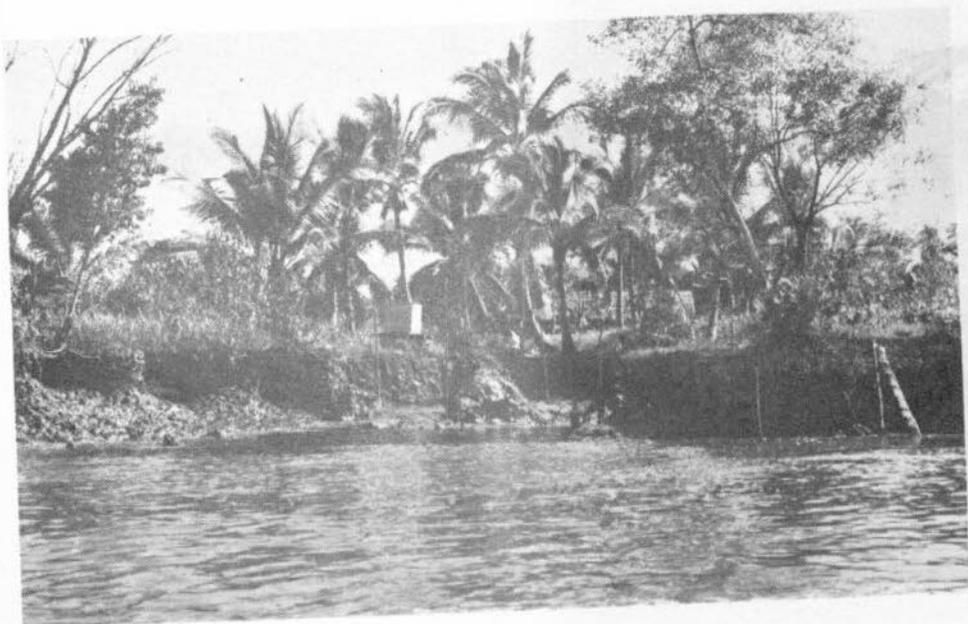
Plate 2. *Fig. 4.* Wave tunnelling into river bank which is subjected to daily tidal fluctuation, commonly seen between Durin and Binatang. Photograph shows Kg. Selamas near Binatang. Most of the old kampong houses, together with fruit trees have been eroded.

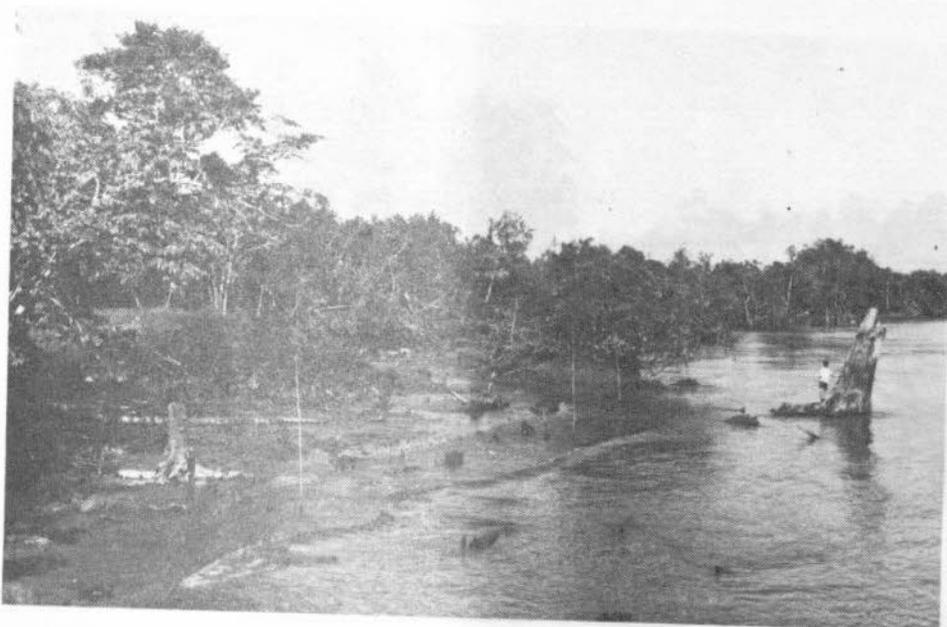
Plate 3. Kampong Mauh along Batang Rajang, downriver from Sibul. Three years ago the river bank was at the tree trunk on the right of the photograph; more than 50 feet of river bank has been eroded during this period.

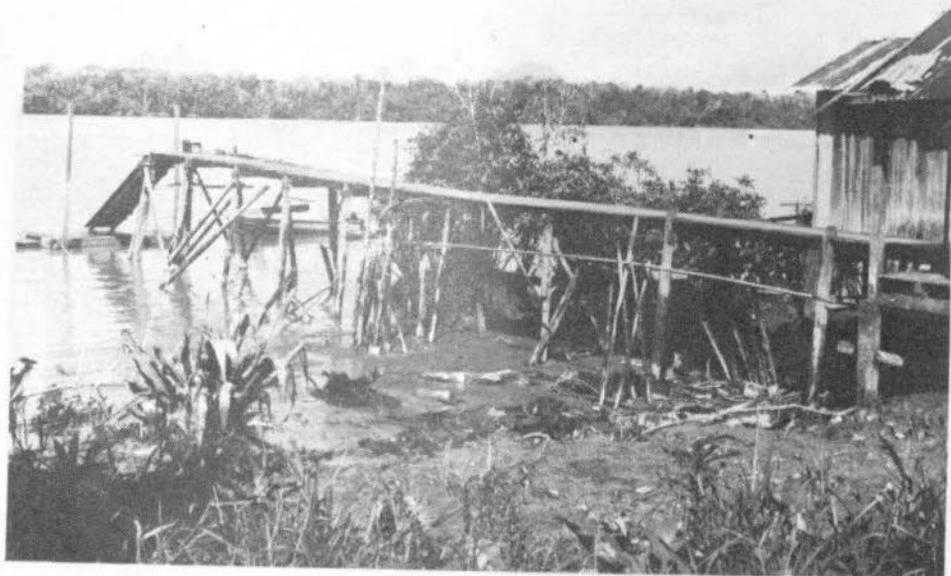
Plate 4. River bank at Bukit Lan along Batang Rajang, downriver from Sibul. Before express boats came into operation, the river bank was at landing raft, 120 feet from the present bank.

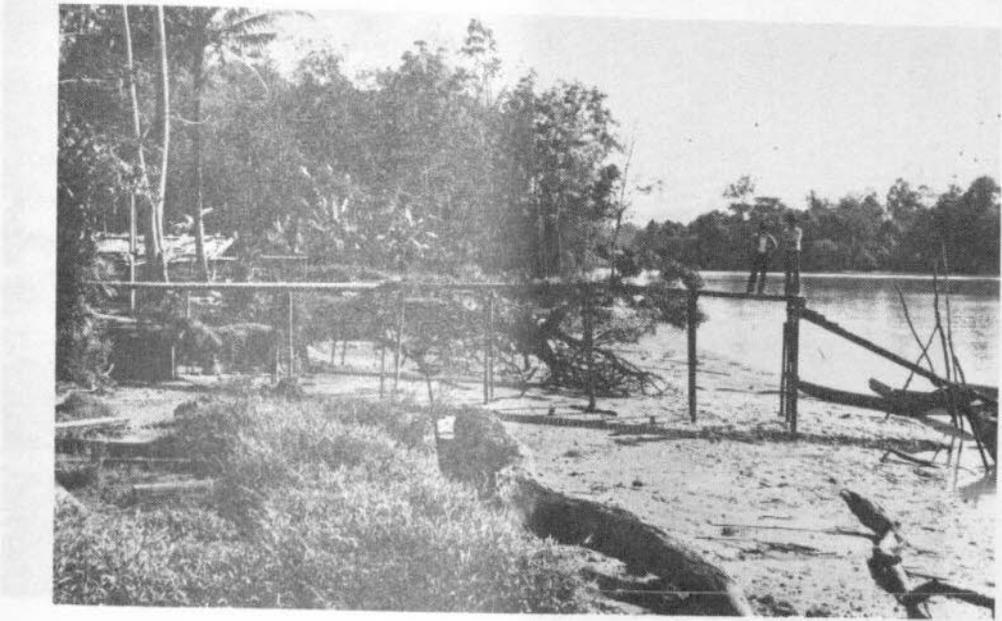
Plate 5. Eroded river bank at Rumah Janin along Batang Igan, downriver from Sibul. More than 100 feet of river bank eroded within 12 years.

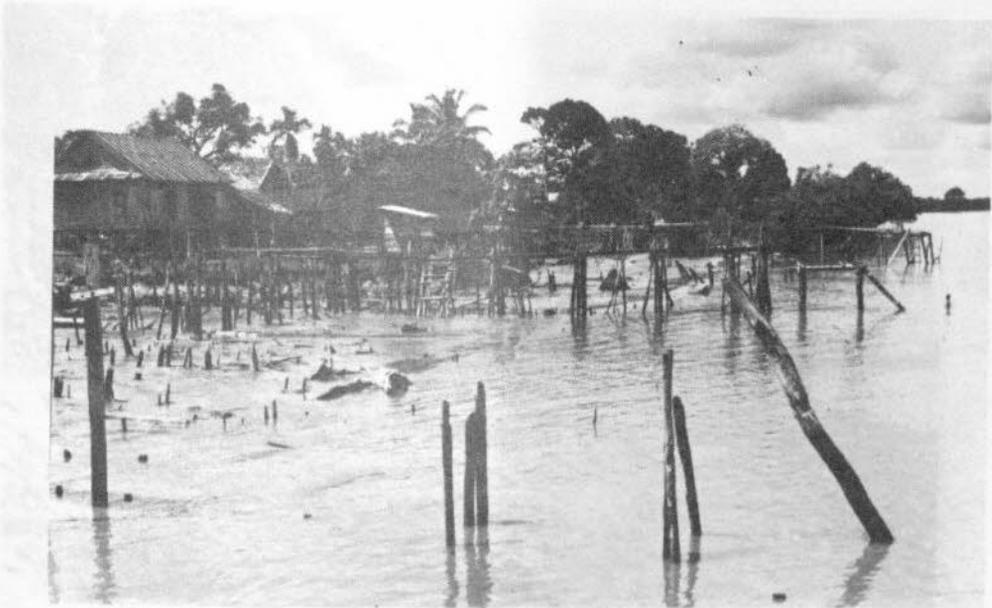
Plate 6. Jetties of Kampong Banyok near Sibul, completely destroyed. More than 120 feet of river bank has been eroded and many houses in the kampong are already endangered by wave erosion.

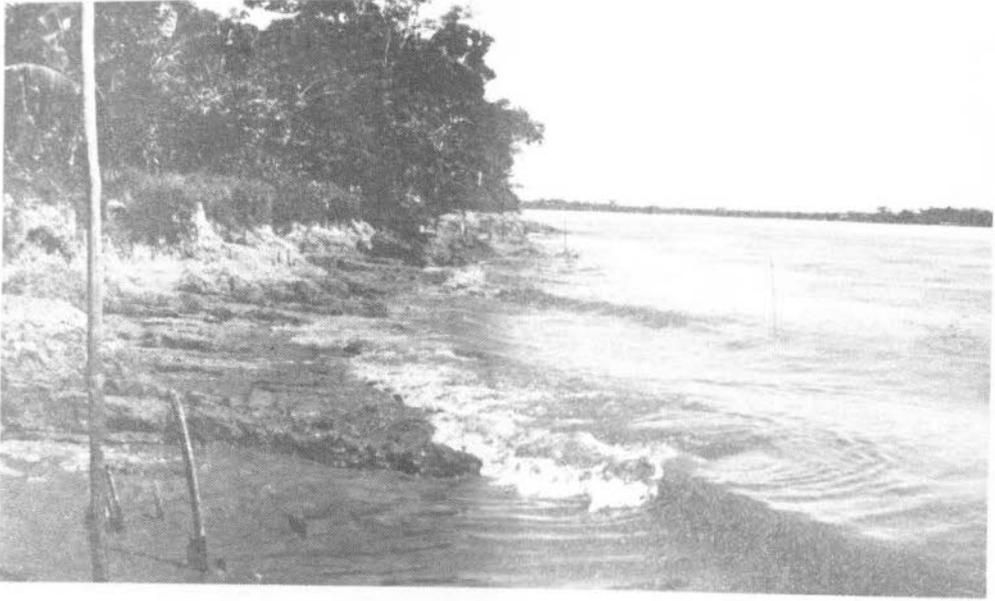
Plate 7. Wave generated by a passing express boat during low tide near Sibou. Erosion is most active during high tide.

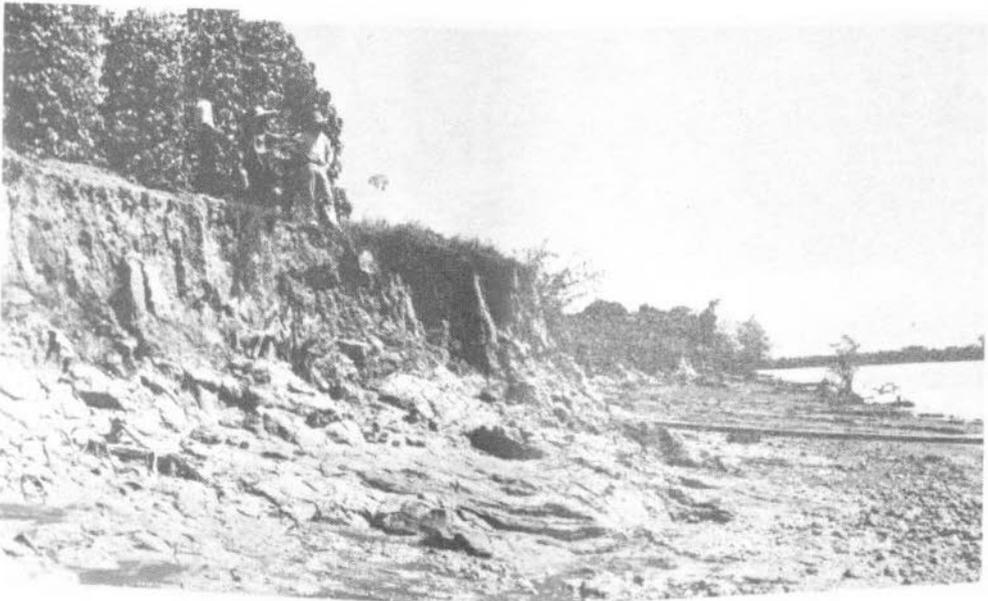
Plate 8. Eroded river bank near Durin. More than 120 feet of river bank eroded during the last 12 years. This farmer has lost most of his good land and pepper vines.

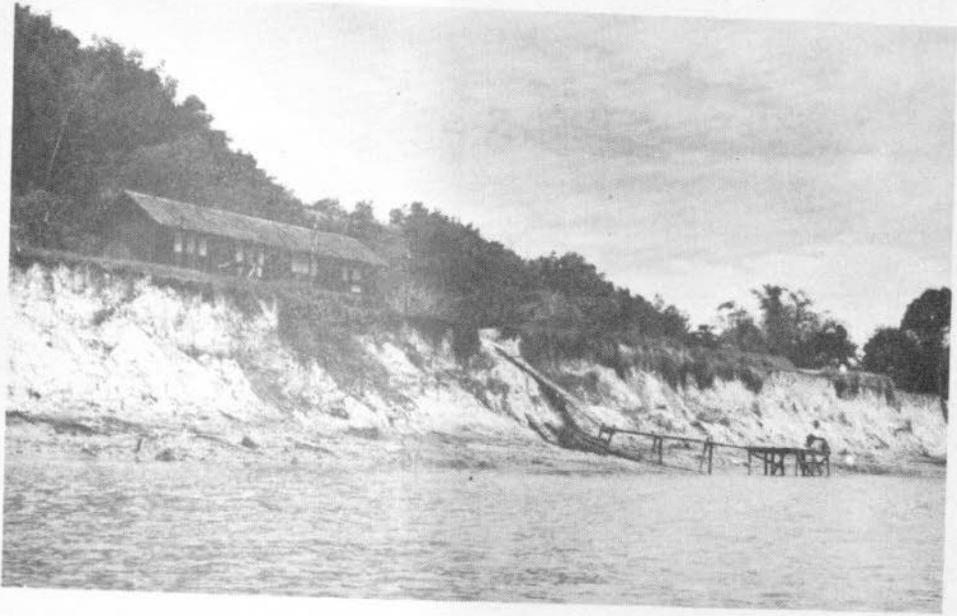
Plate 9.

Very severe erosion occurs on this deep but weakly consolidated alluvium commonly seen between Kanowit and Song along Batang Rajang. The base of this alluvial deposit is being undermined during the dry season and as the river rises during the Landas, wave erosion causes extensive vertical collapse.

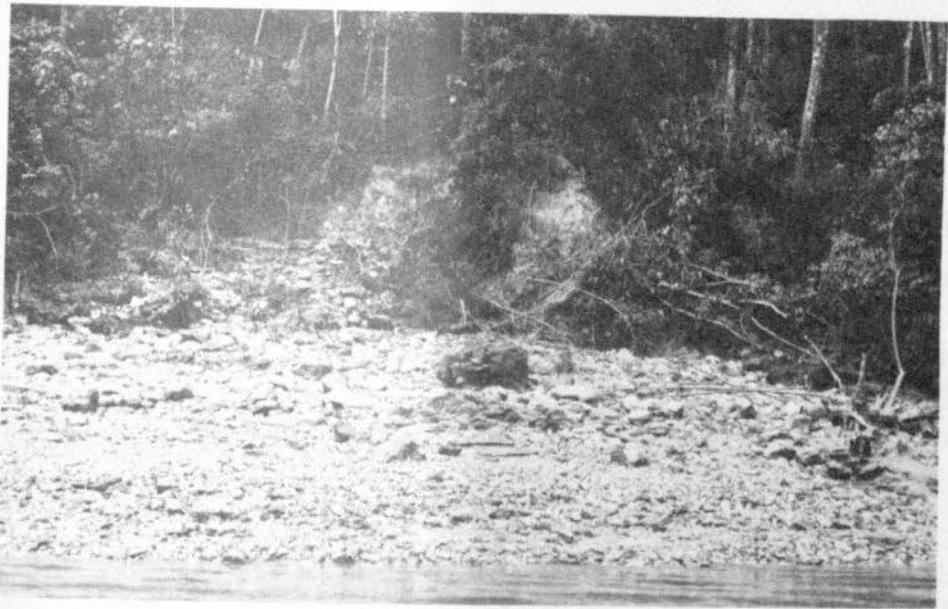
Plate 10.

15-30 feet below the river bank and wave erosion at this time is confined to the steepening of the footslope or base of the alluvium. Some of this eroded material is deposited as rock debris at the footslope (Plate 10) but when the river rises during the landas, this material is removed and results in slope steepening and slope or river bank retreat. The profile of the river bank has a more irregular outline, with strong indentations or embayments in stretches formed from alluvial deposits between residual hills.

Colluvial fan of rock debris being built up at the footslope and low water mark during the dry season; this fan deposit will be completely removed during the Landas, resulting in steepening of the hill slopes flanking the river between Song and Kapit.
