**Government of Saint Lucia  
Ministry of Planning and Development**

**Watershed and Environmental Management Project  
Phase II**

**Final Report  
November 1997**

**Annex 1 Review of Phase I Works  
Annex 2 Hydrology and Meteorology  
Annex 3 Floods and Flood Plain Hazard Mapping**

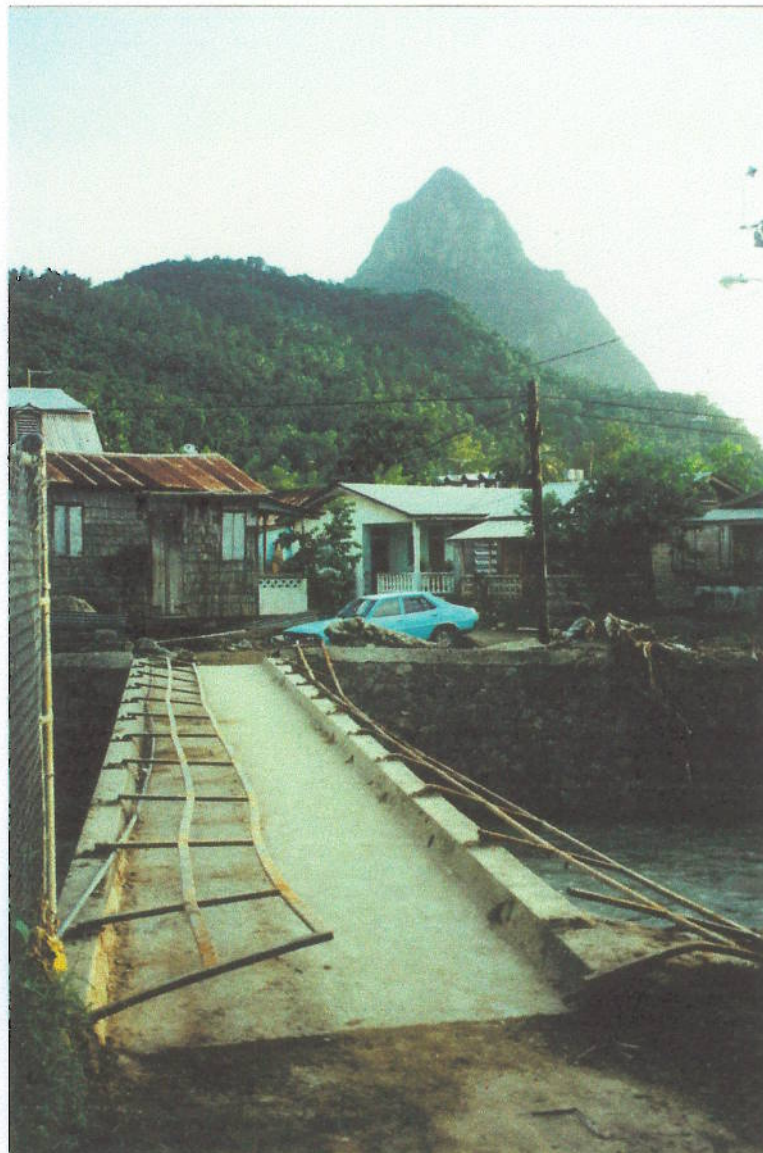
Photo 5 Soufriere Footbridge: Deep girder restricts waterway opening of bridge causing flooding.

Photo 6 Soufriere Footbridge: Handrails broken due to the pressure of floodwater.

Considerable flooding and damage was caused in Soufriere during the most recent major storm event. The main cause of this has been assessed to be the small footbridge which is located near to the main school in the town and passes over the channel. The river is totally confined at this location, on a bend in the river, where the channel section if anything is narrower than elsewhere. The span of the bridge is about 15m although the active channel, because of the bend of the river is only about 10m. The footbridge is based on two large steel I beams of depth 560mm, supported centrally by a pier and supporting a 260mm reinforced concrete slab. On the 13th of November, with a low flow in the river, the clearance from water level to bridge soffit was measured as 1.54m. It is a substantial structure and would hold back trees or other debris which impinged against it. Both handrails were flattened by the October 16th event as debris must have collected against them as the bridge was overtopped, directing flows out of the channel into town. See **Photos 5 and 6**.

The footbridge predated TSD and the Phase 1 works. It was probably not tested during TSD since flows were lost out of channel upstream. However, there are indications that the flood discharge down the river on the 26th was larger than TSD however no flood discharge estimates are available to substantiate this. The main evidence is the condition of the channel upstream from the new bridge, this has reportedly a far greater density and extent of deposited large boulders than post TSD..

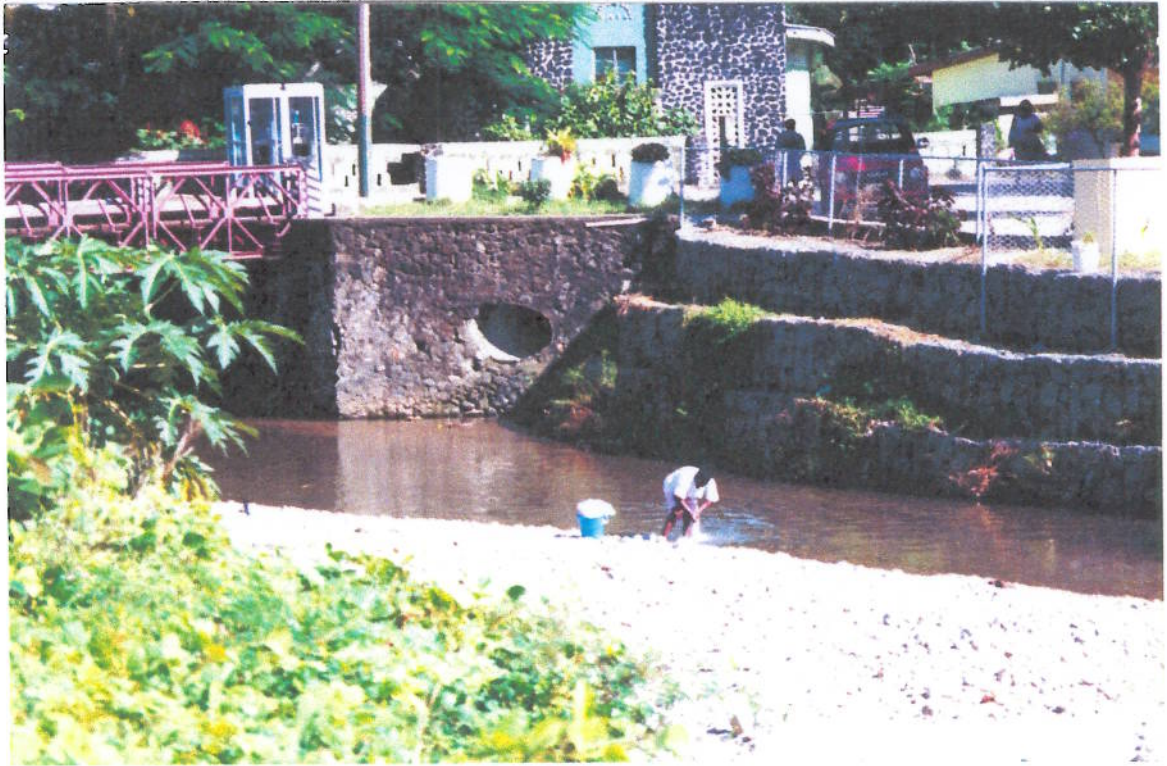
Photo 11 Phase 1 Works: Canaries just upstream of Photo 13. New retaining wall. Gabions fore.

The damage caused by the large discharges of October 26th was considerable. The collapse of the masonry wall and the dislodgement of some of the gabion protection measures is presented in **Photos 11 and 12**. Discussions with several local residents revealed that the general opinion was that the floods of 26th in the River Canaries were as bad if not worse than those of TSD. The Phase 1 works had not been designed for such an event. The damage to the main west coast road bridge at Canaries, some 100m downstream from the retaining wall failure is shown in **Photos 13 and 14**.

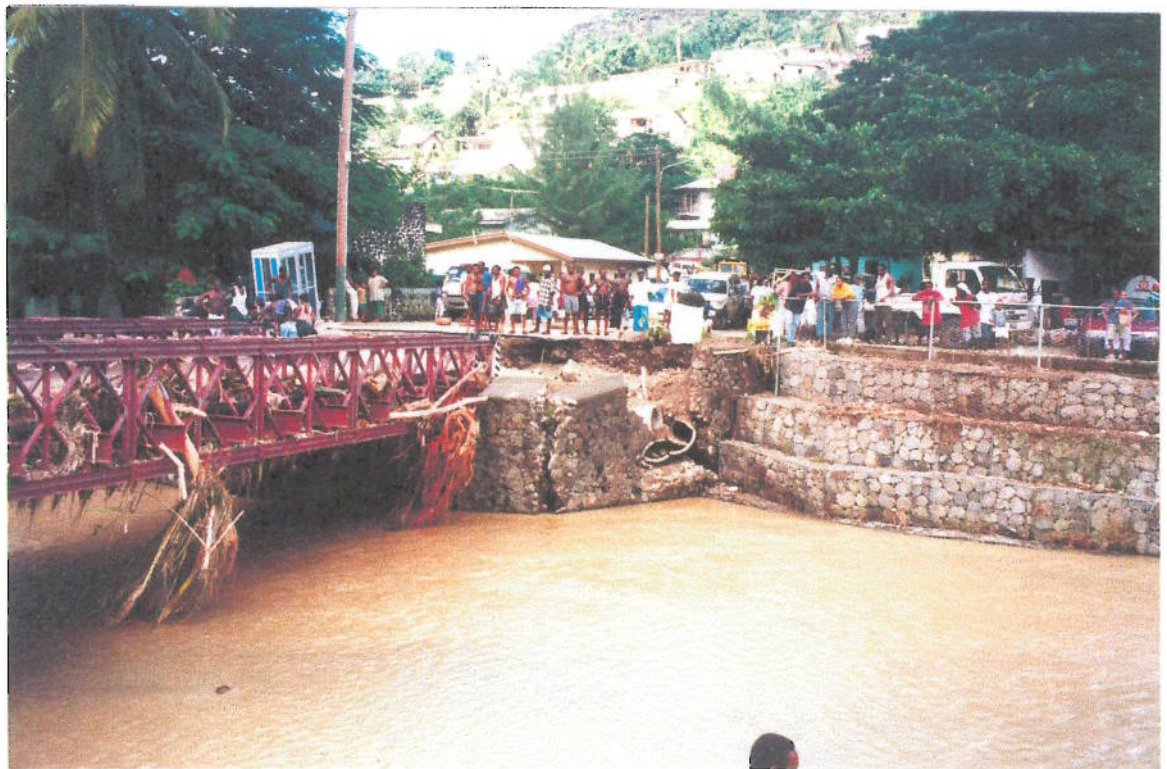
Photo 13    Canaries: Main West Coast Road bridge right abutment before 26th: Poor condition?

Photo 14    Canaries: Location as per Photo 13 showing abutment collapse after flood of 26th. Oct..

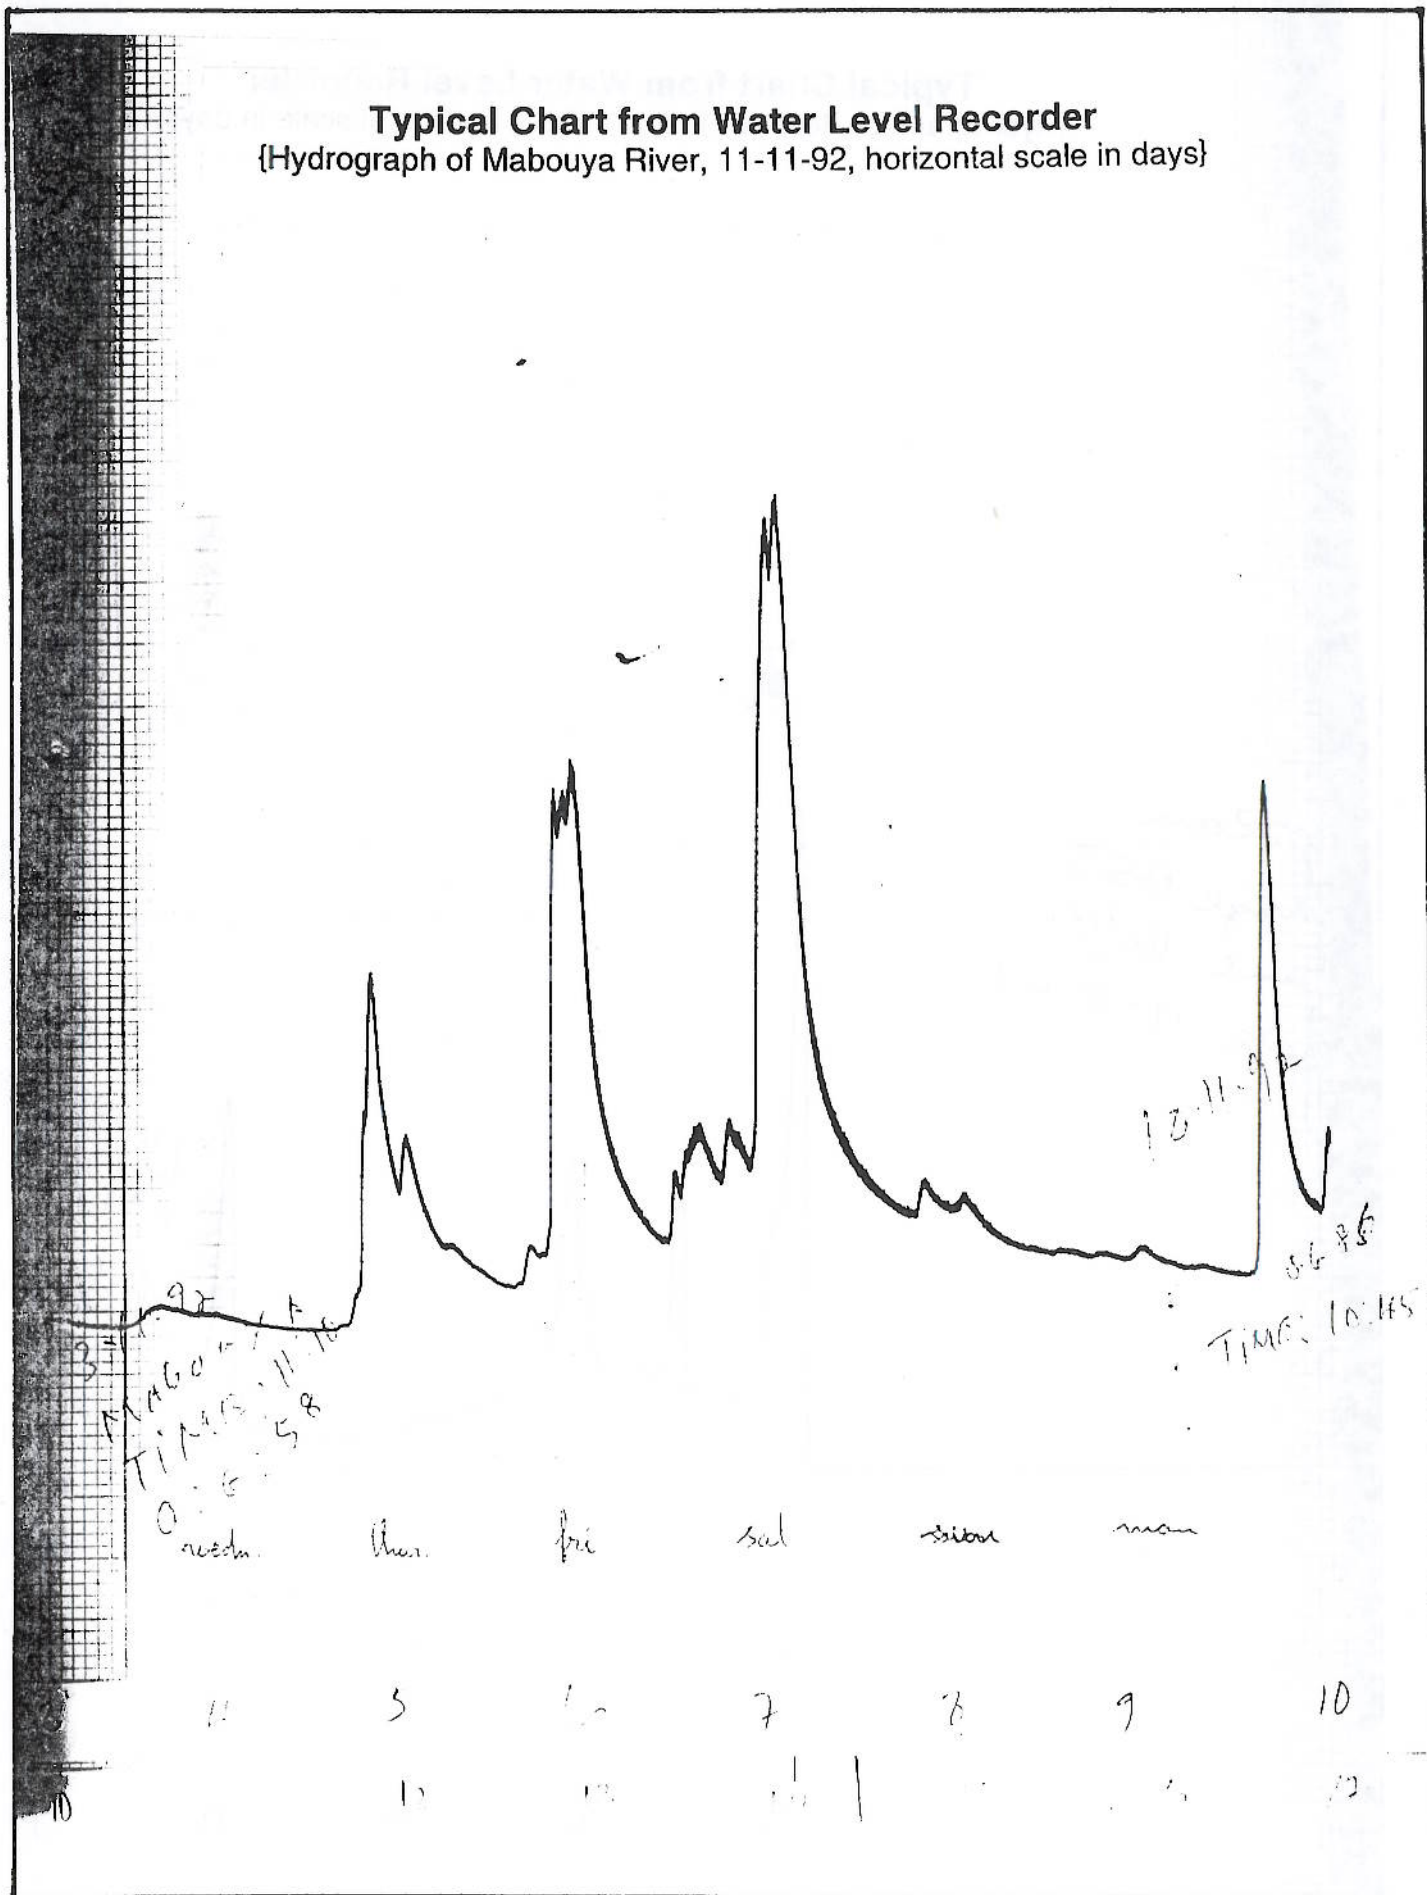
Figure 3.4

**Typical Chart from Water Level Recorder**  
 {Hydrograph of Mabouya River, 11-11-92, horizontal scale in days}

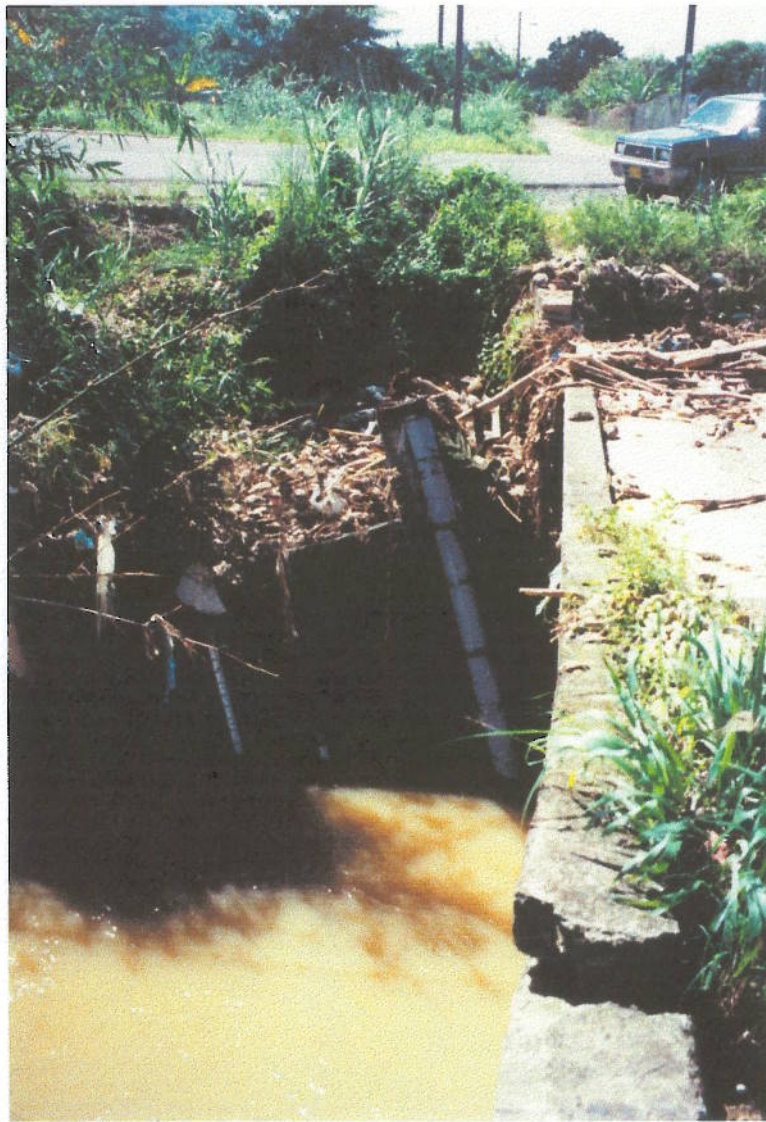
Photo 19 Cul de Sac River. Broken water level recorder station at Ferrands Bridge.

Historically WASA used to measure discharges at their intakes, however this has been discontinued

due to budgetary problems and due to the absence of suitably trained personnel within the organisation. It is the intention of AESD to undertake this task on behalf of WASA. It is unsure as to whether the AESD planning in this respect will meet WASAs requirements. This needs to be addressed in the context of equipment proposals for Phase 2 of this Study and in relation to the capacity of AESD to undertake the tasks implied.

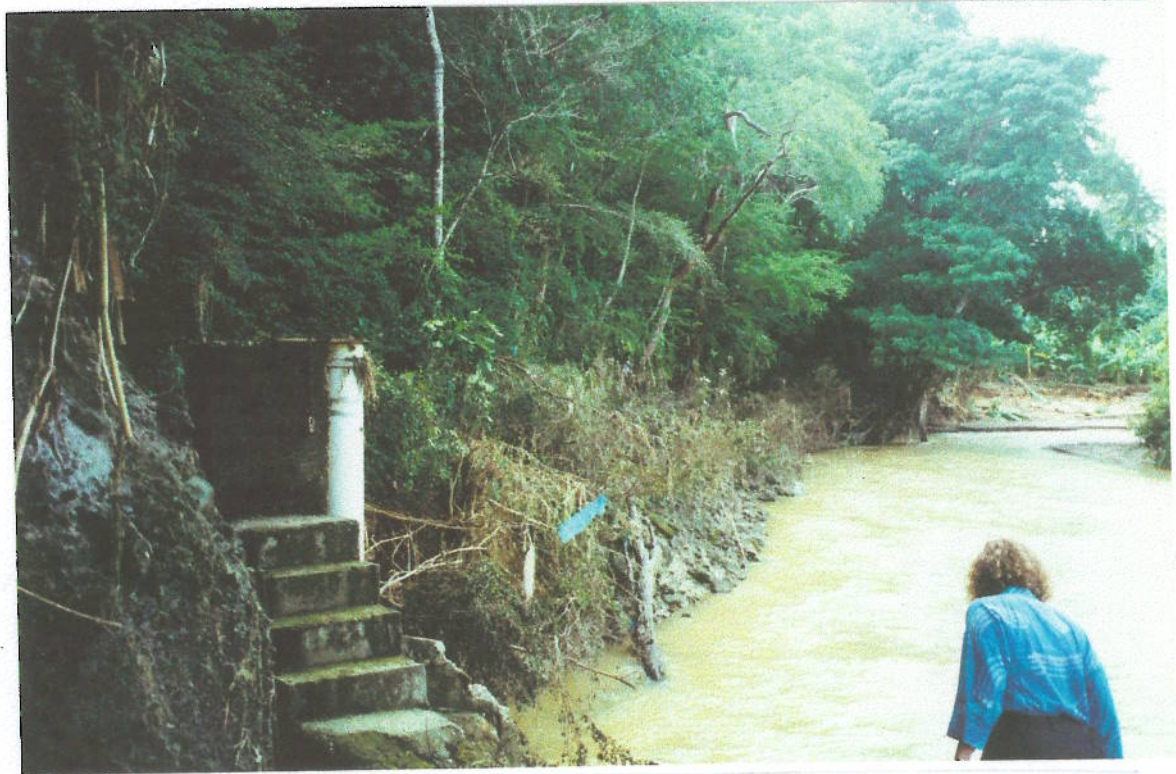
Photo 20 Troumassee River. Broken water level recorder station at Beauchamp Estate.

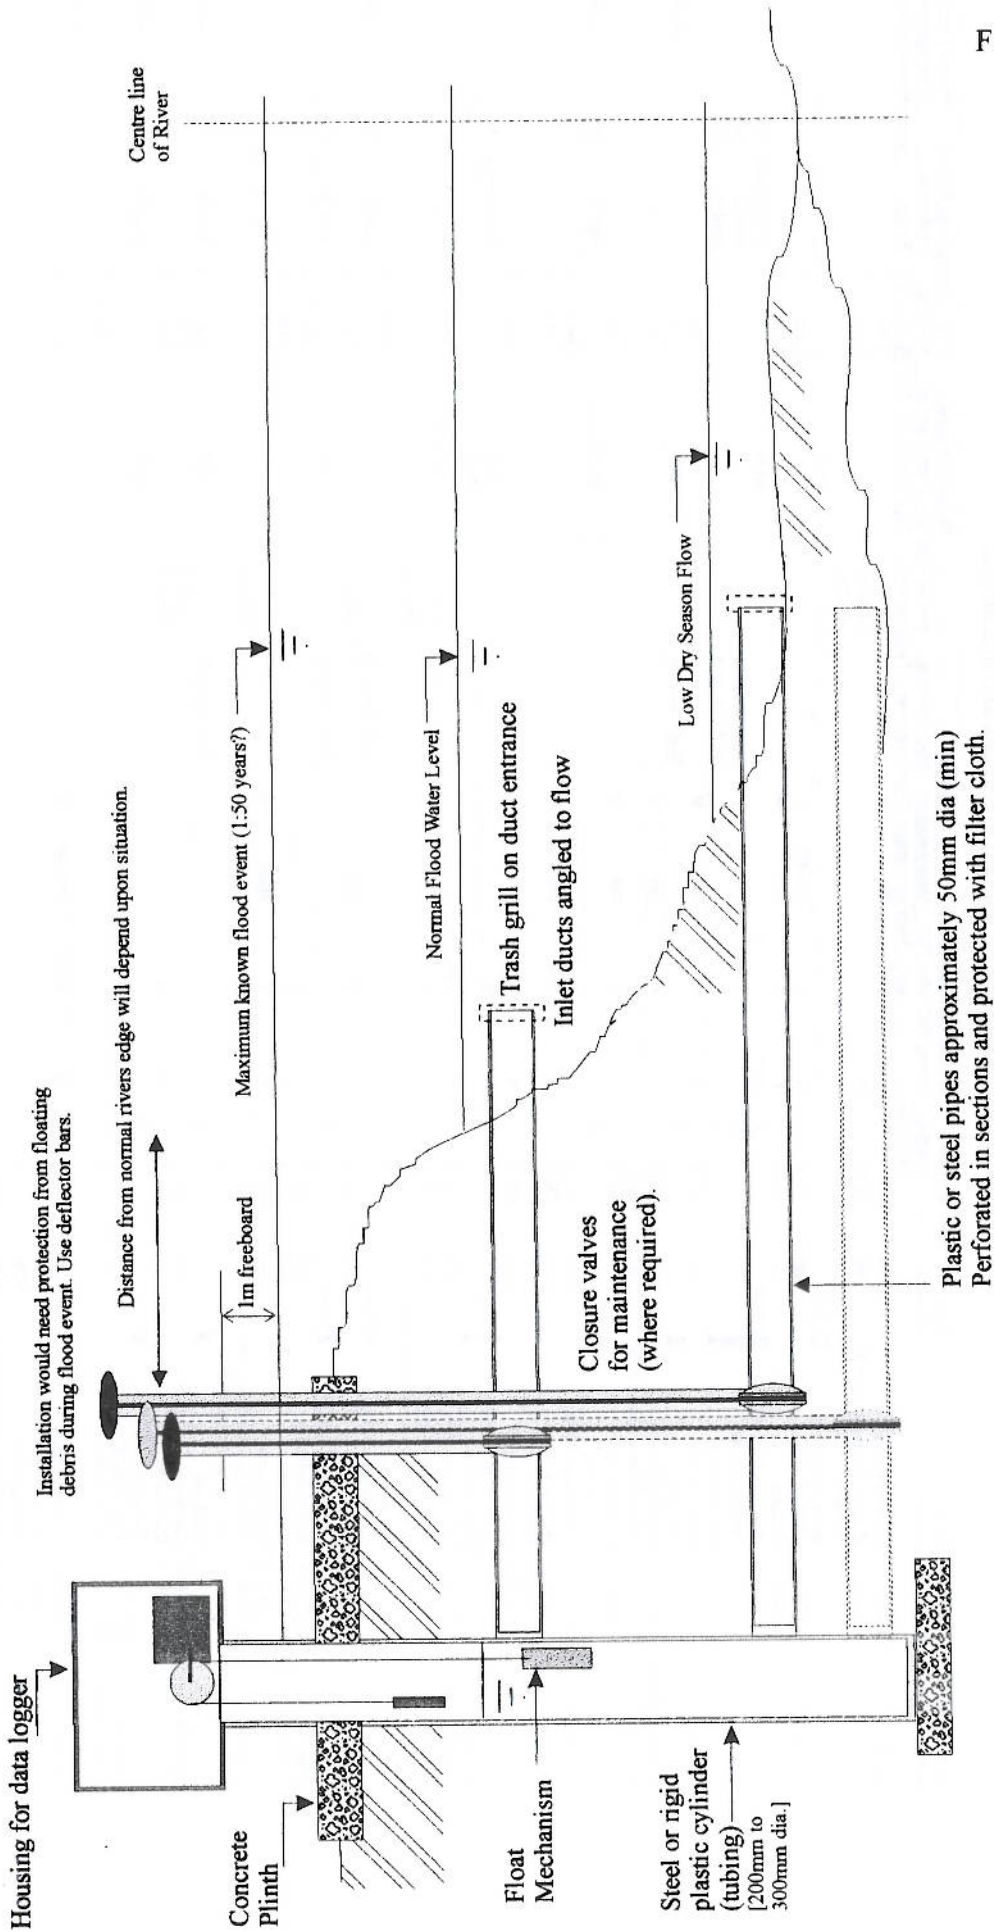
Figure 3.8

{Outline sketch only }

Note: Access/ facility for regular cleaning out of intake ducts is critical

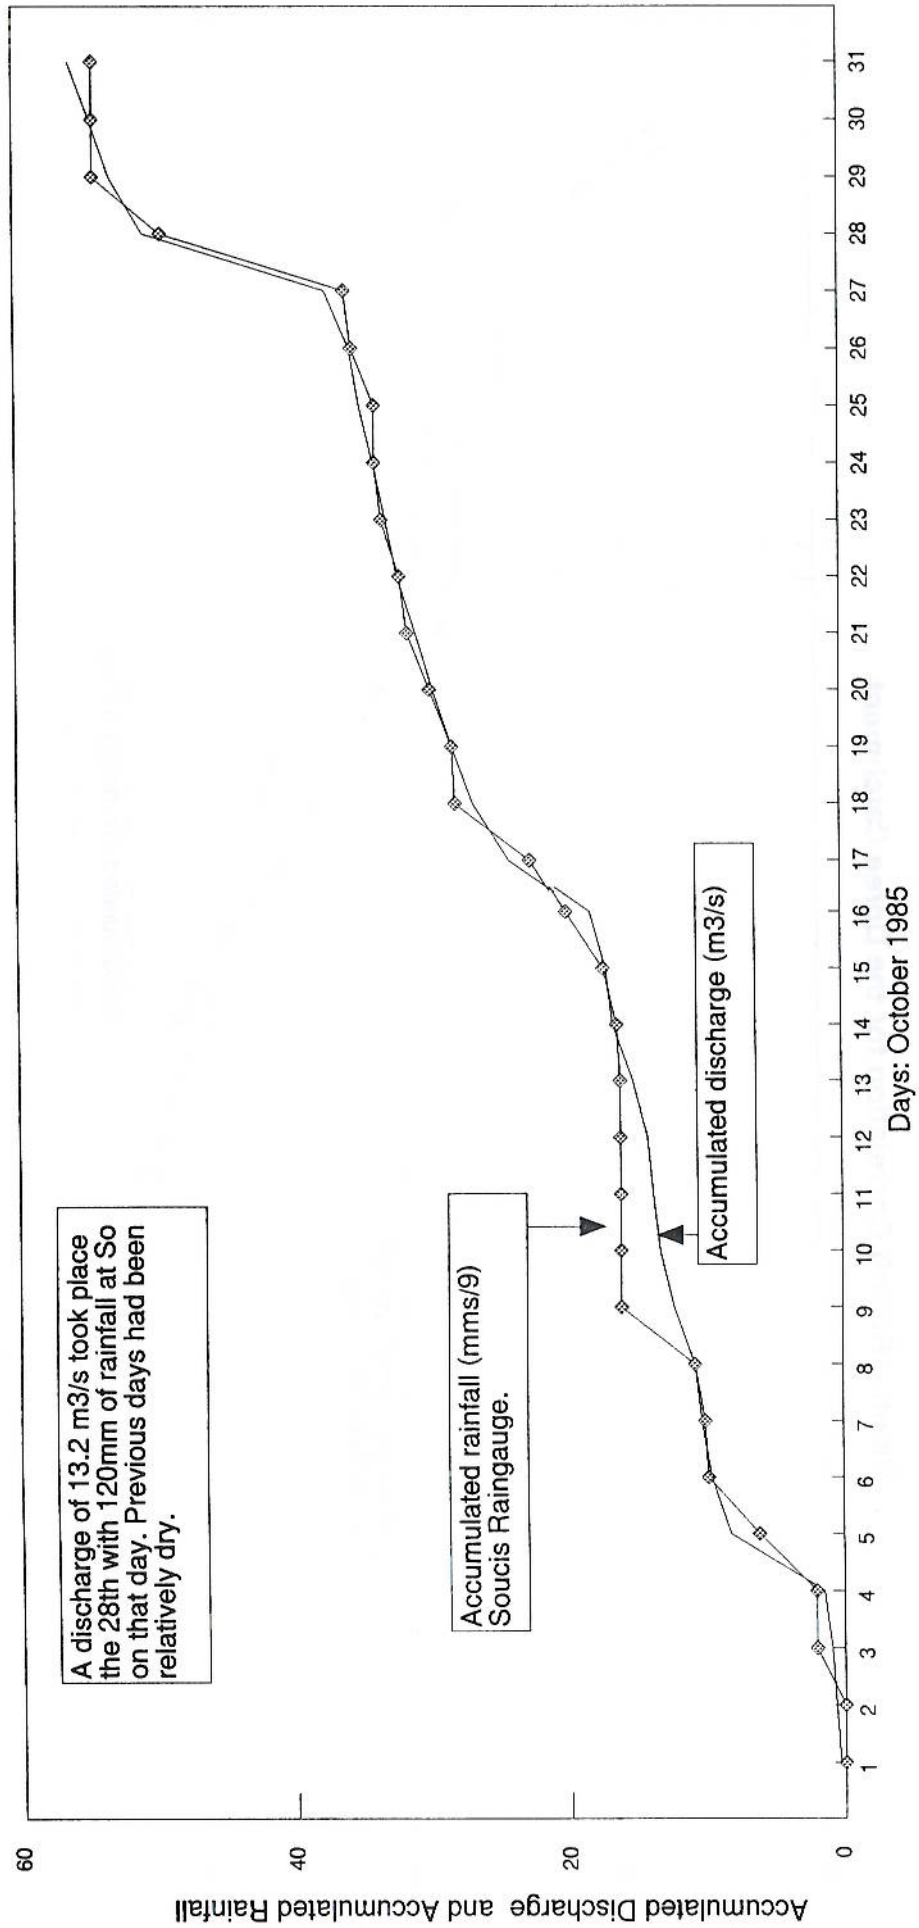
### Rainfall Runoff Correlation for the Cul de Sac Catchment, October 1985

A discharge of 13.2 m<sup>3</sup>/s took place on the 28th with 120mm of rainfall at So on that day. Previous days had been relatively dry.

Accumulated rainfall (mms/9) Soucis Raingauge.

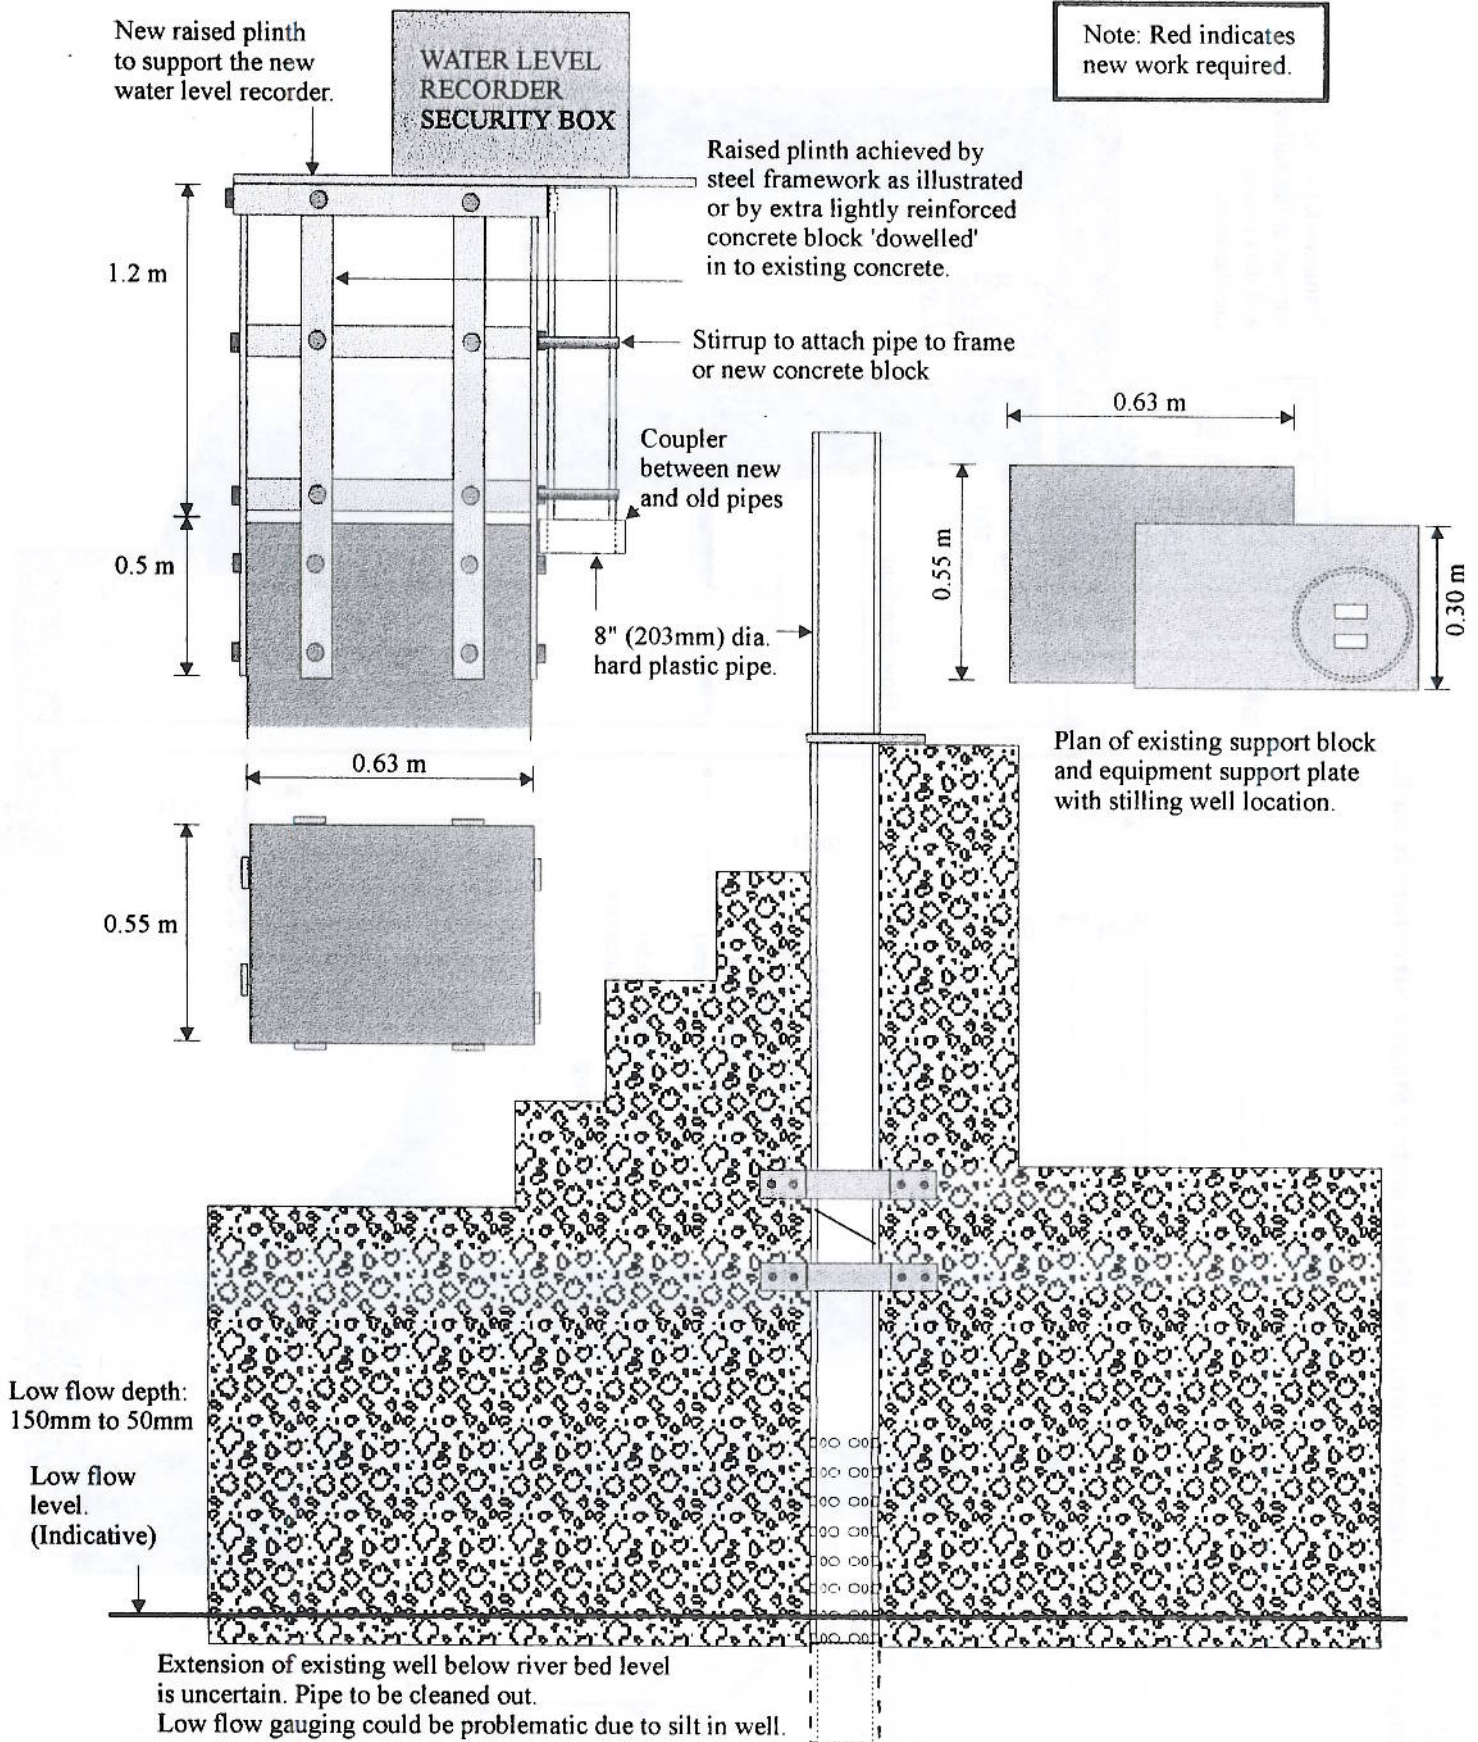
## Rehabilitation of the Hydrometric Gauge at Beauchamp Estate

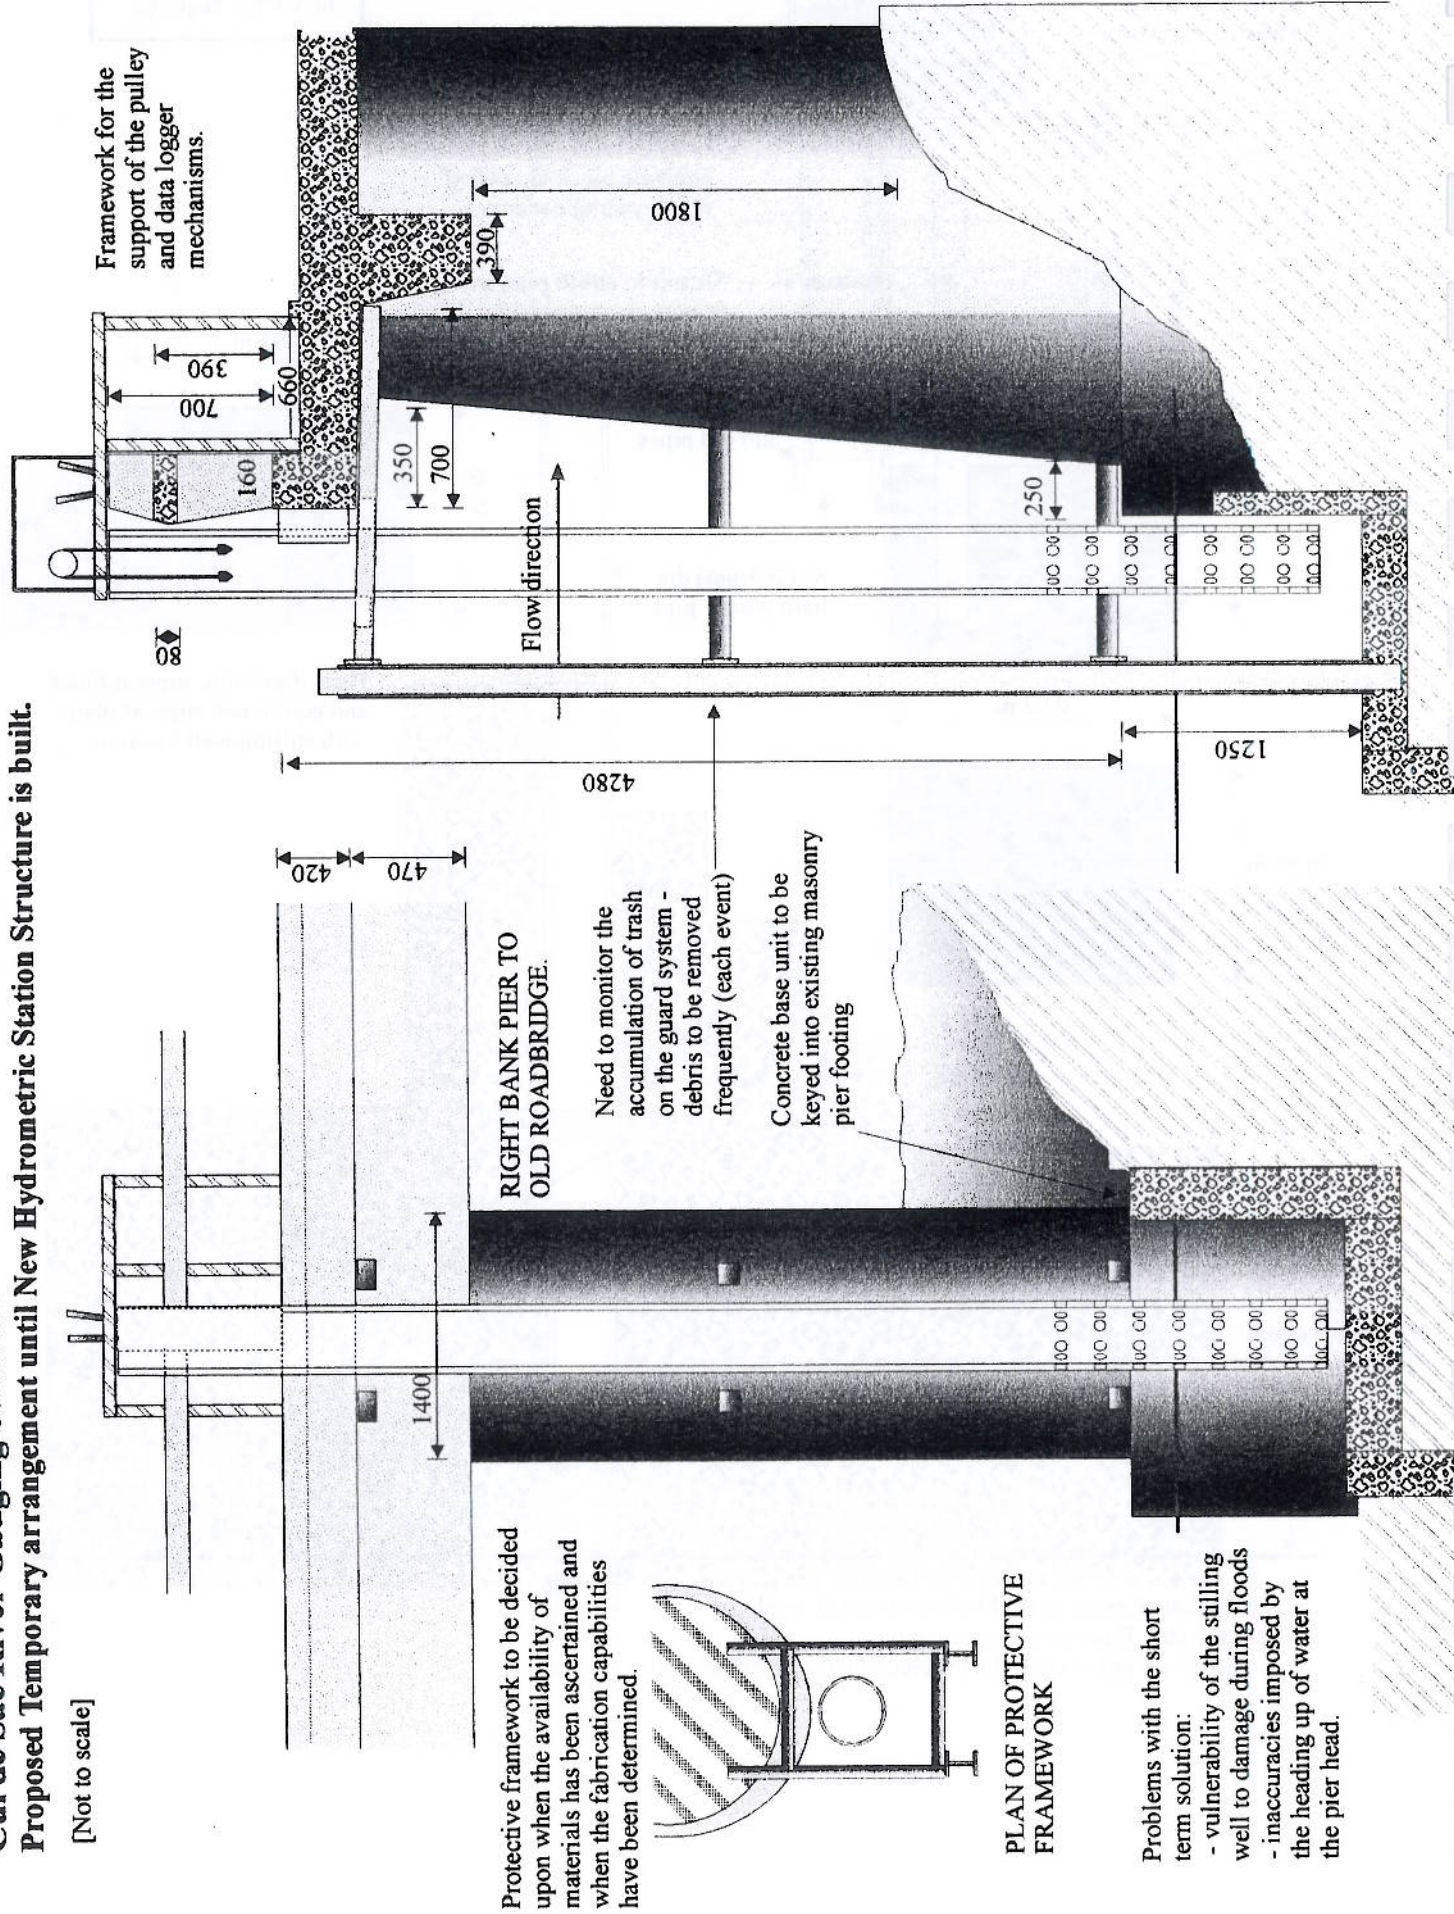
# Cul de Sac River Gauging Station. : Proposed Temporary arrangement until New Hydrometric Station Structure is built.

[Not to scale]

Protective framework to be decided upon when the availability of materials has been ascertained and when the fabrication capabilities have been determined.

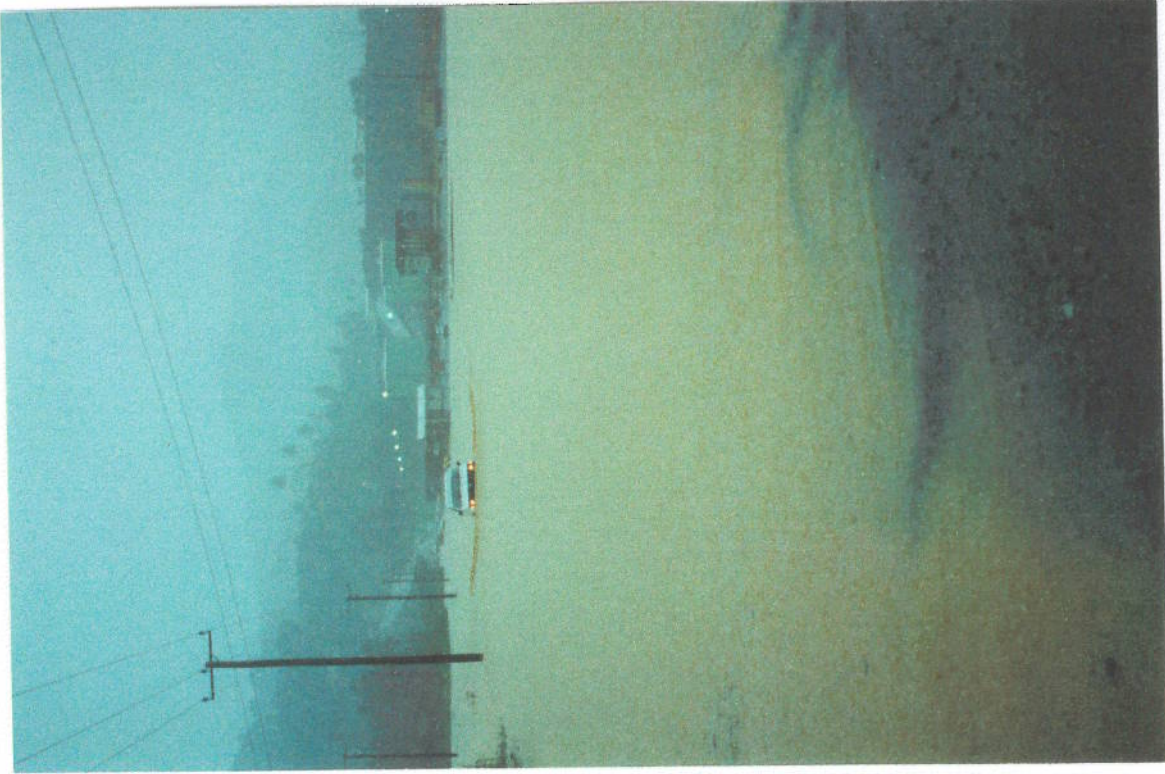
Photo 29 Cul de Sac Valley. Main west coast road looking south during flooding of 26th October

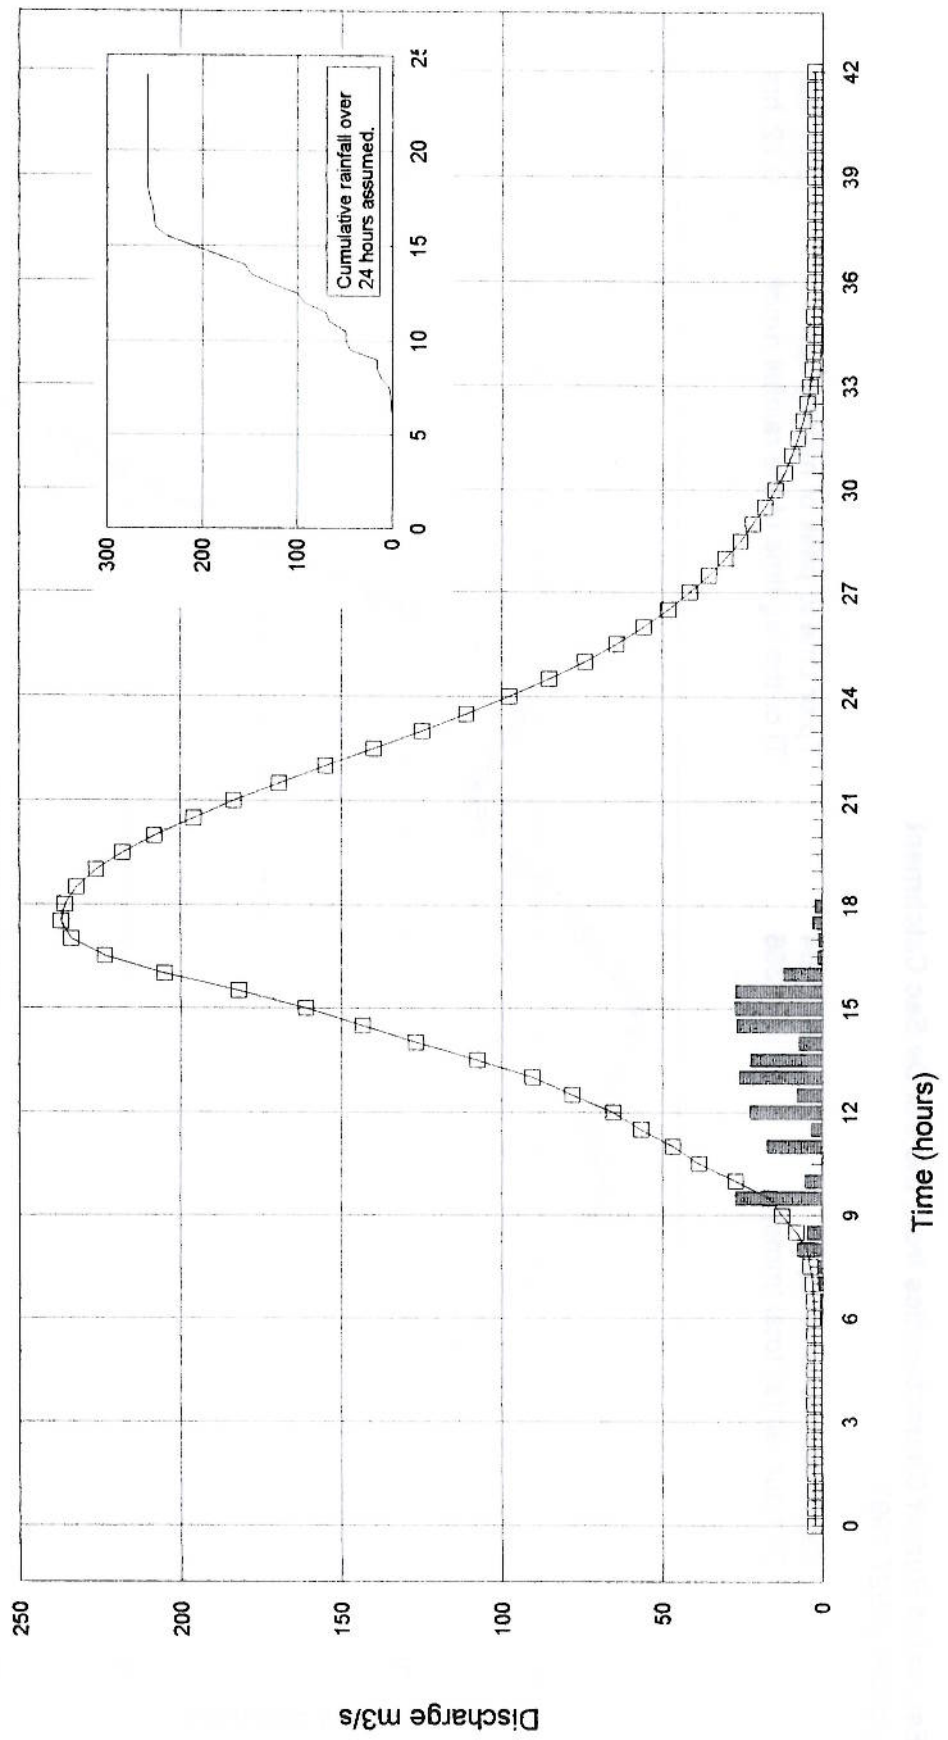
**Estimated Runoff Characteristics from the Cul De Sac Catchment**  
**October 26/27 1997**

Catchment Area (km <sup>2</sup> )	33.64	Tp or time to peak of hydrograph	2.57 hrs
24 hour rainfall total (mms)	366	Tl or the lag time of the rainfall runoff	0.72 hrs

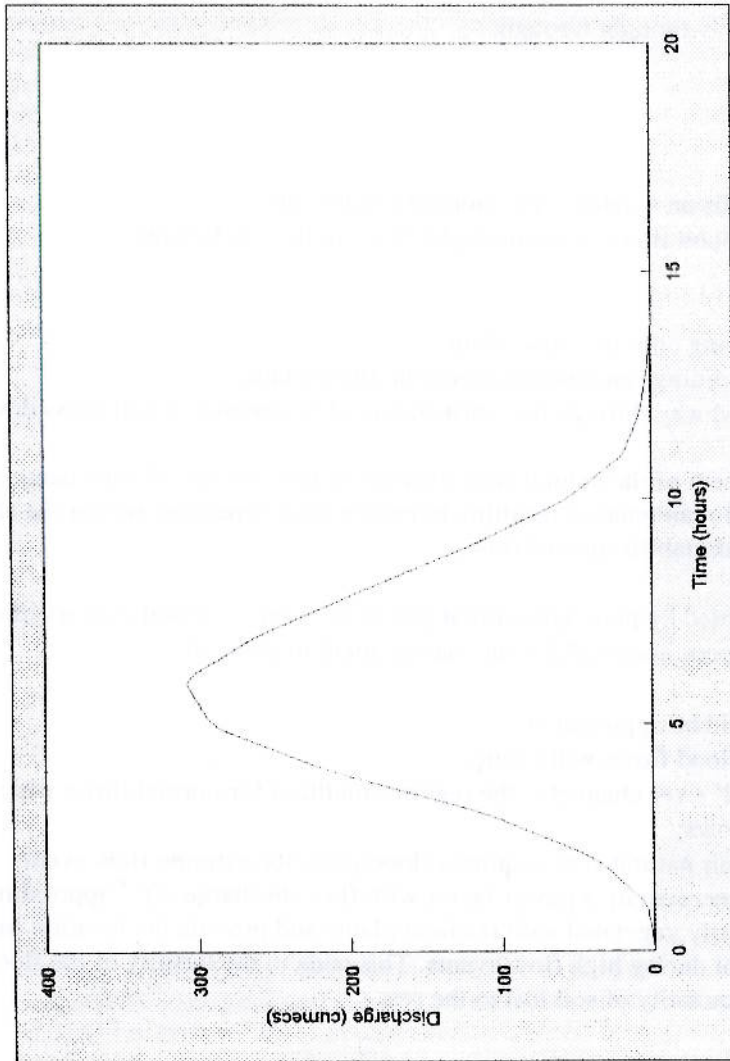
Modified to show impact of change in banana cultivation practice on flood peak  
SCS CN number changed from 0.70 to 0.60  
[This is considered to be a significant change on what is considered to be a high gross area planted]

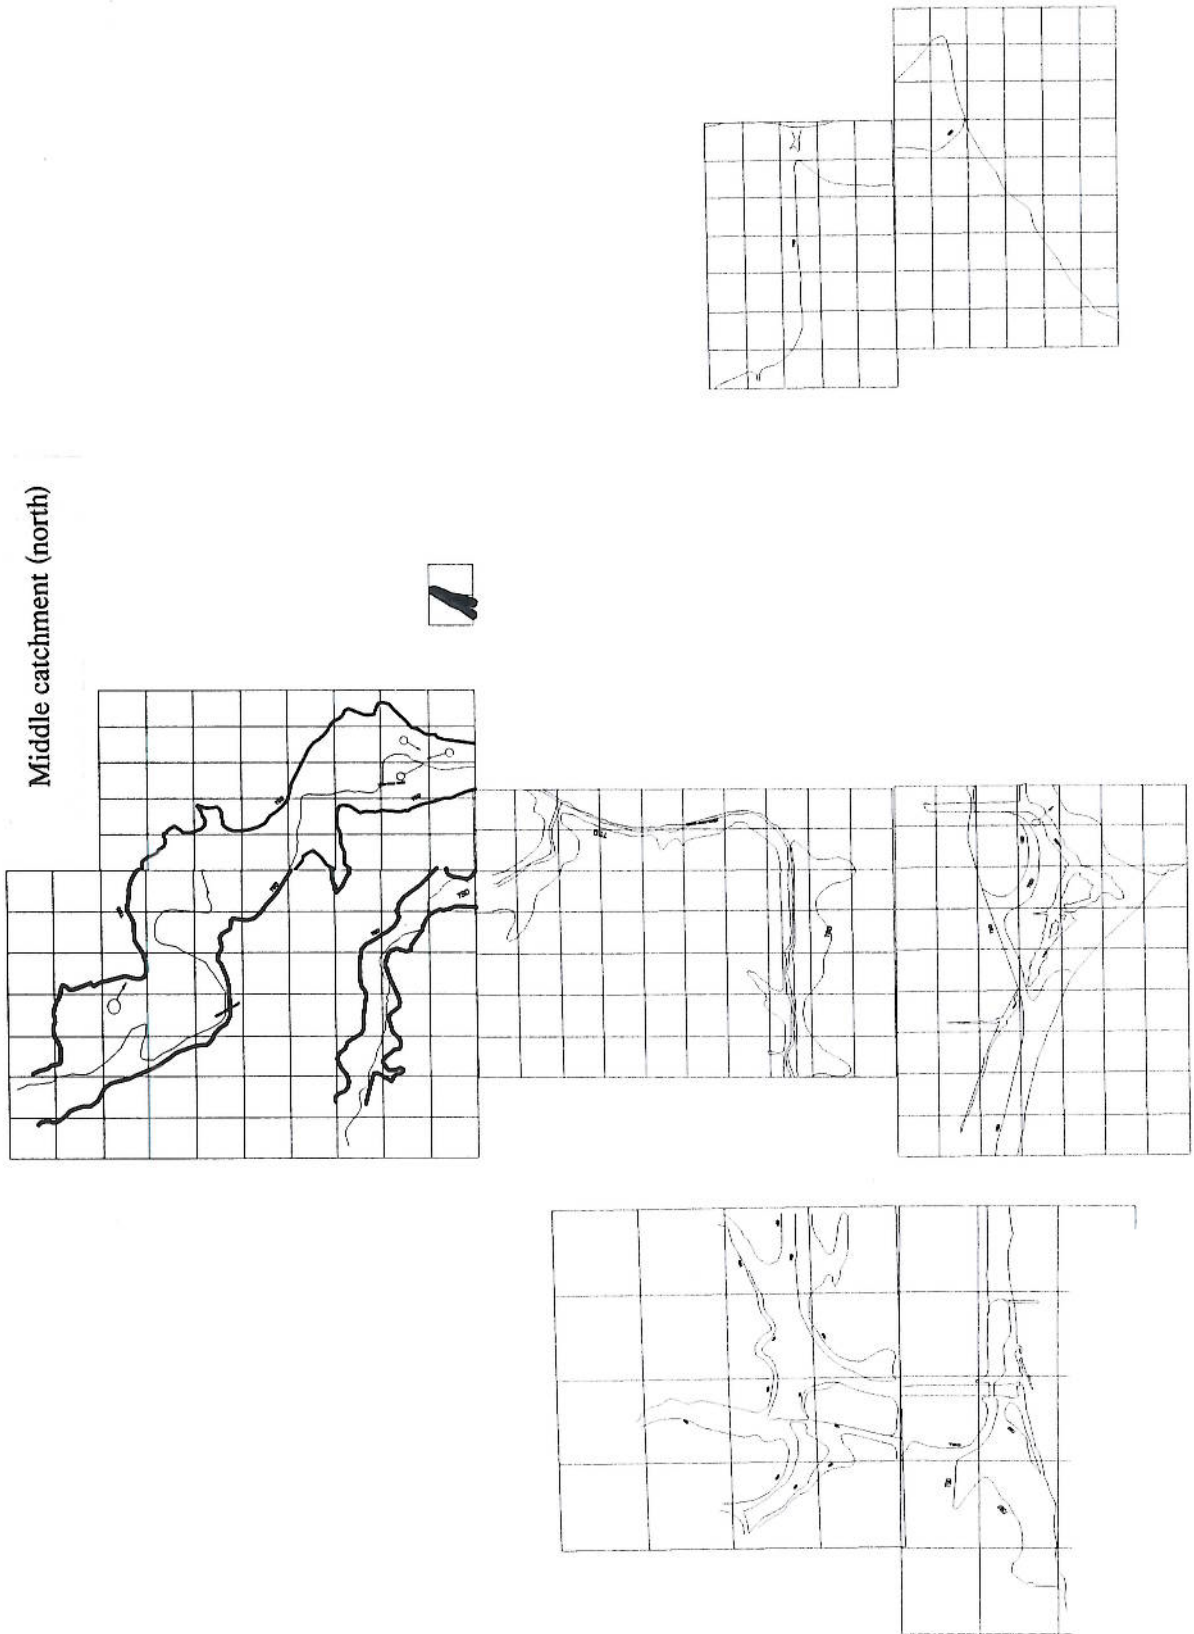
Layout of the Autocad .DXF files created showing the extent of flooding
