Government of Saint Lucia
Ministry of Planning and Development

Watershed and Environmental Management Project
Phase II

Final Report
November 1997

Volume 3
CONTENTS LIST

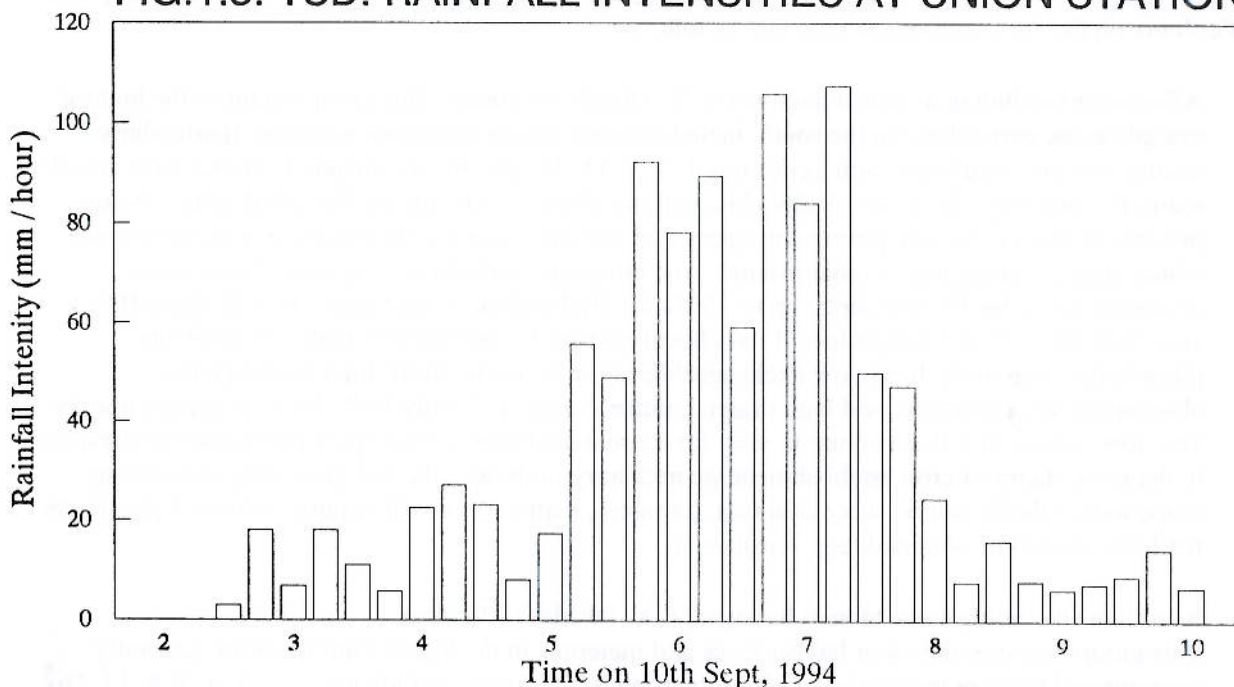
FIG.1.3: TSD: RAINFALL INTENSITIES AT UNION STATION

Rainfall intensities at Union Agricultural Station for 15-minute increments are shown in Fig.1.3. These can then be compared with infiltration rates measured in the field under different regimes of banana trash management (see Section 1.2.3 in this Annex, and detailed notes in Annex 7).

To cope with the erosivity factor of rainfall the soil surface should show infiltration rates in excess of 50mm in 1 hour (>0.8mm/min), 70mm in 2 hours ((0.6mm/min) and 120mm in 3 hours (0.4mm/min). Rainfall Intensity Rates over short periods (5minutes) can reach 2.3 mm/minute. These intensities are the maximum that can be expected in most years (i.e. outside hurricane and tropical storm events).

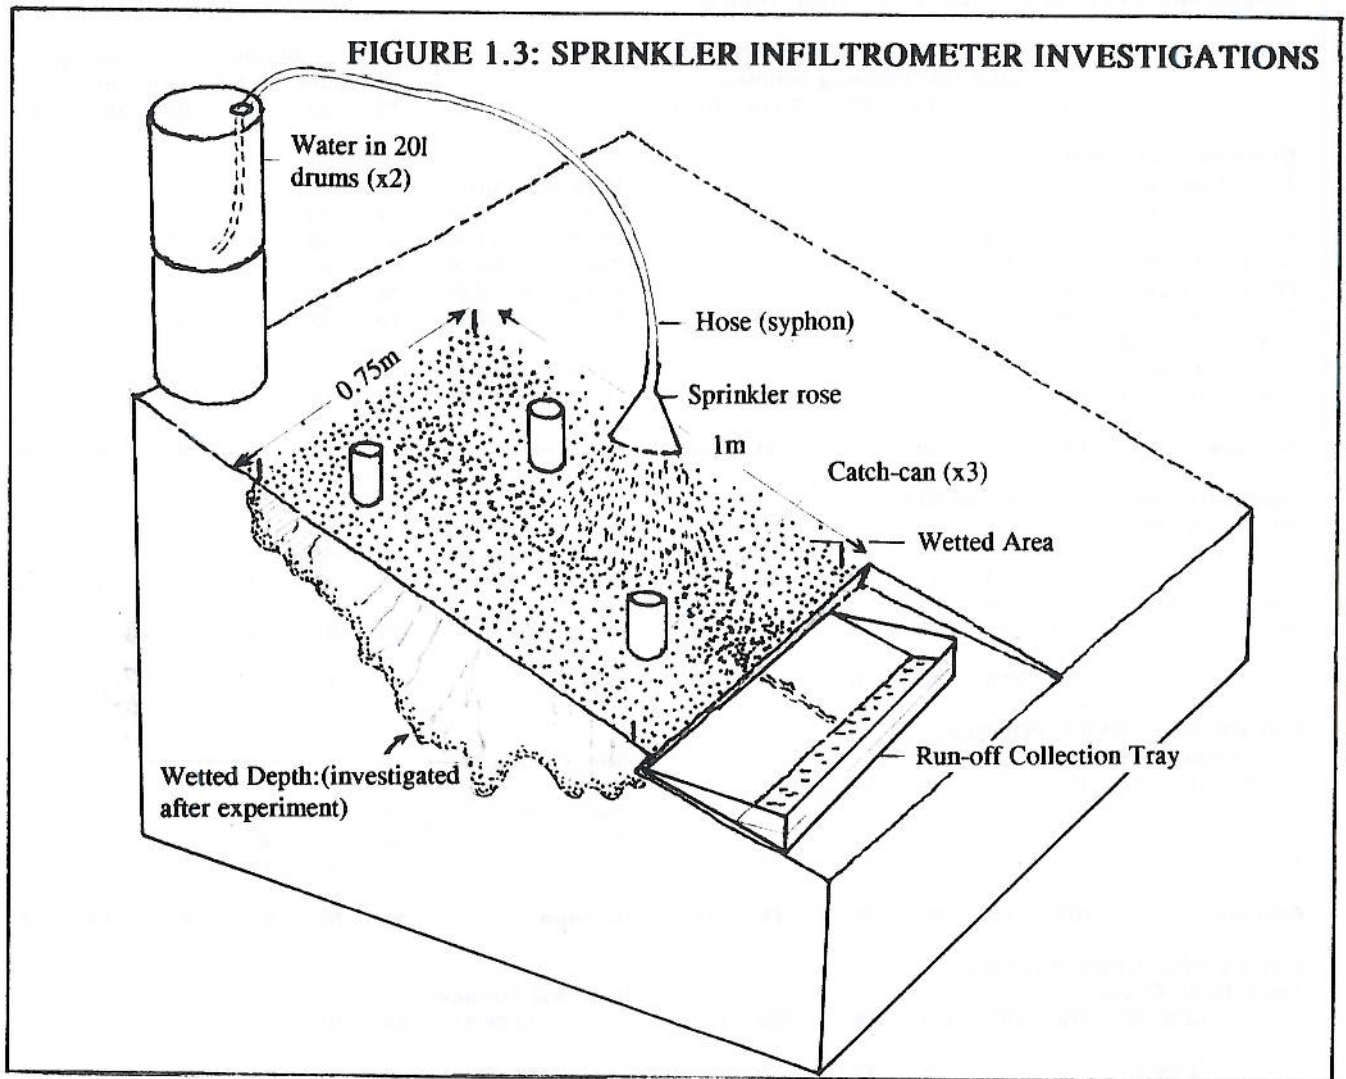
FIGURE 1.3: SPRINKLER INFILTROMETER INVESTIGATIONS

Measurements on surface infiltration rates for upland soils appear not to have been undertaken in St. Lucia, and thus a programme for measurement by sprinkler infiltrometer was adopted for this project. This was subsequently used in the field trials programme as a key characteristic of the soils under different banana trash management regimes. The sprinkler infiltrometer, rather than the double ring infiltrometer, was chosen in that it simulates rainfall more closely: water is applied by means of a sprinkler rose. For the double ring infiltrometer, which more closely simulates flood irrigation, damage to the soil surface by driving in the ring and by flooding creates very artificial conditions. The measured rates are thus quite different from those observed from the sprinkler infiltrometer or those measured from lysimeters and run-off plots.

Results of the infiltration tests showed that there was a large variability of infiltration rates over short distances, but a strong correlation between high infiltration rates and presence of trash cover, earthworm presence and worm channel density. Comparing trash-covered with bare soil surfaces, initial infiltration rates (first 15 minutes) were increased from an average of 48 to 100 mm/hour; terminal rates were increased from an average of 17 to 42 mm/hour. The average amount of water infiltrated over the 90 minute trial period (60+30 minutes) was 40 and 88 mm respectively. [See Table 1.6(top) for actual results over 32 tests on the 4 trial sites.]

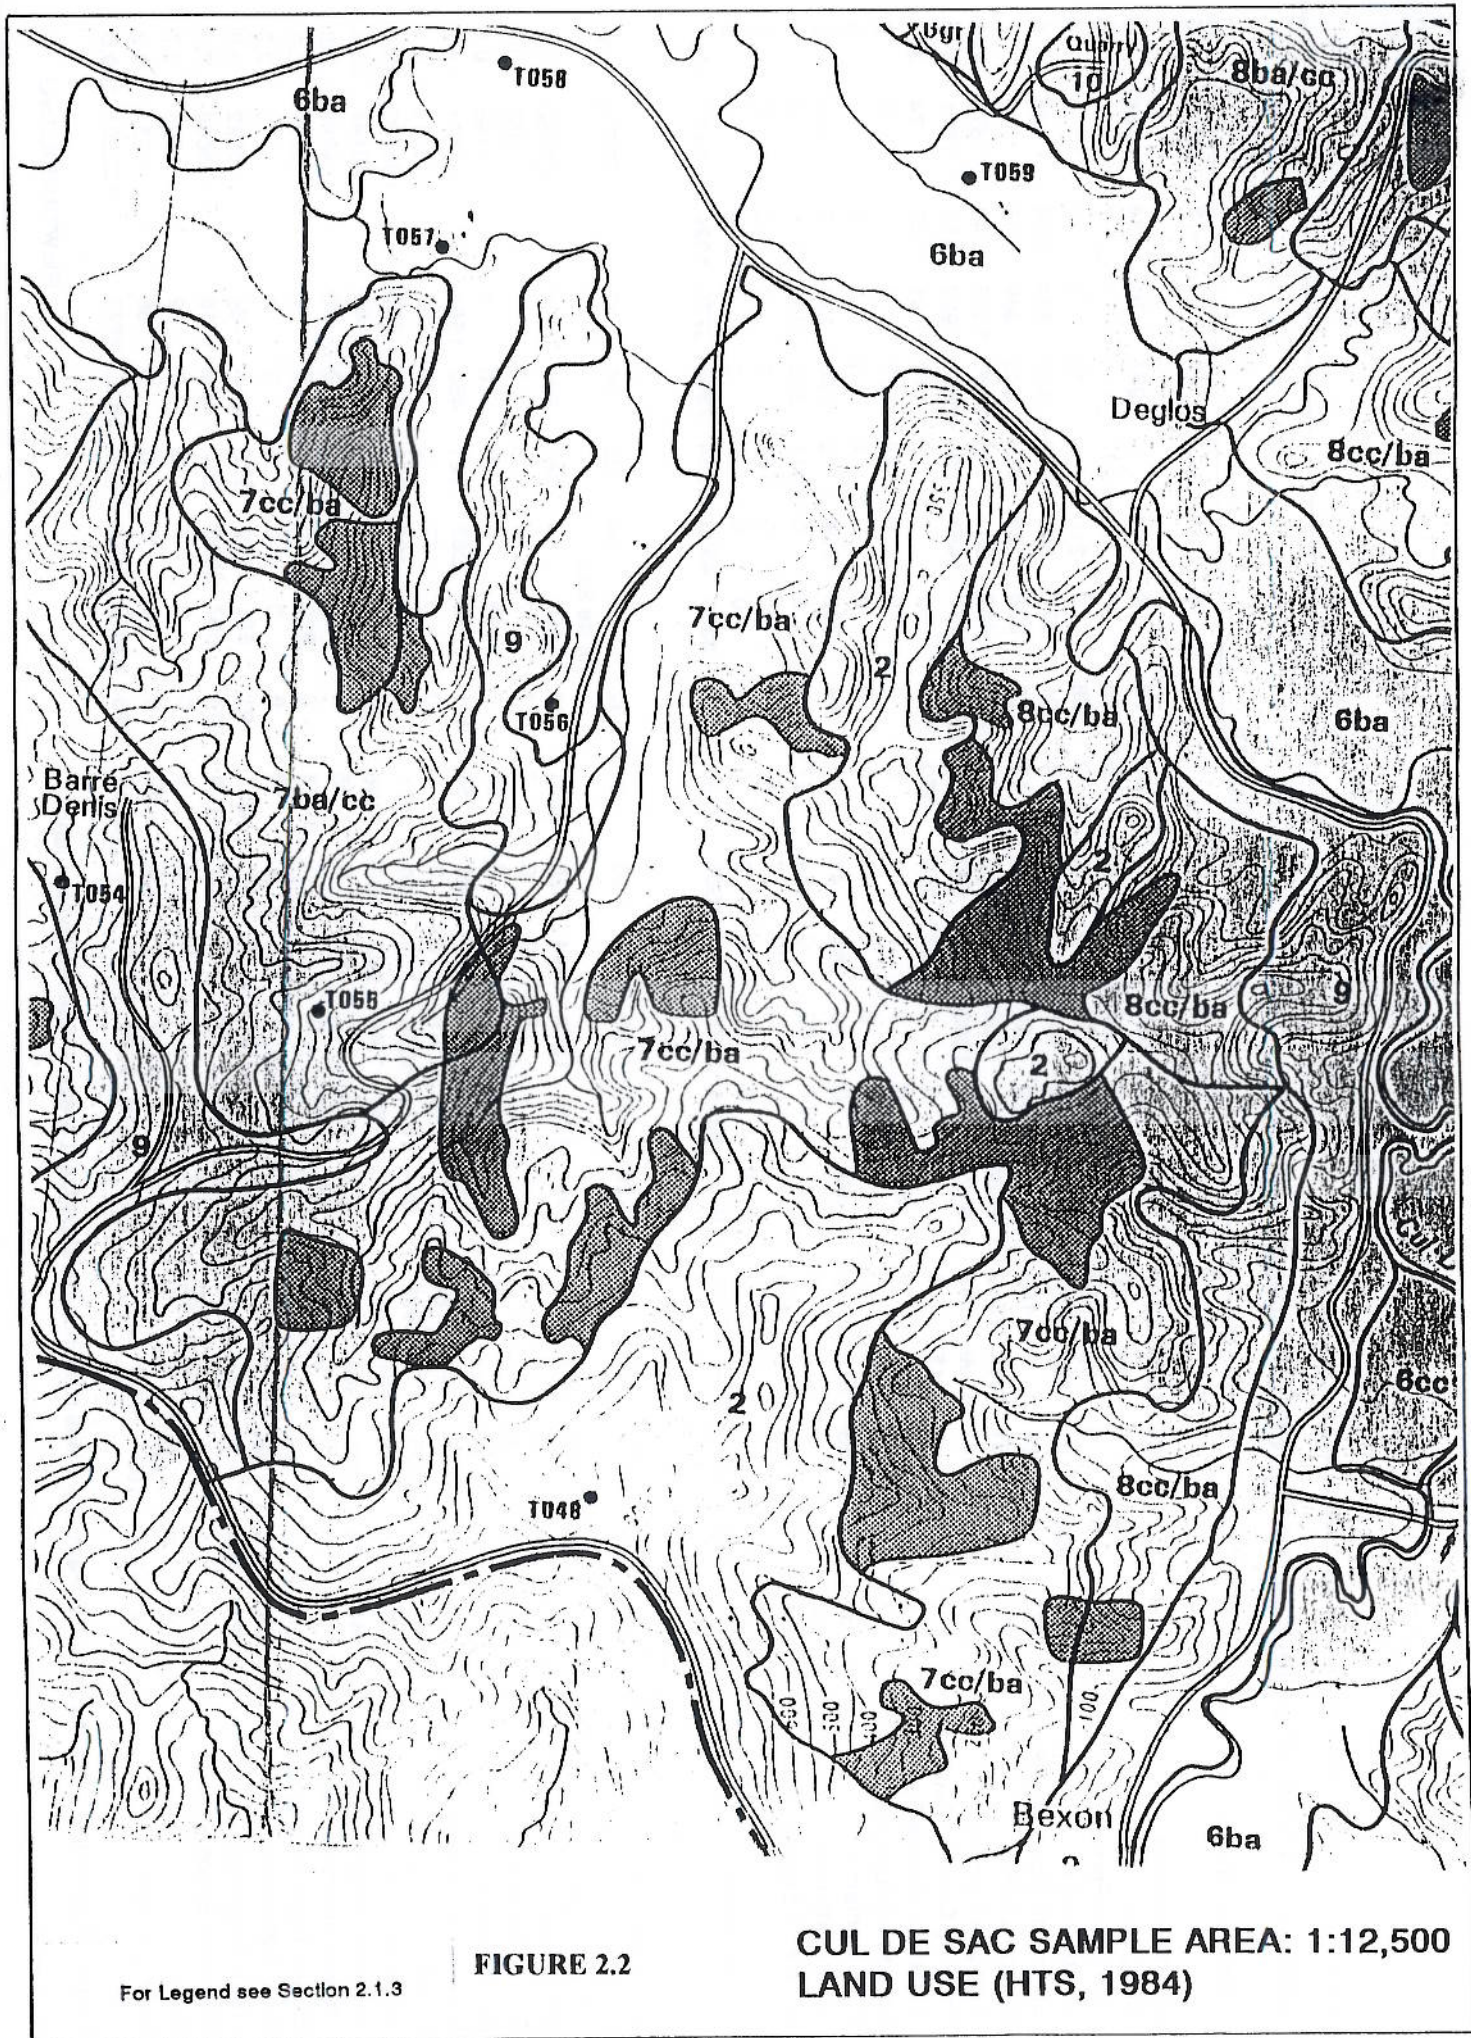
FIGURE 2.2

CUL DE SAC SAMPLE AREA:
LAND USE (ROCHE ITEE, 1992)

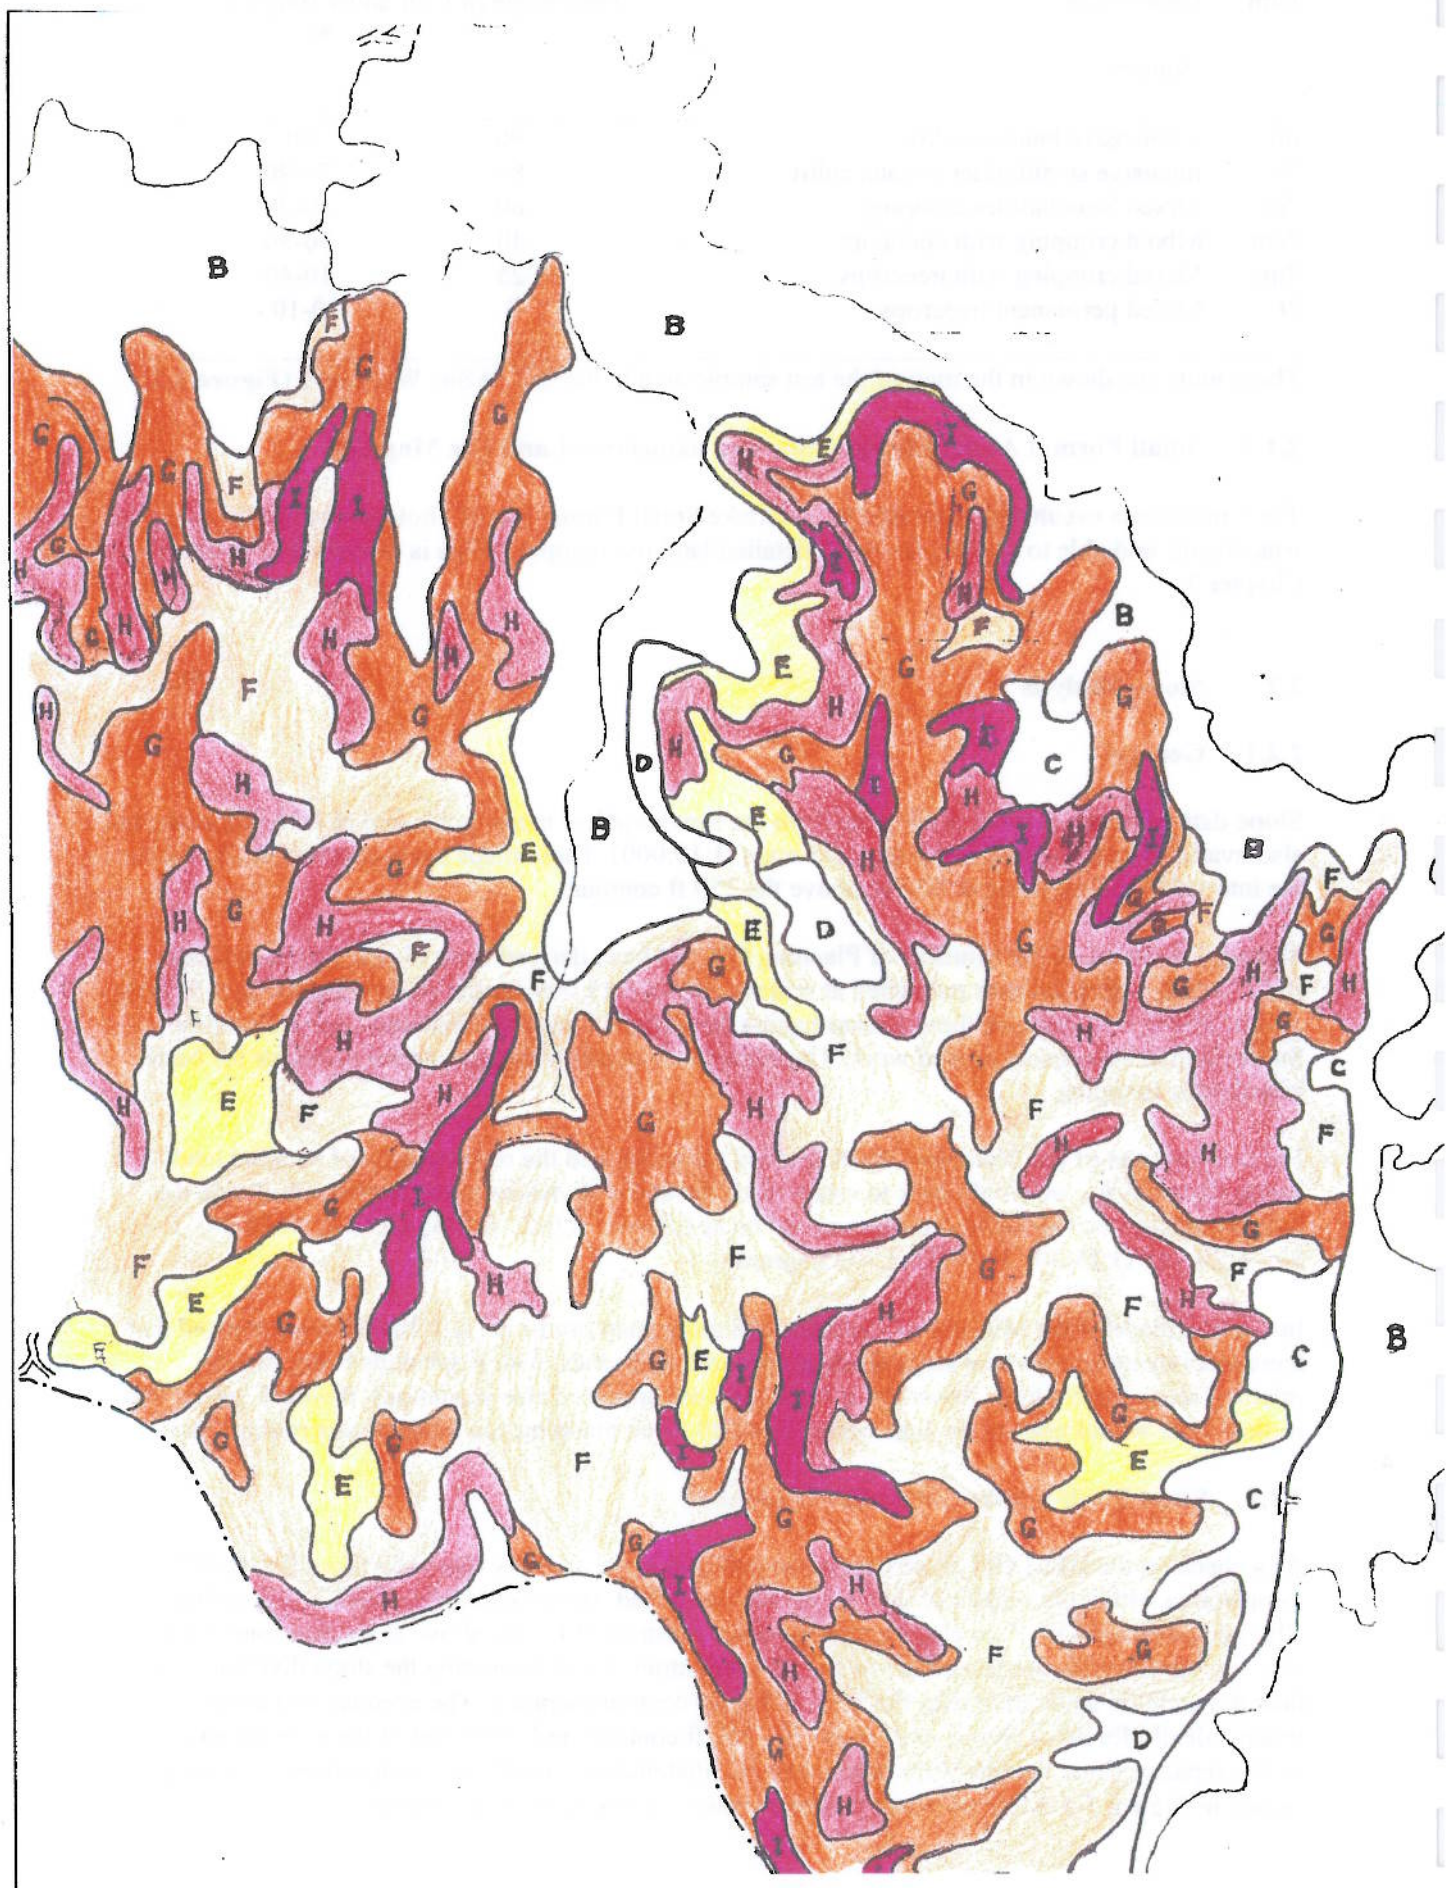
FIGURE 2.4

As a check on the DEM GIS slope data a conventional slope analysis was undertaken for the 900-ha sample area within the middle of the Cul de Sac watershed, (agro-ecological zone Ck, but including alluvial floodplain Ca). Two slope templates were constructed for the above slope divisions, for the two contour intervals above and below the 250 ft contour. Lines separating the slope divisions were then drawn in on an overlay over the 1:12,500 scale contour mapping. The exercise was done independently for areas above, and below, the 250 ft contour, and at the end of the exercise any areas of discrepancy along the line were further investigated and then rectified. The resulting slope map is shown in **Figure 2.4**. Measurements on slope classes on this map are as follows:

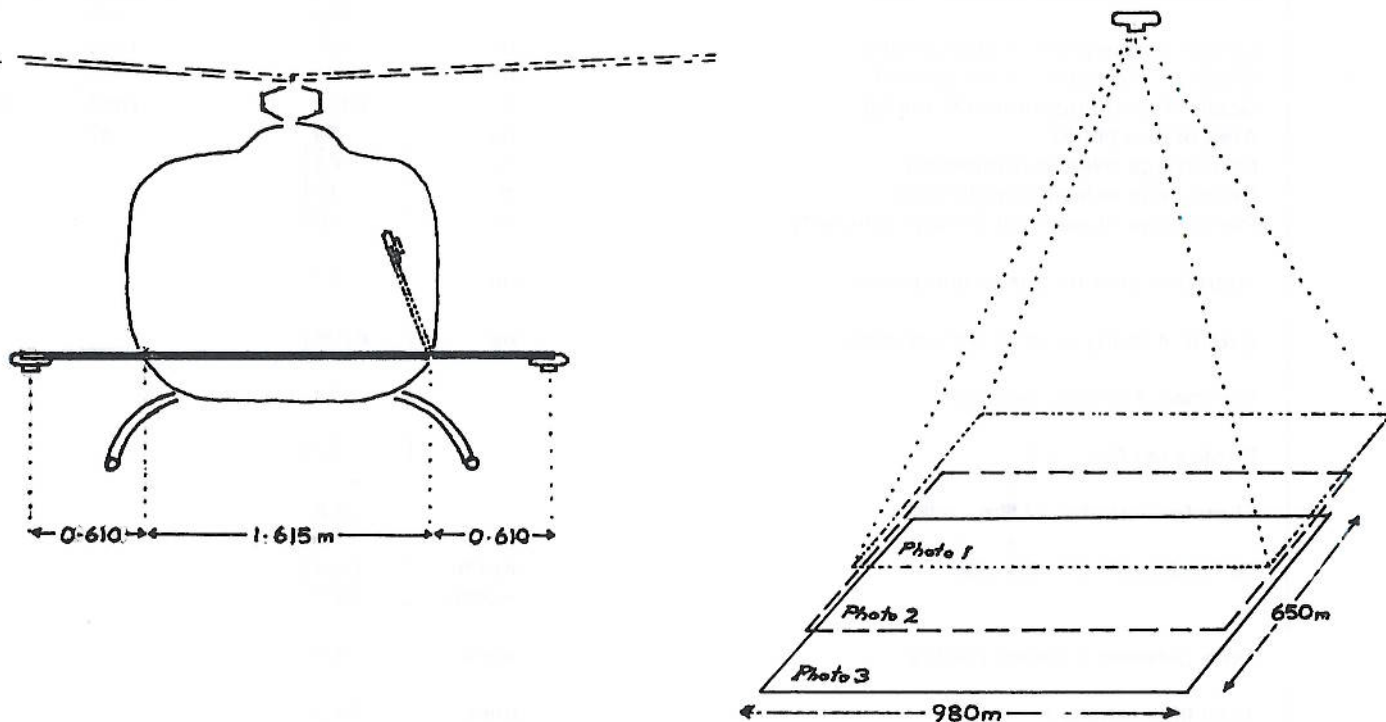
Figure 3.1: Mounting device for 35mm cameras in Aerospatial Helicopter

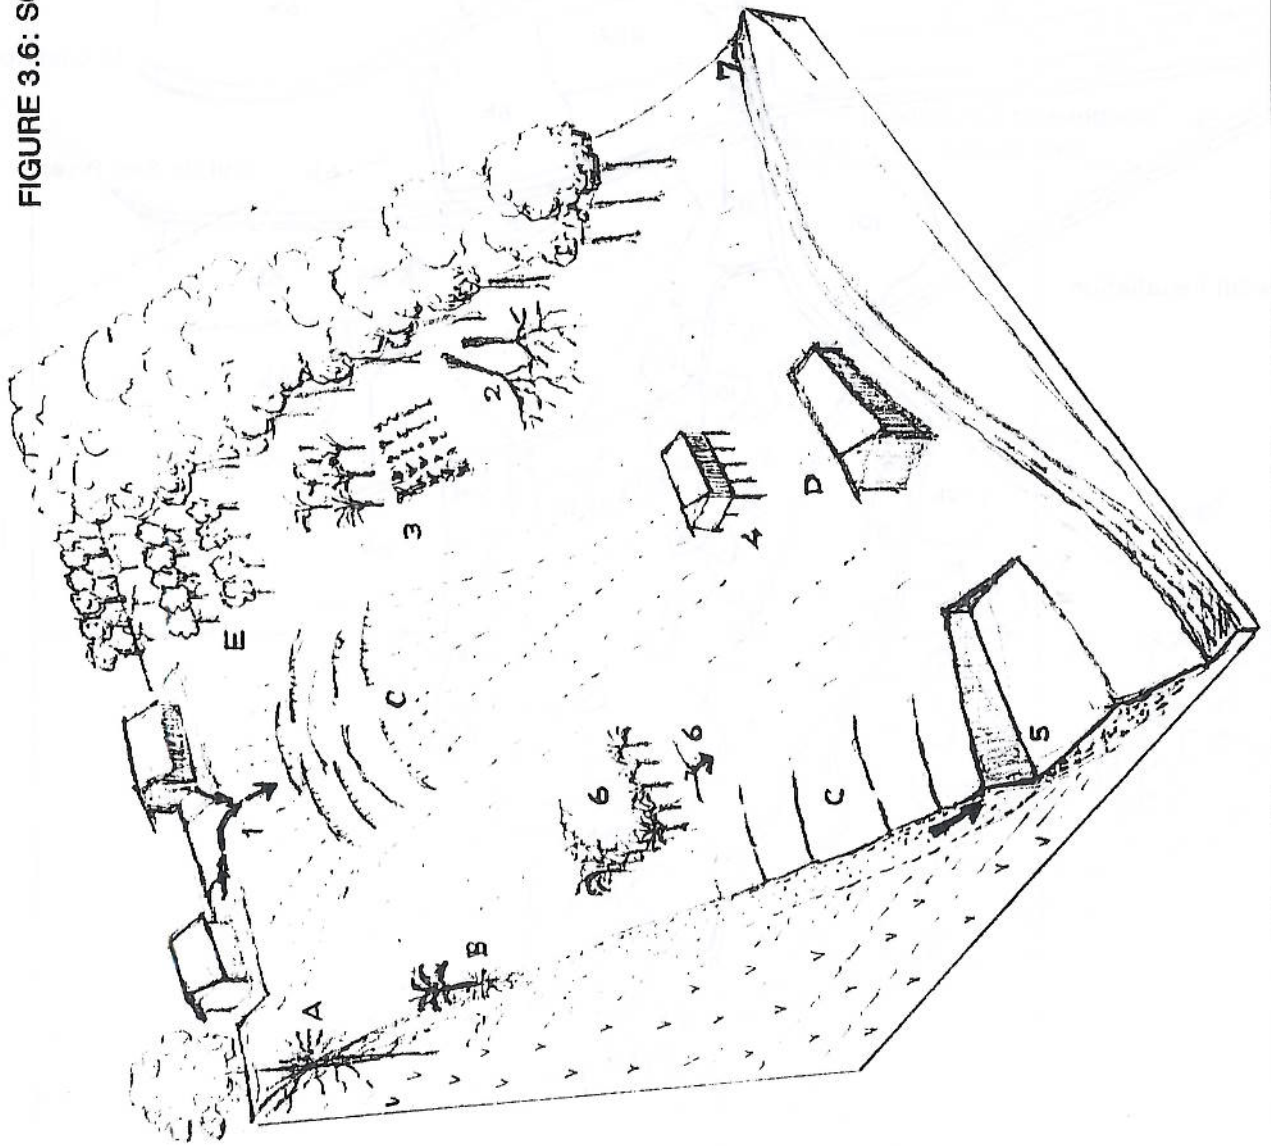
FIGURE 3.6: SCHEMATIC BLOCK DIAGRAM: RAVINE POISSON AREA

- A. *Well – established tree: deep taproot and dense, strong network of surface roots anchoring soil to firm bedrock*
- B. *Banana rooting: network of surface roots, but less strong, and complete lack of deep taproots*
- C. *Cracks and terra cettes formed by incipient mass movements: major landslide quite probable here during next TSD – type rainfall*
- D. *Buildings under threat from burial by landslide materials*
- E. *Better land use practice: underplanting of bananas on sloping land (20 – 30deg) with fruit – trees: close spacing on contour (eg 12ft) – wider spacing between contours (eg 24 – 30ft). Bananas to continue as nurse crop for 3 – 4 years.*

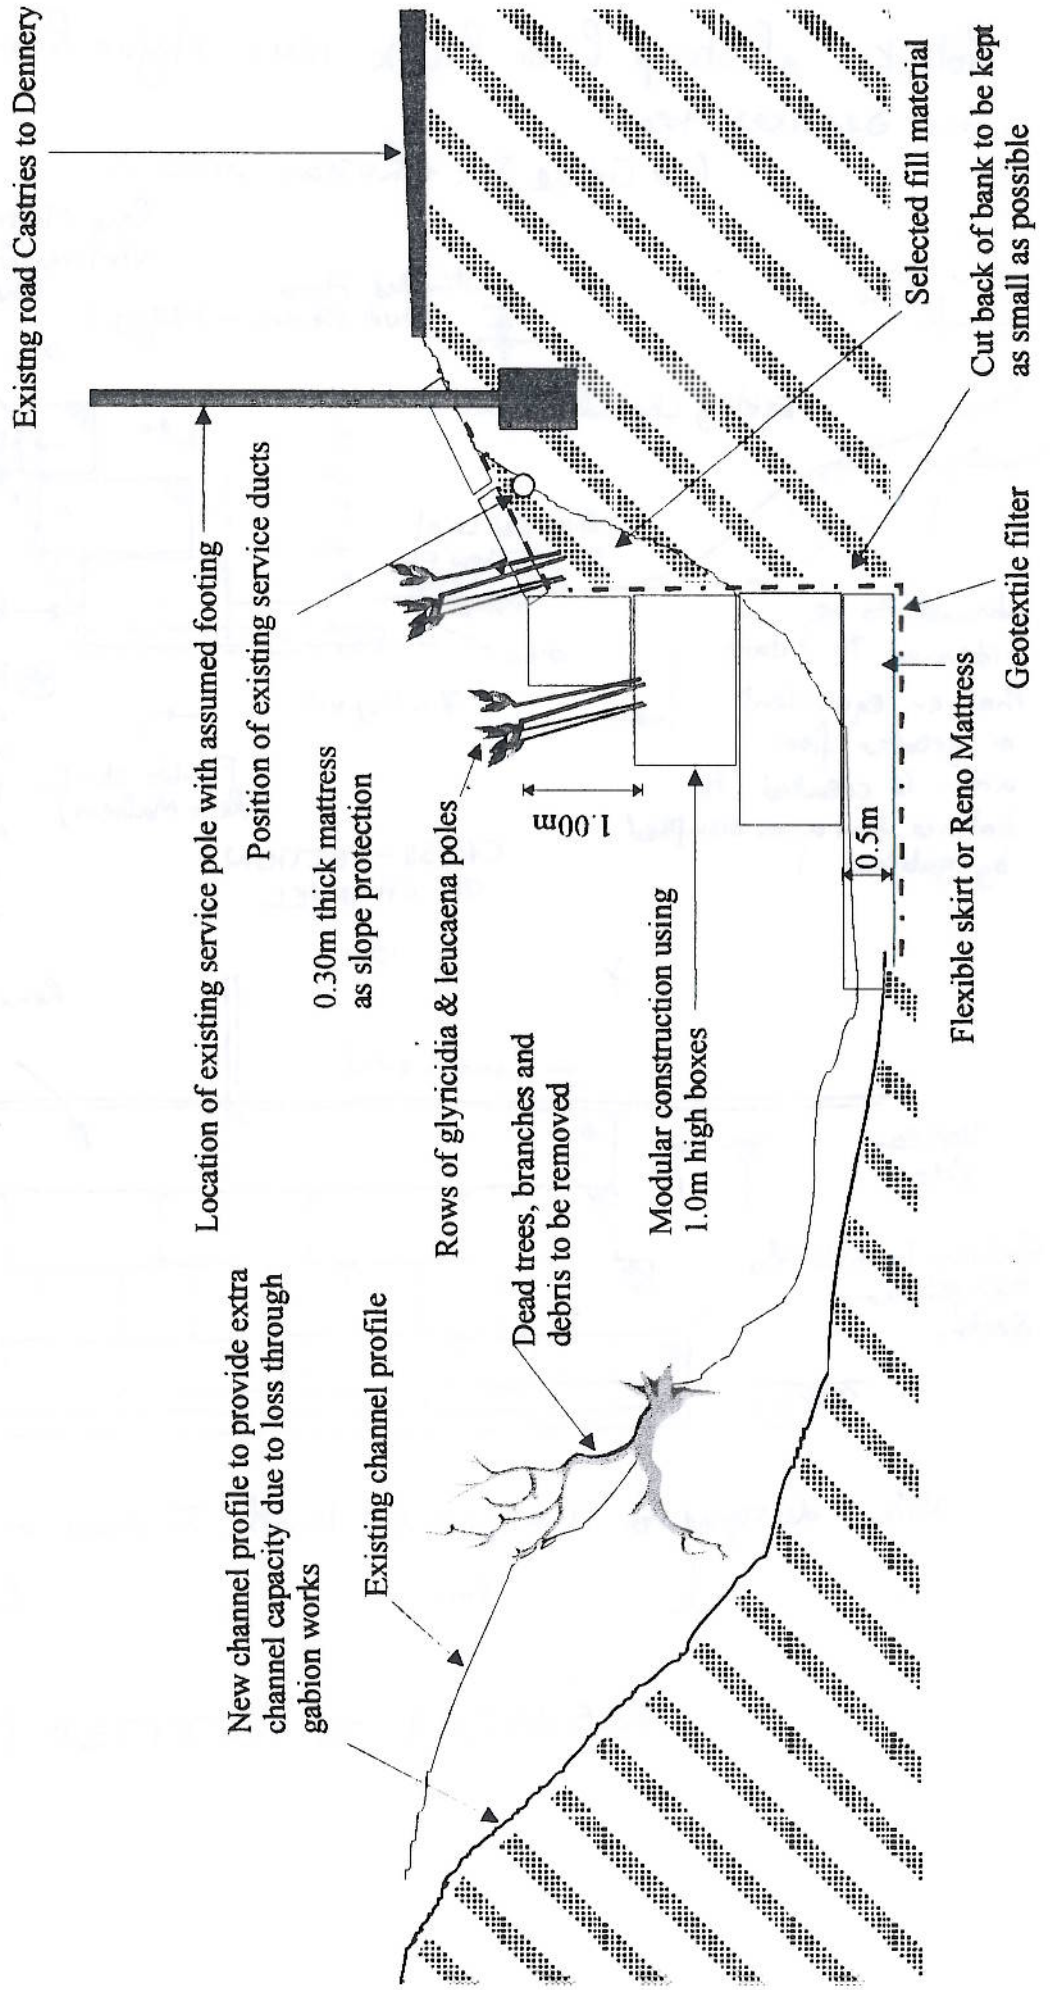
River Engineering Trial Number Eng 3.

River Bank Protection in Vicinity of Important Infrastructure/ Services

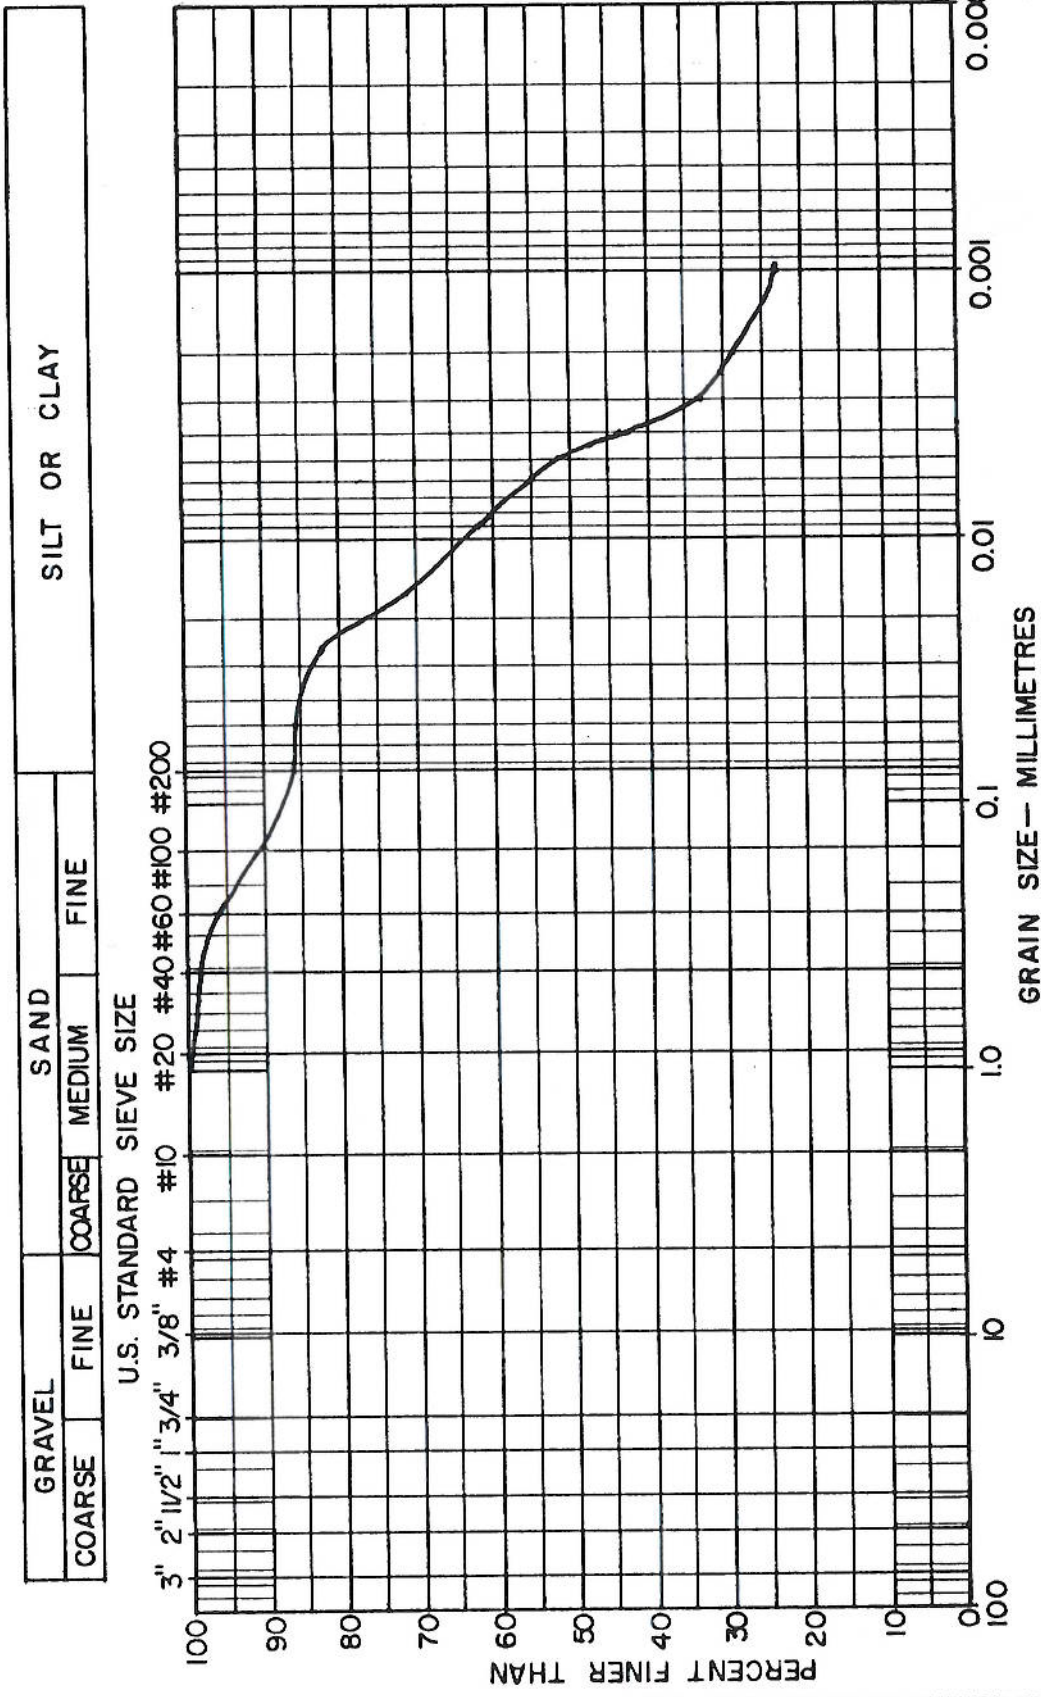
GRAIN SIZE CURVE

REMARKS: clayey SILT, trace of sand, low plasticity, moist, brown

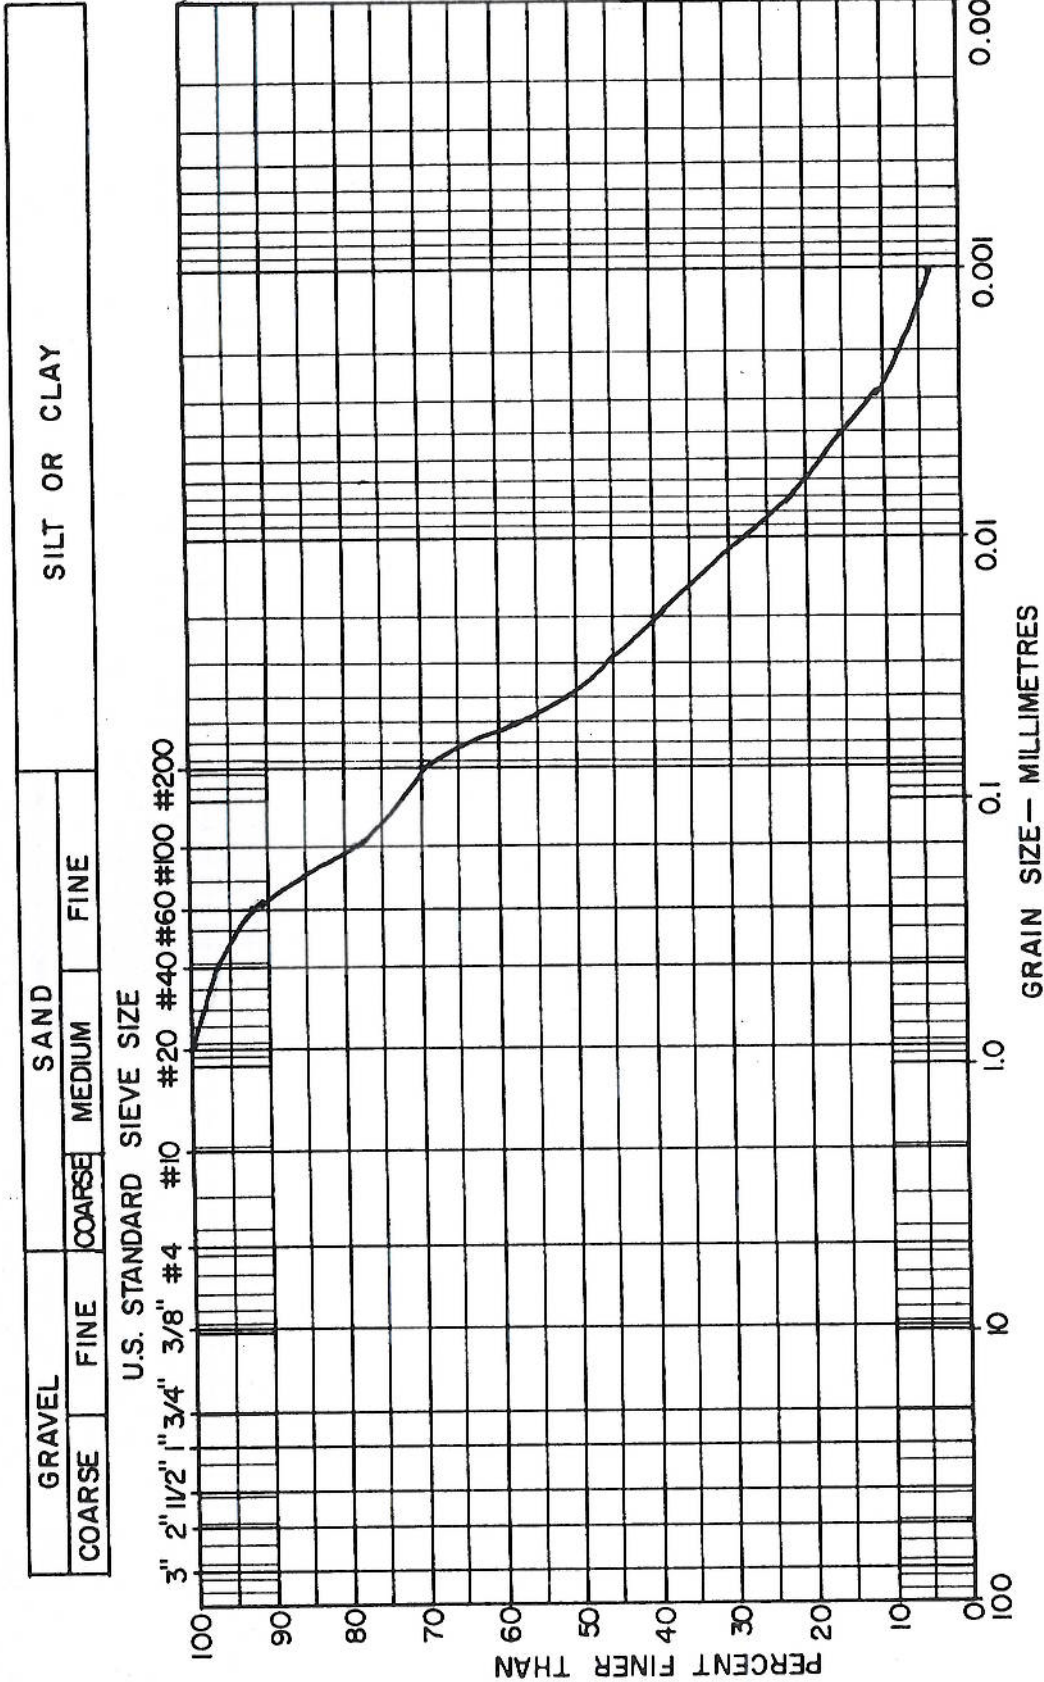
GRAIN SIZE CURVE

REMARKS: clayey SILT, some sand, low to non plastic, moist, brown

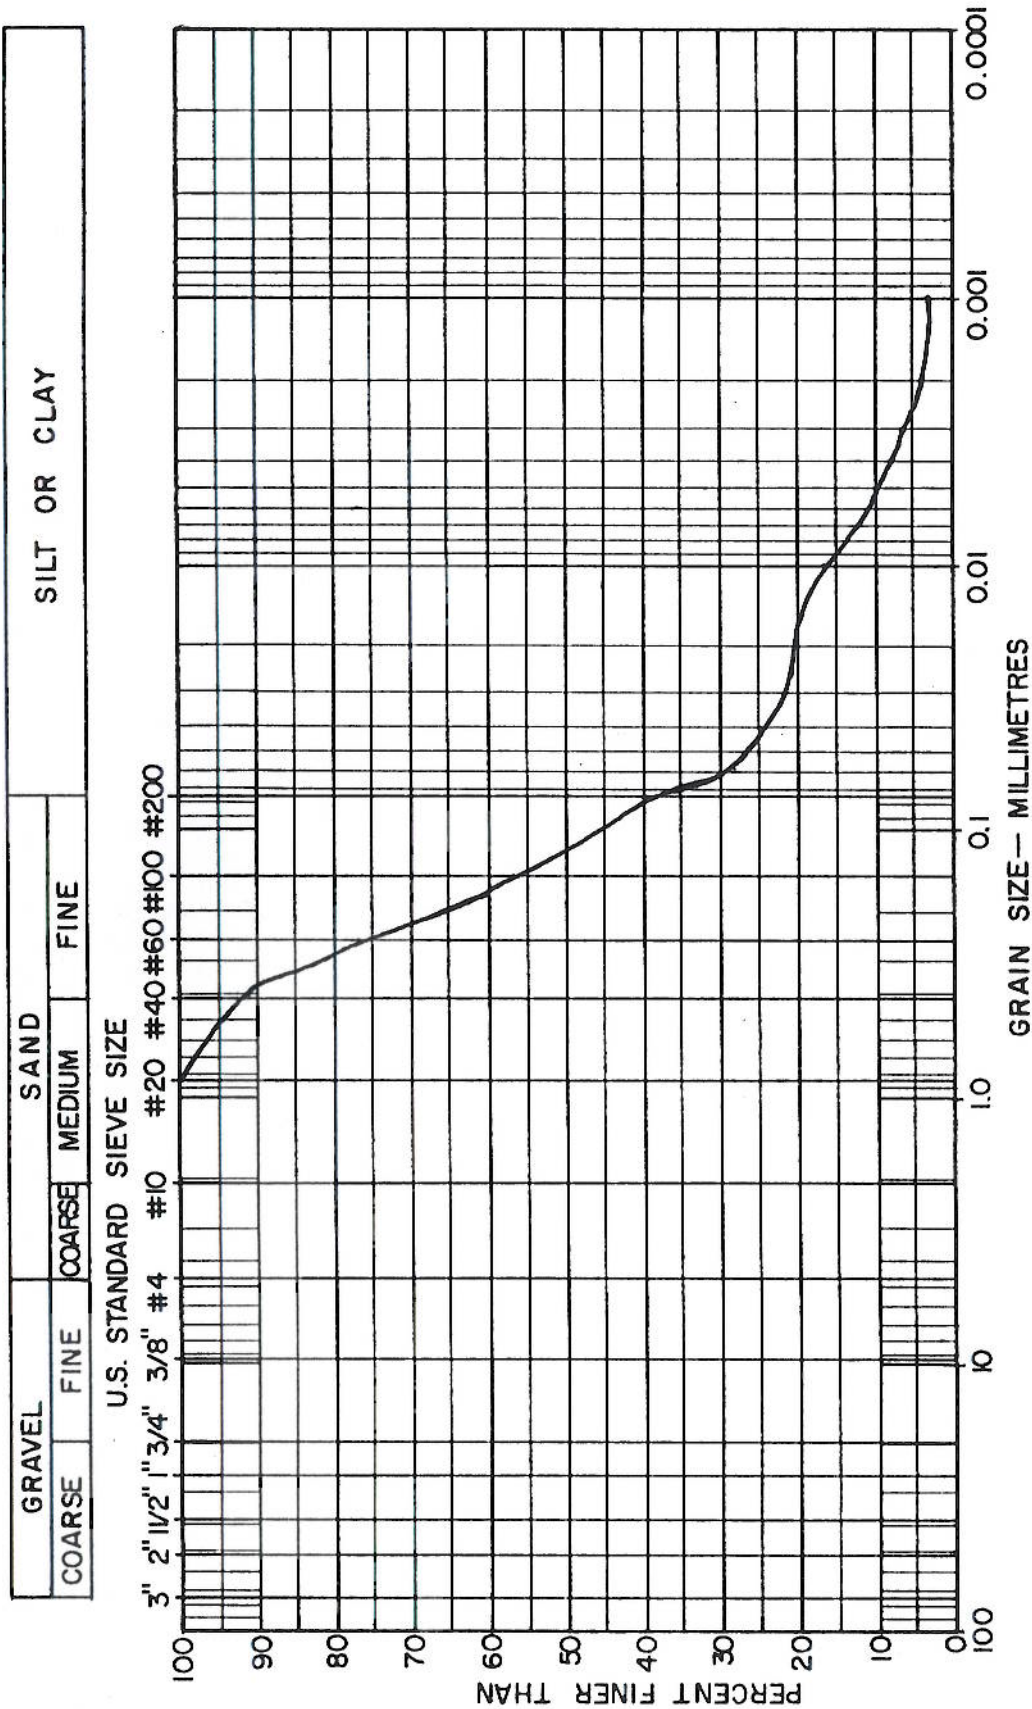
GRAIN SIZE CURVE

REMARKS: SAND & SILT, trace of clay, non plastic, moist, brown

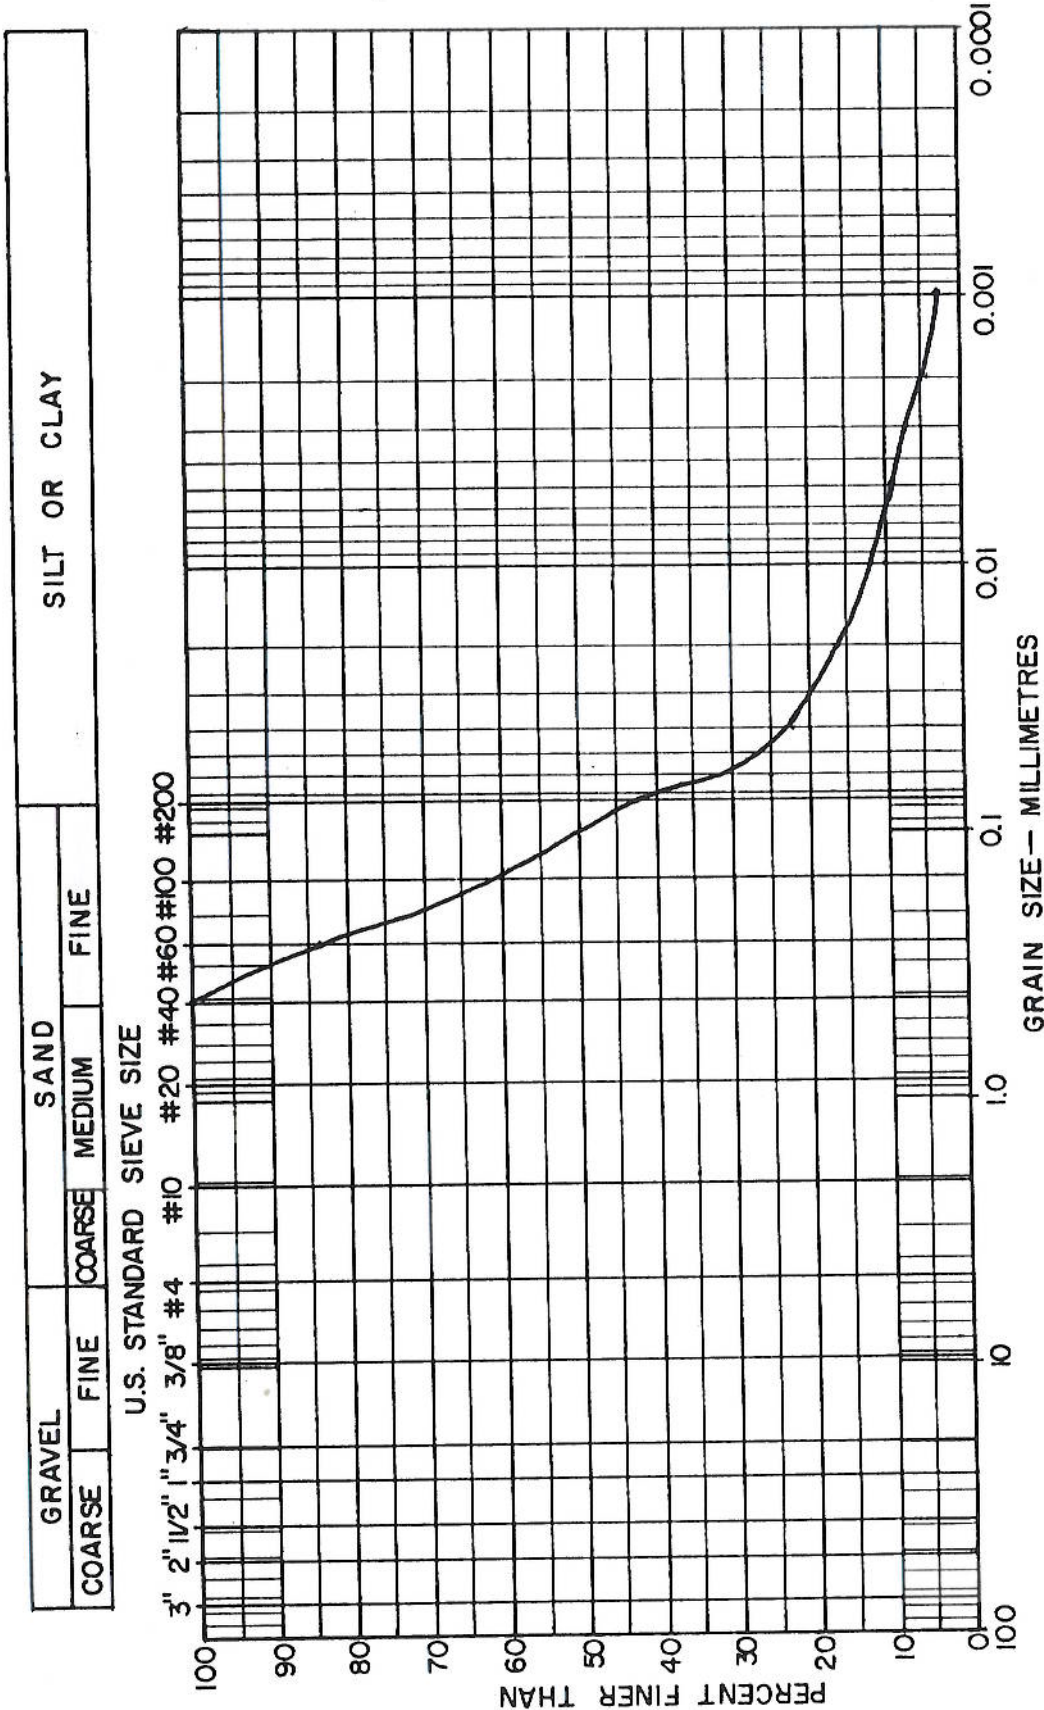
GRAIN SIZE CURVE

REMARKS: clayey SAND & SILT, non plastic, moist, light brown

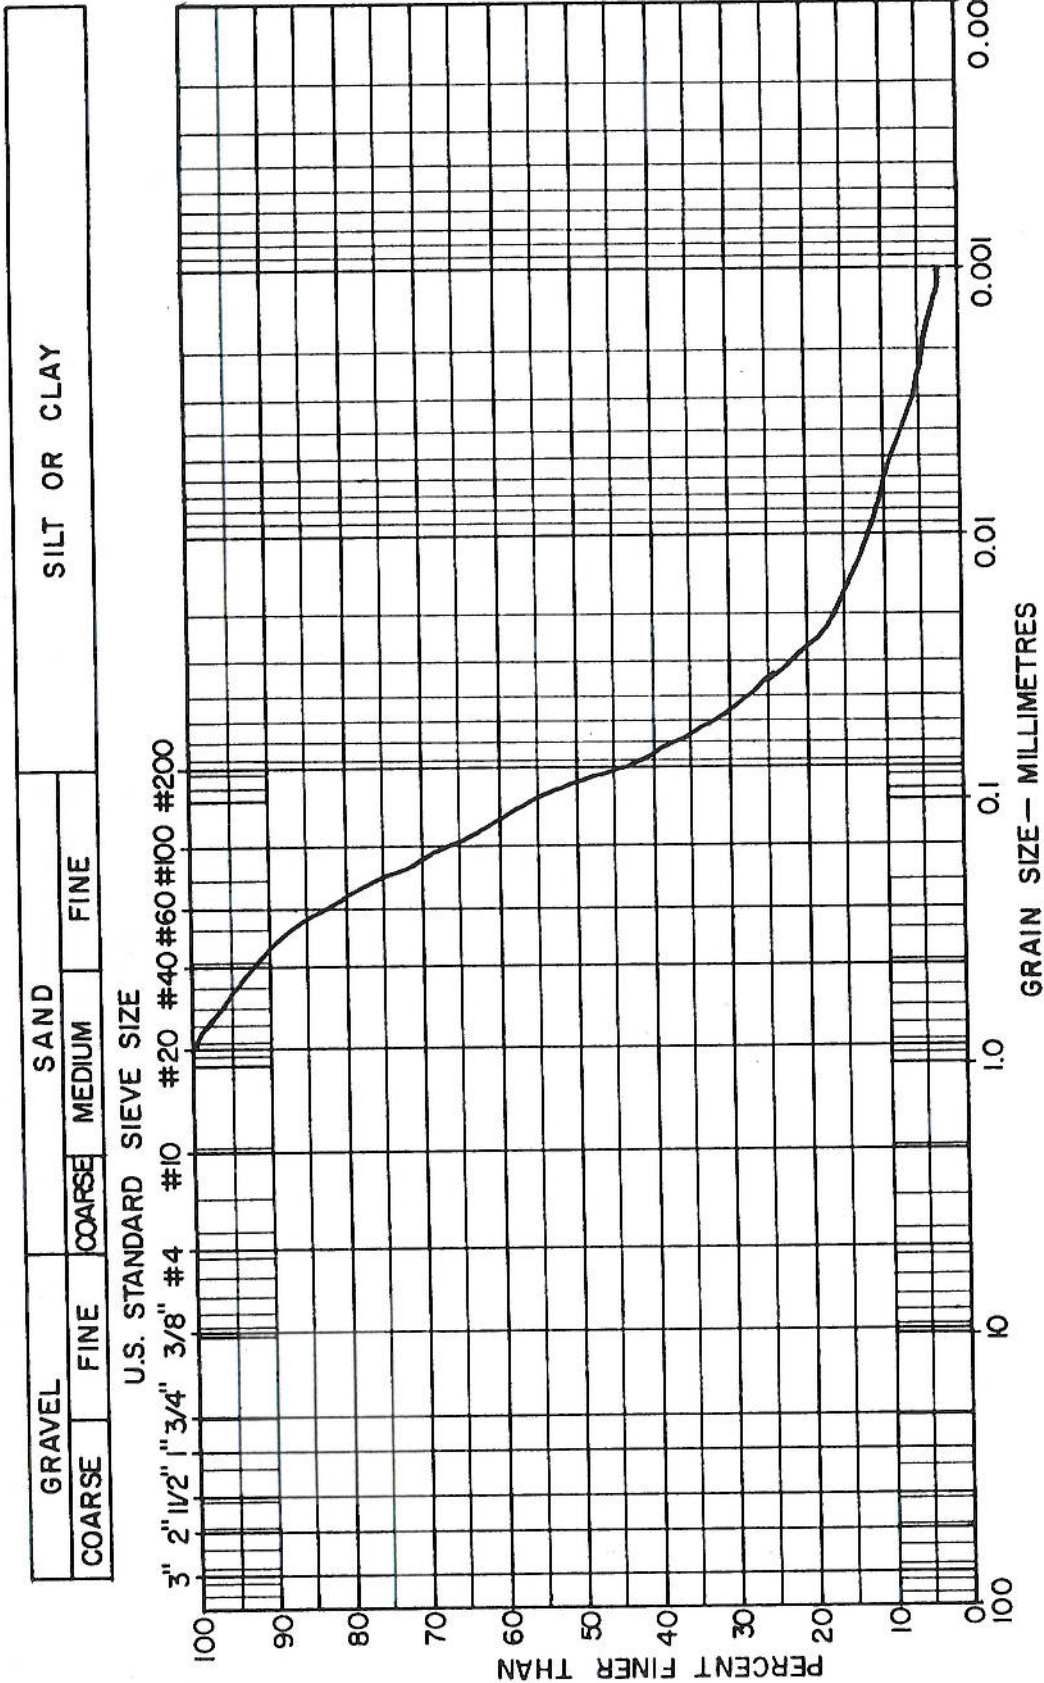
GRAIN SIZE CURVE

REMARKS: sand & SILT, trace of clay, non plastic, moist, light brown
