Government of Saint Lucia
Ministry of Planning and Development

Watershed and Environmental Management Project
Phase II

Final Report
November 1997

Volume 3
CONTENTS LIST

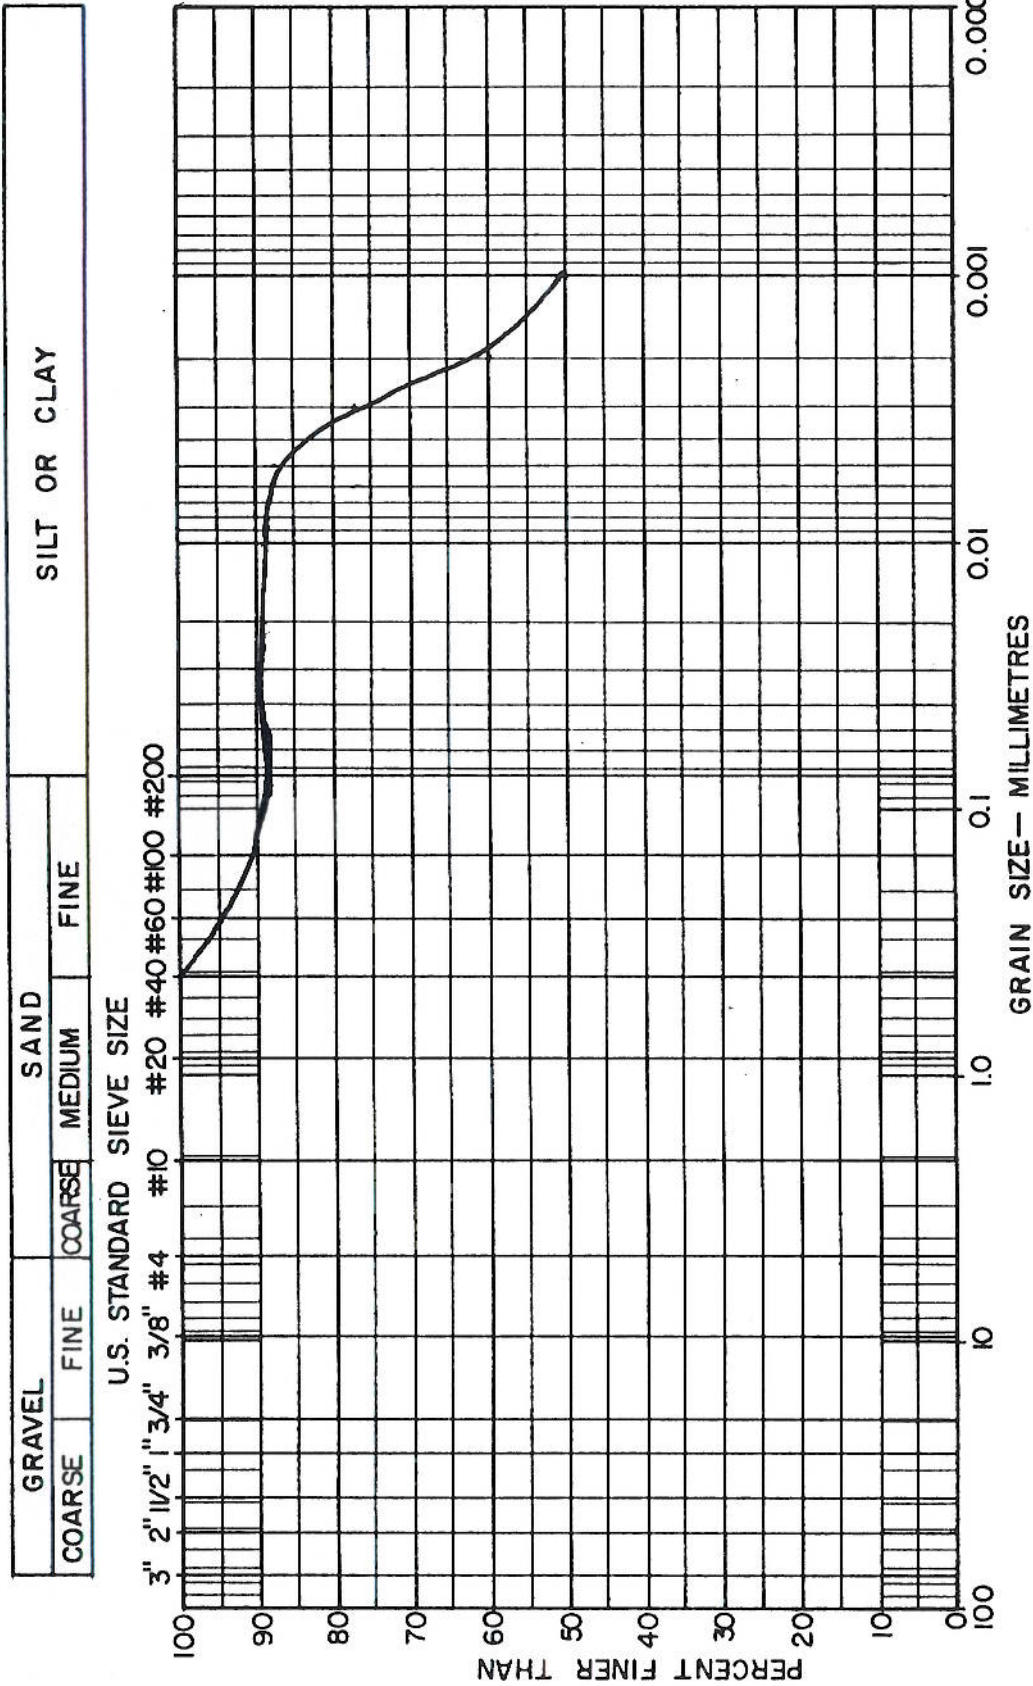
GRAIN SIZE CURVE

REMARKS: silty CLAY, trace of sand, high plasticity, moist, reddish brown

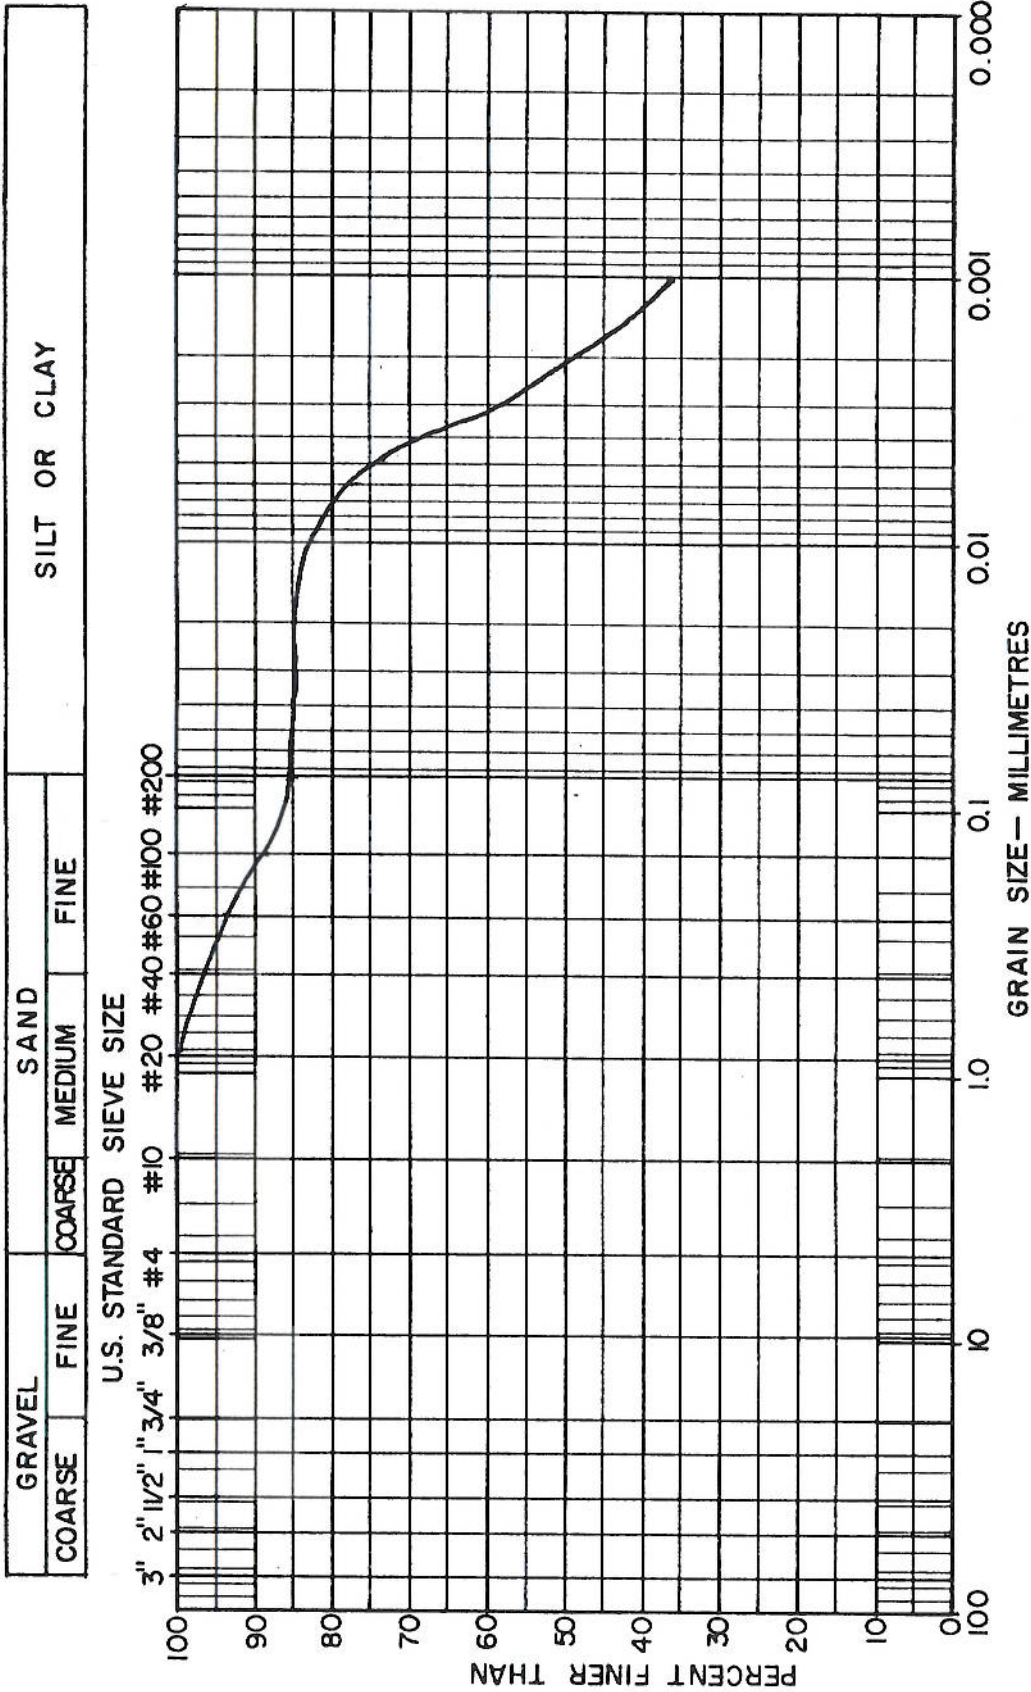
GRAIN SIZE CURVE

REMARKS: silty CLAY, little sand, high plasticity, moist, reddish brown

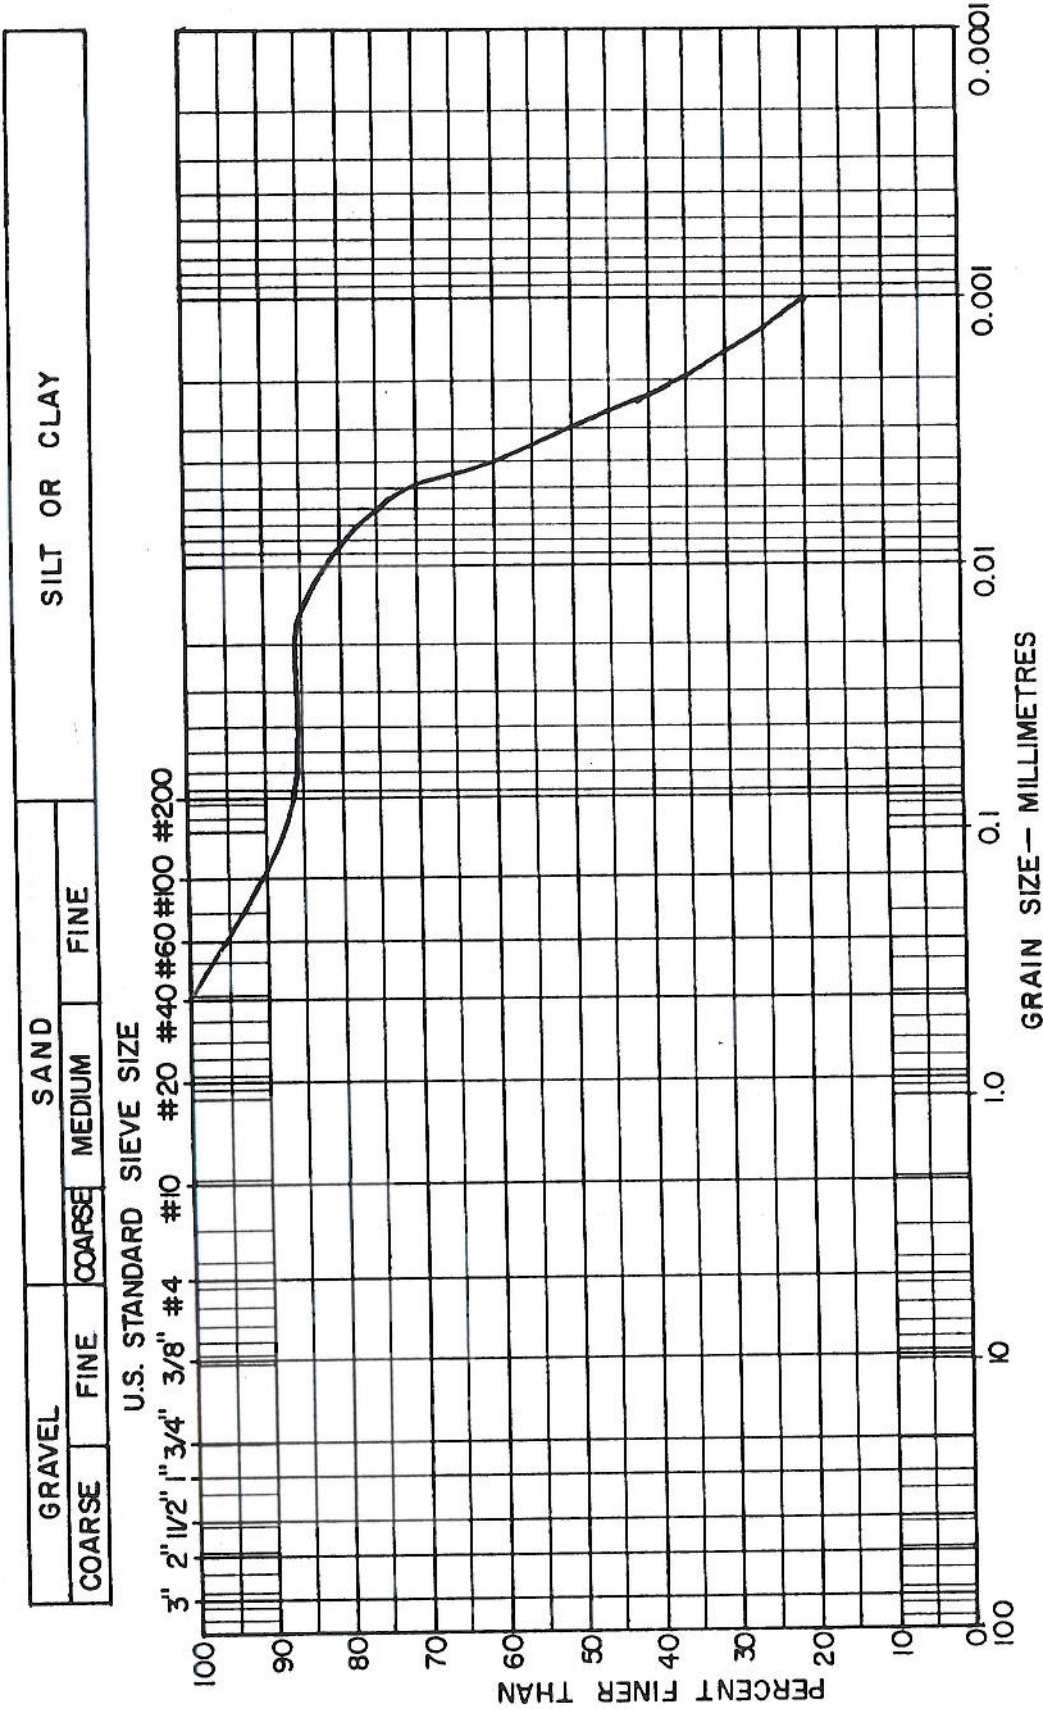
GRAIN SIZE CURVE

REMARKS: silty CLAY, little sand, high plasticity, moist, reddish brown

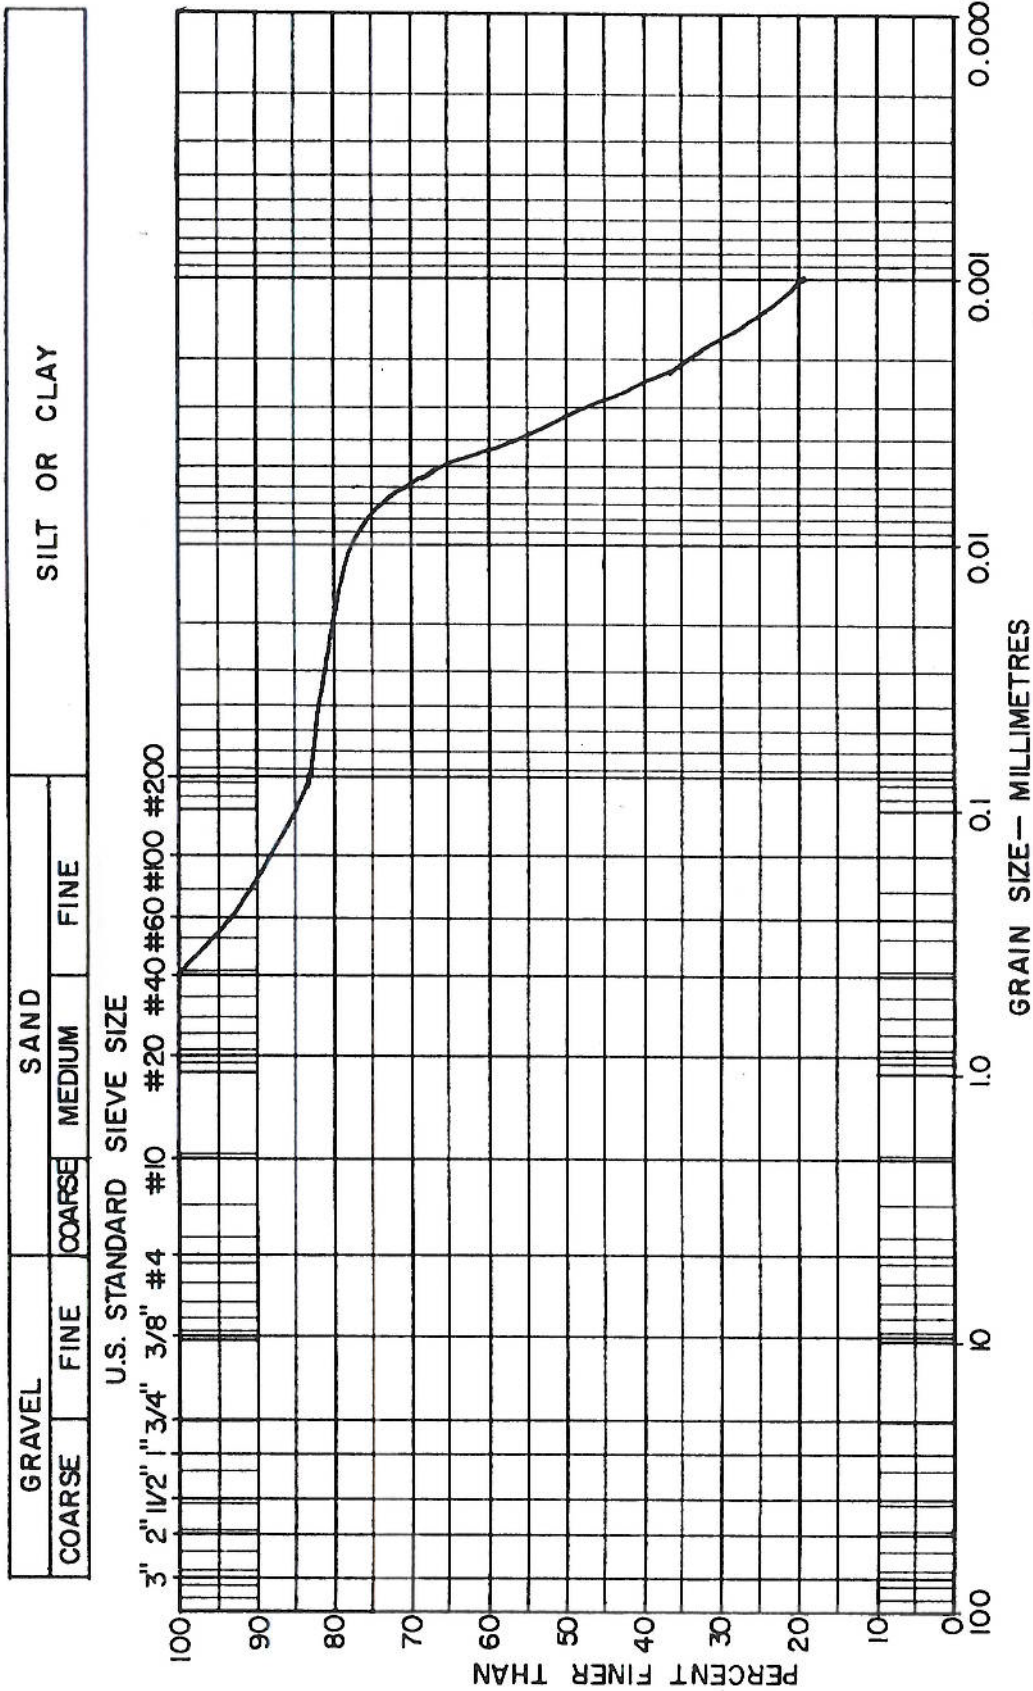
GRAIN SIZE CURVE

REMARKS: silty CLAY, little sand, high plasticity, moist, reddish brown

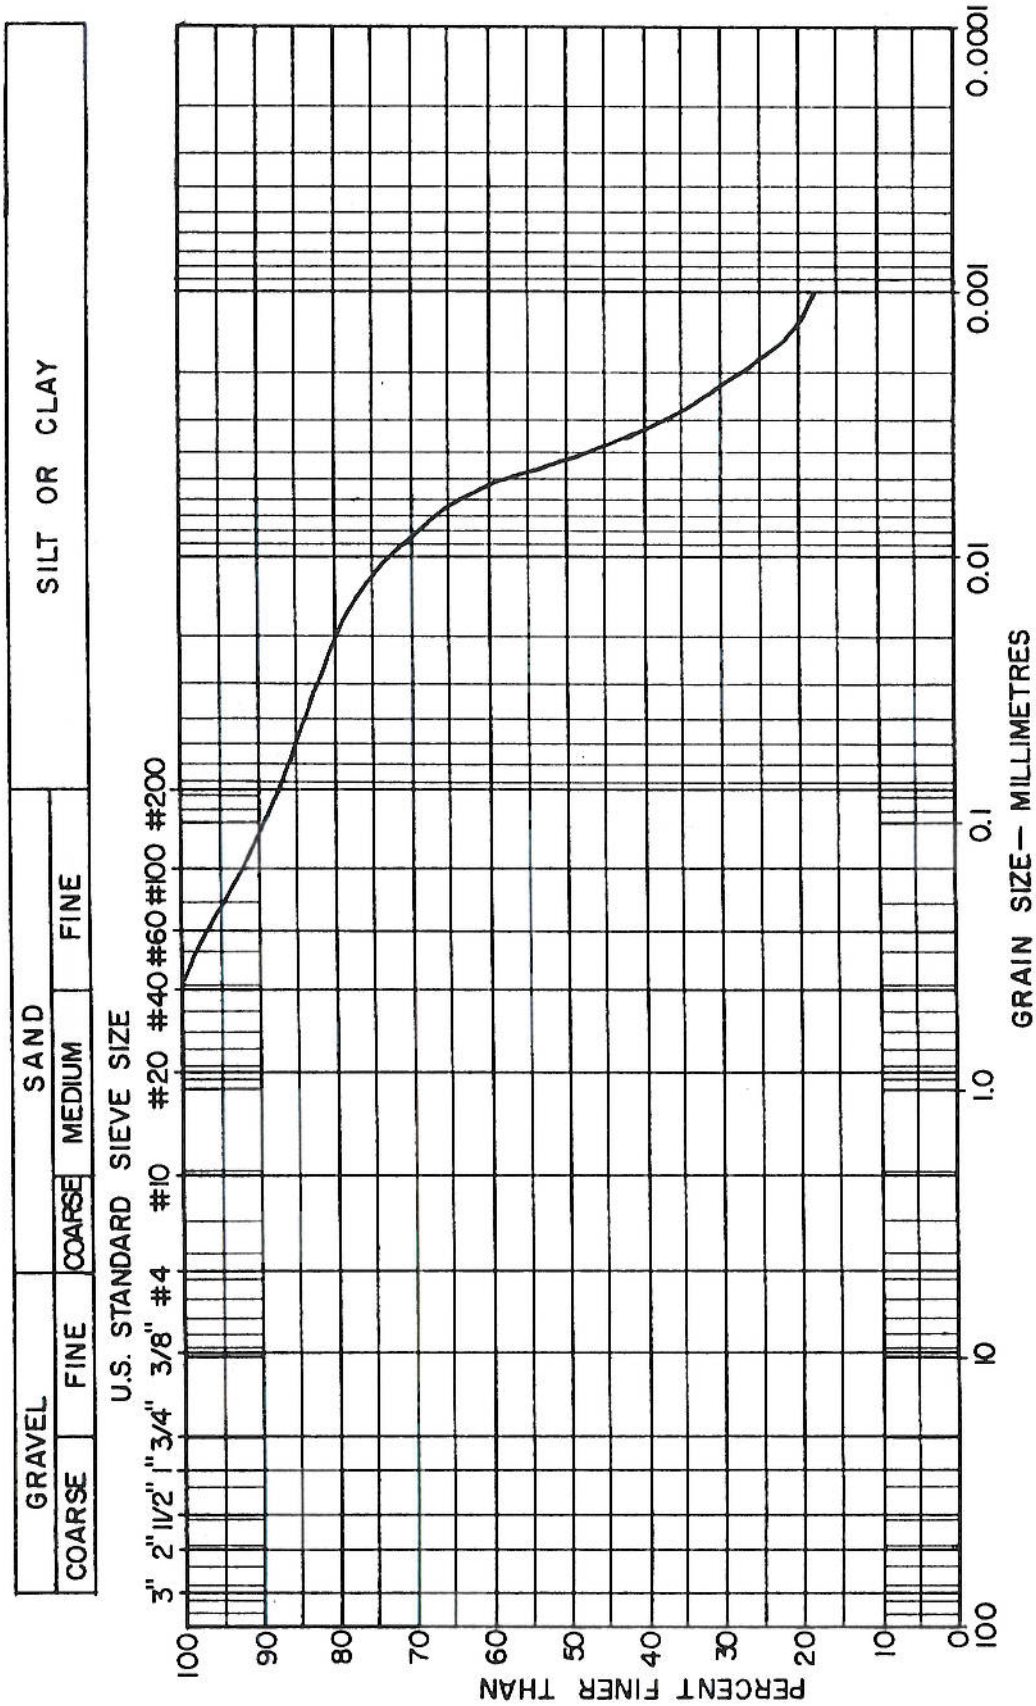
GRAIN SIZE CURVE

REMARKS: silty CLAY, little sand, high plasticity, moist, reddish brown

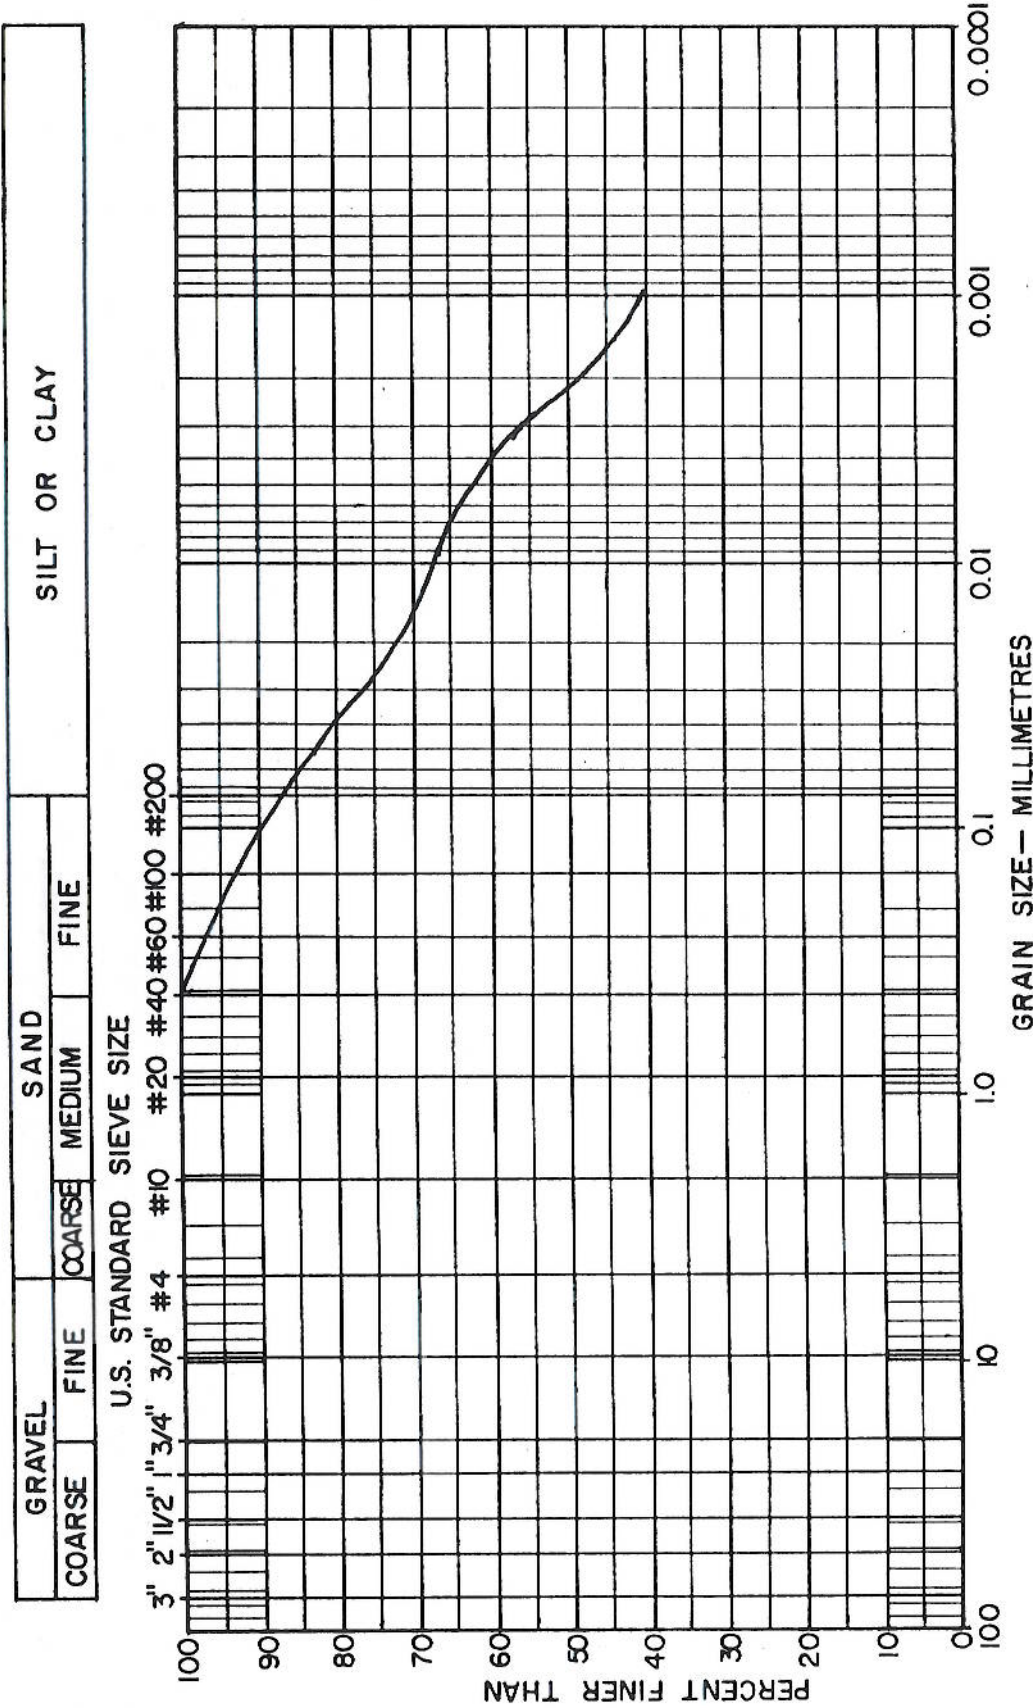
GRAIN SIZE CURVE

REMARKS: SILT & CLAY. little sand, medium to low plastic, moist, reddish brown

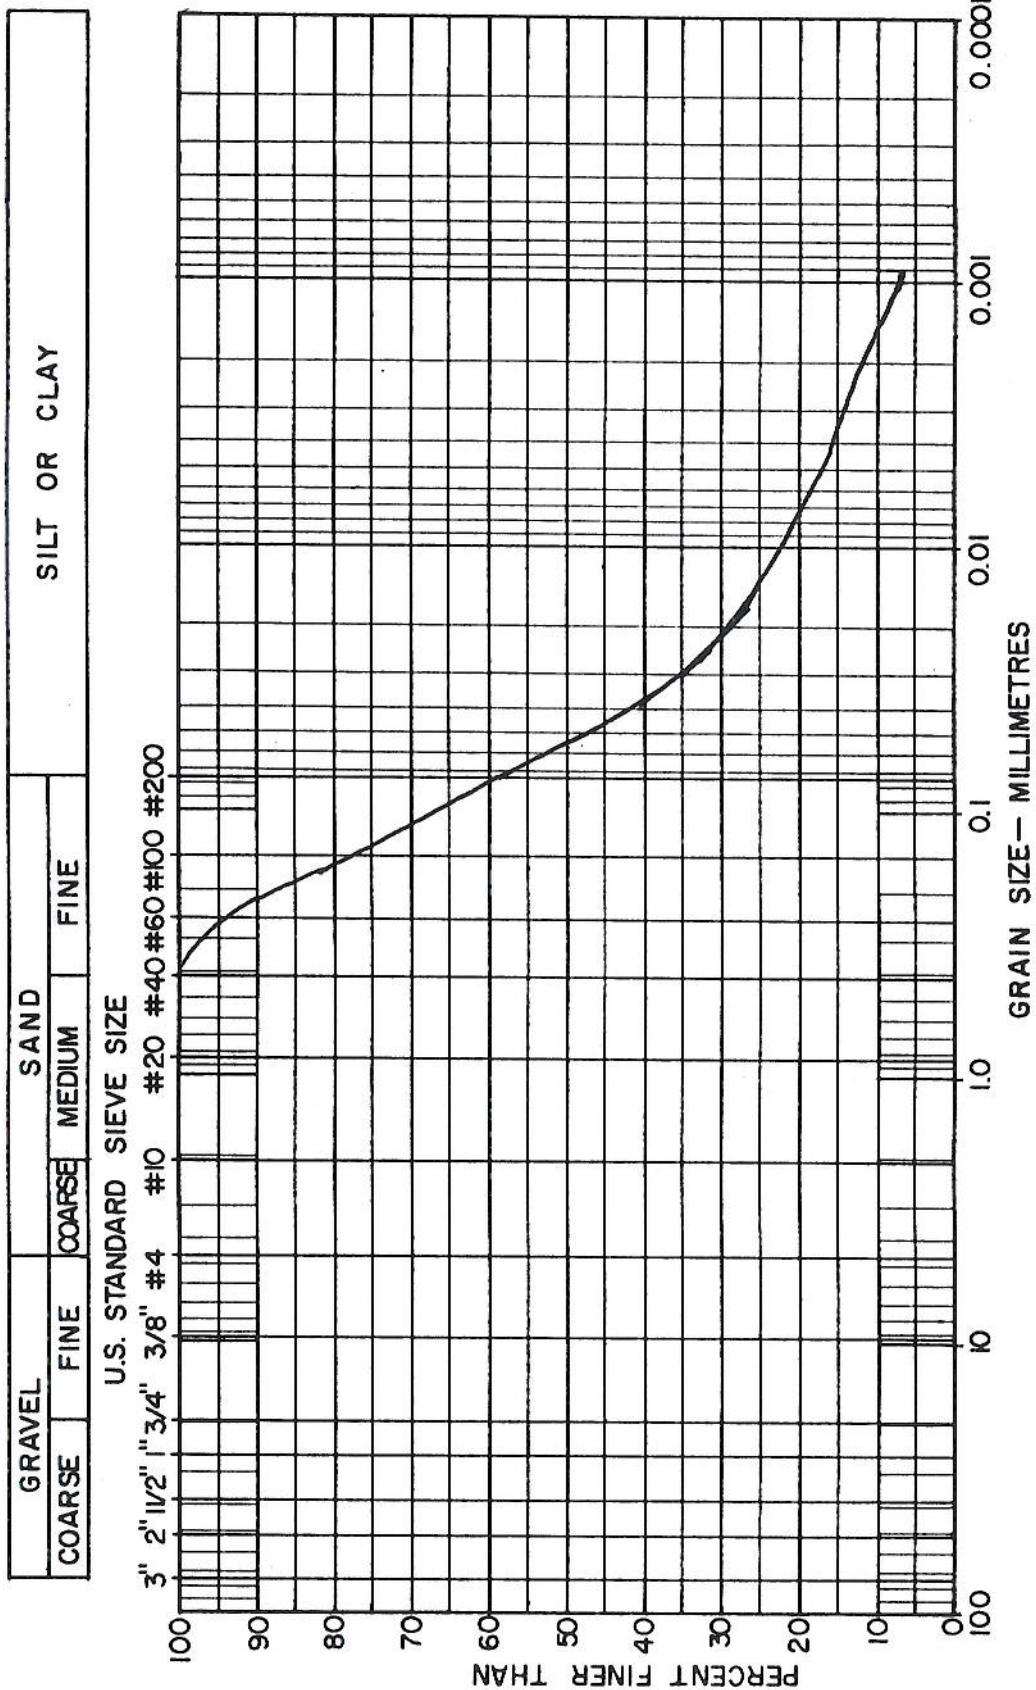
GRAIN SIZE CURVE

REMARKS: clayey SILT & SAND, low plasticity, moist, reddish brown

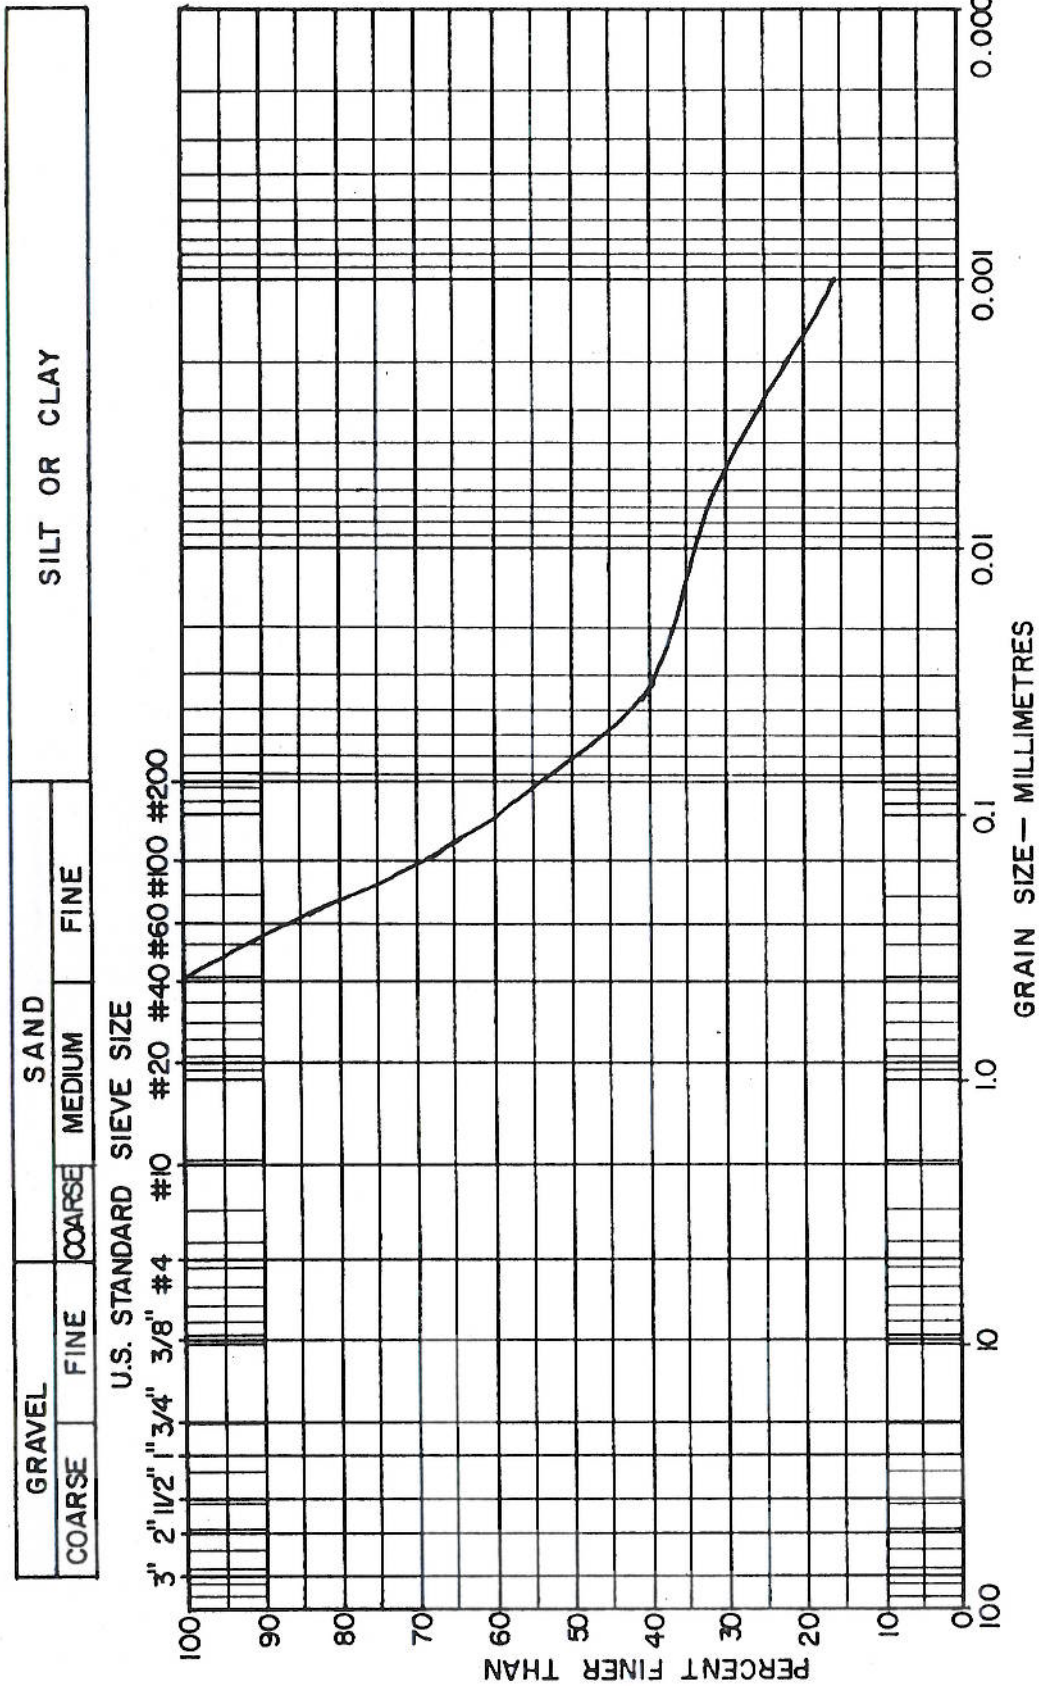
GRAIN SIZE CURVE

REMARKS: clayey SILT & SAND, low plasticity, moist, grey

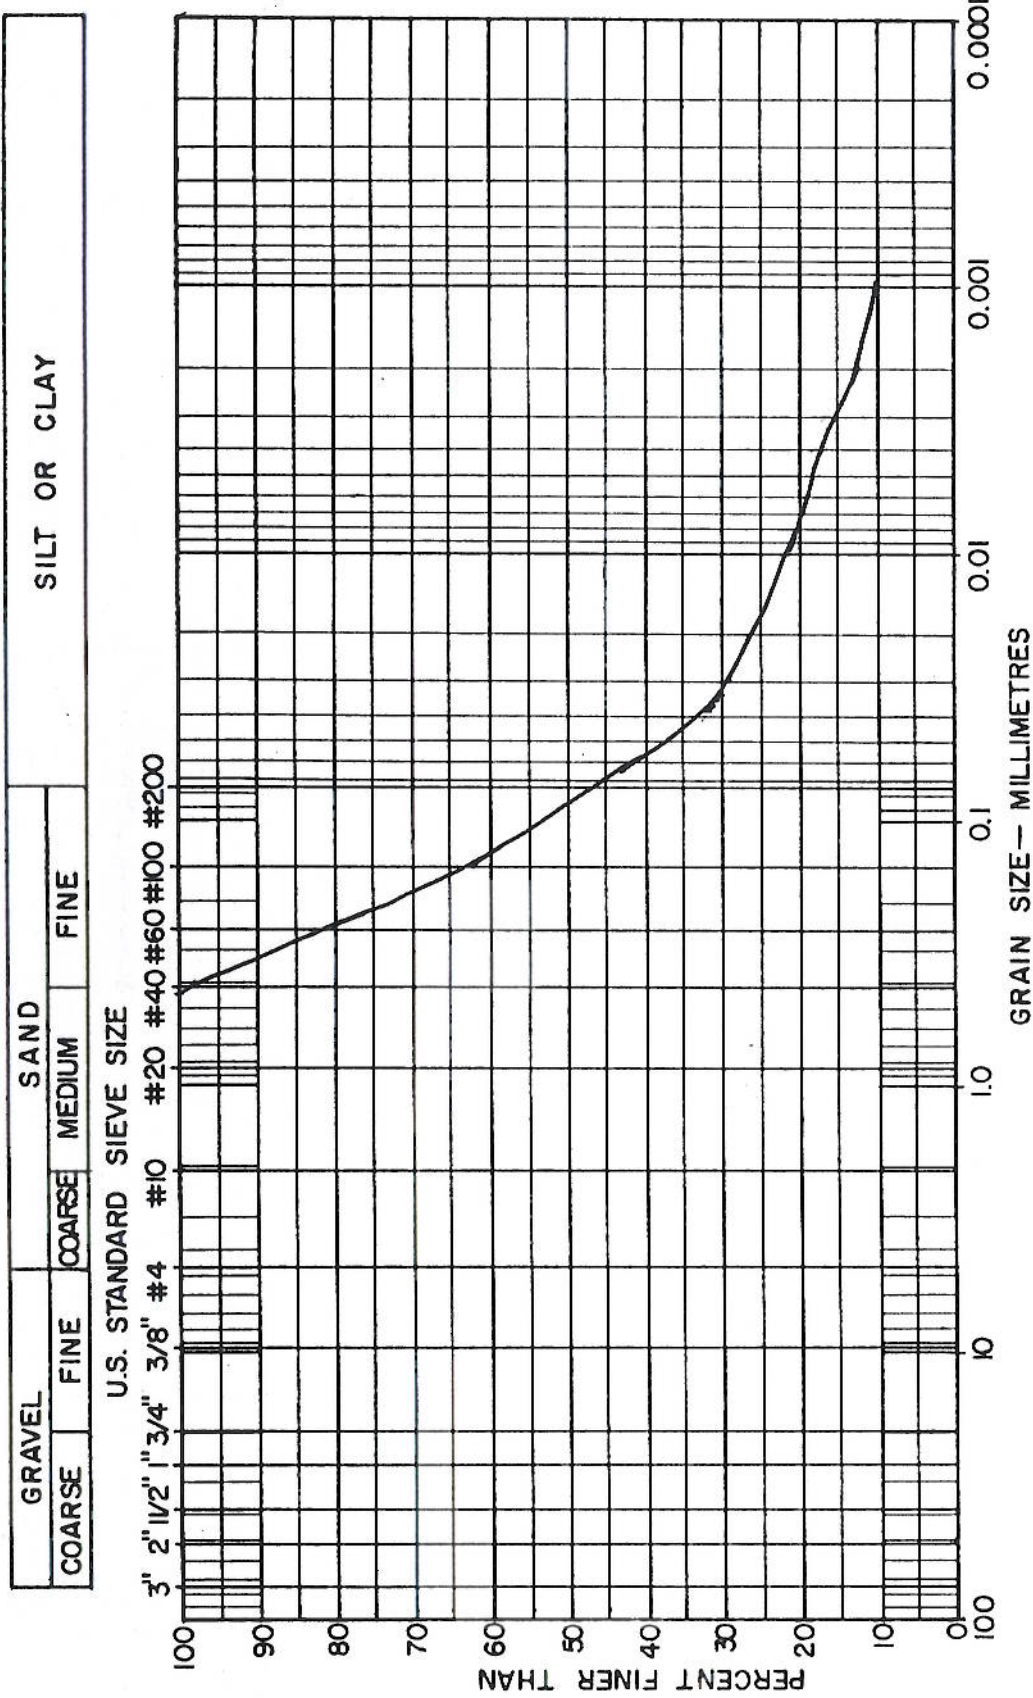
GRAIN SIZE CURVE

REMARKS: clayey SAND & SILT, low plasticity, moist, grey

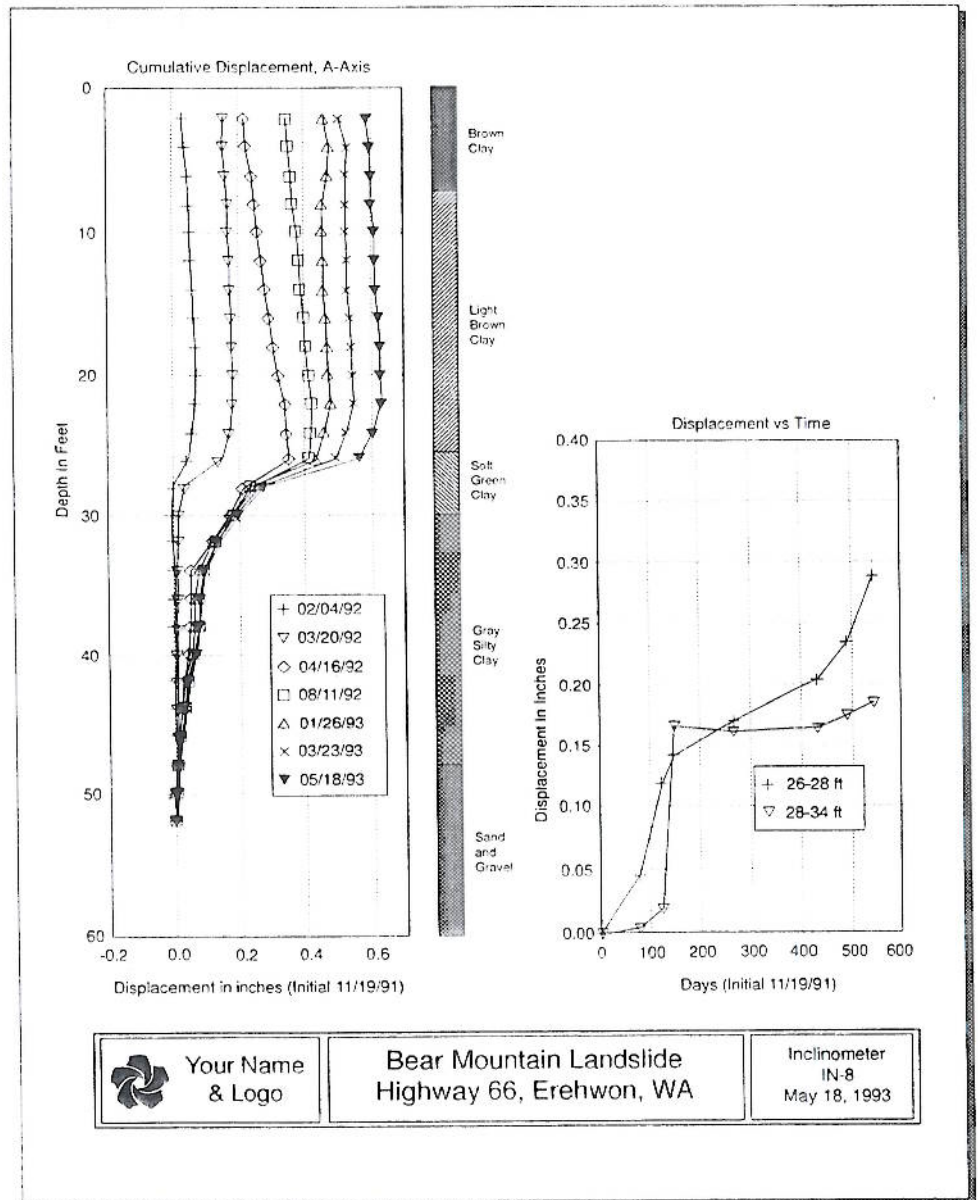
Graphs of Displacement Generated by the DigiPro Program

Displacement Changes in deviation, i.e. changes in the position of the casing, are called displacements. The change at one interval is called incremental displacement. The sum of incremental displacements is called *cumulative* displacement. DMM can produce reports and simple graphs of displacement. Slope Indicator's DigiPro program can produce more sophisticated graphs for up to 21 datasets.
