**WATERSHED AND ENVIRONMENTAL  
MANAGEMENT PROJECT - PHASE II**

**INCEPTION REPORT**

**October 1996**

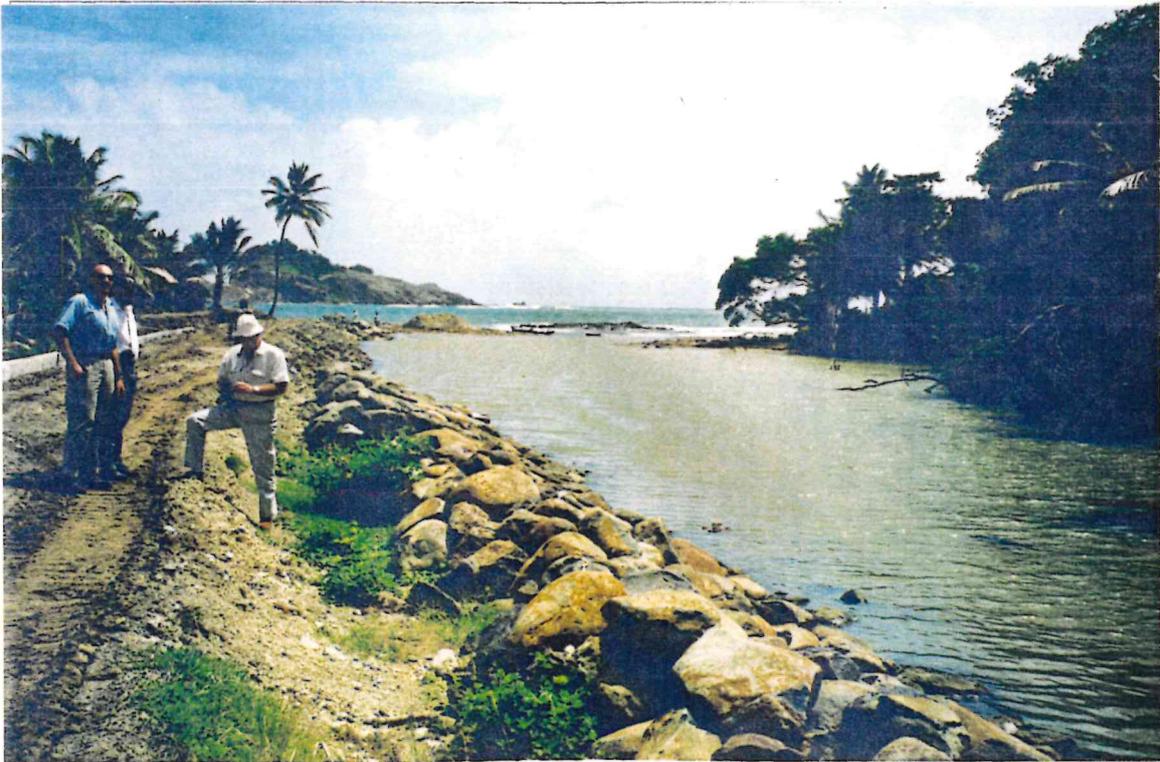
Photo 1 Massive rip-rap protection to Dennery town (view DS to outfall). Work still to be completed.

The initial impression was that of extensive river works carried out to protect urban areas and infrastructure. Photo 1, presented at the end of the report, shows the major rip-rap river bank works to protect Dennery town. Photos 2 shows a gabion wall in the Cul-de-Sac river designed to protect a single house, but more importantly the main road between Bexon and Castries. Photo 3 shows an example of the severe damage which took place adjacent to the river in the town of Soufriere. Photo 4 depicts the same location but with the gabion training walls that were constructed on both banks of the channel to protect the houses from further damage and to provide the basis for rehabilitation. All of those works provided the designed protection in the 26th October event.

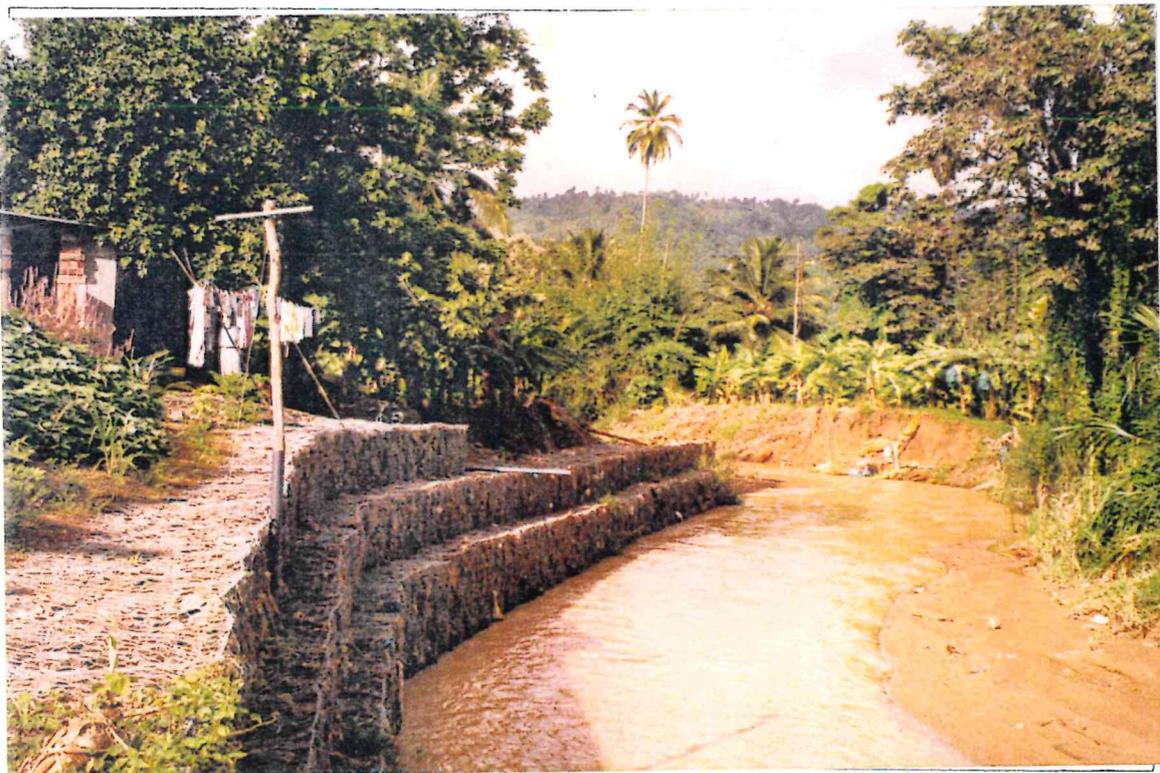
Photo 2 Gabion wall in Cul de Sac to protect infrastructure has inadvertently trained flow across the river to scour opposite bank (view DS)

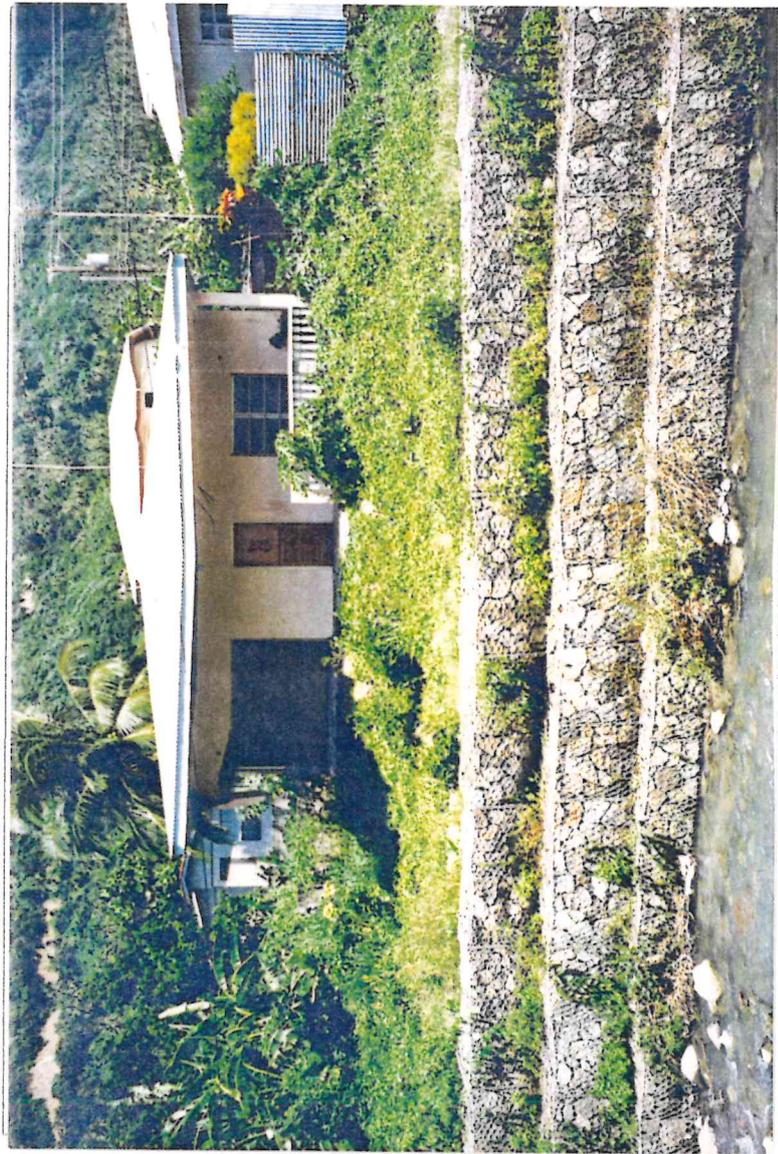
Photo 4 October 1996

**Photograph 4      Damage to the Right Bank of the Soufriere River**

Damage on Right Bank of Soufriere River as it enters the Town repaired under Phase 1

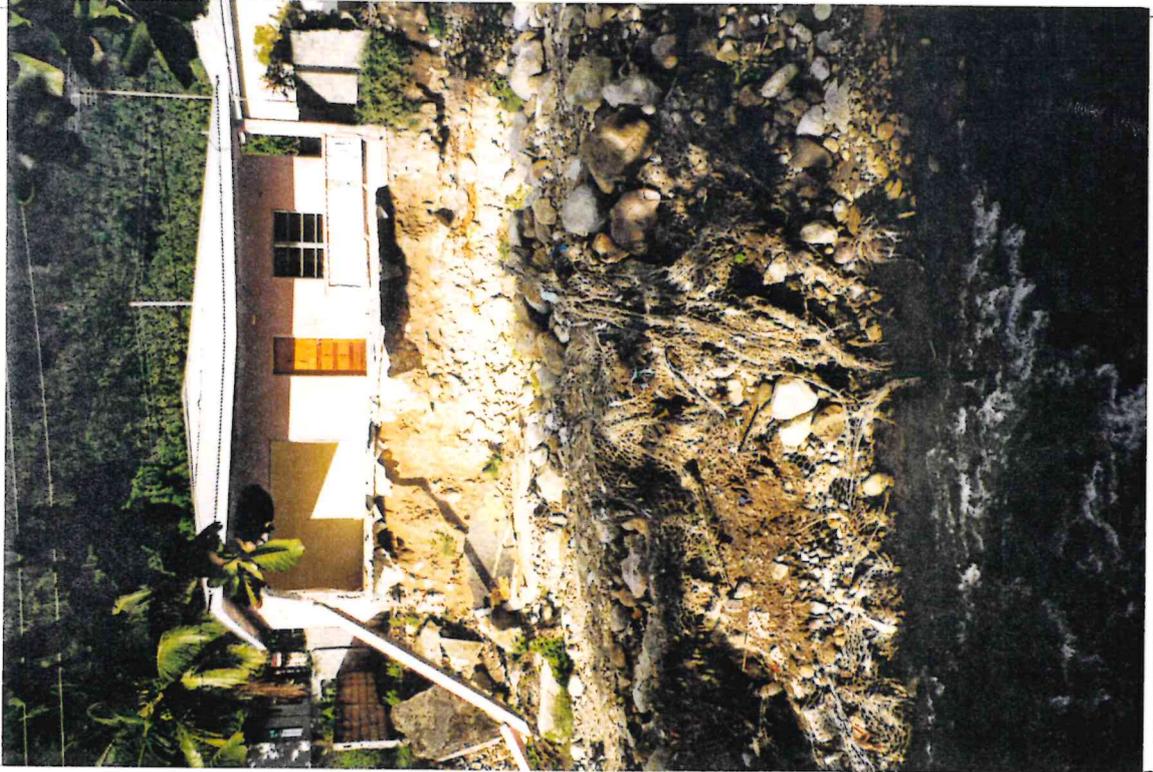
Photo 3 December 1994

**Photograph 3      Damage to the Right Bank of the Soufriere River**
